Bald Head Island, N.C. Beach Monitoring Program

Monitoring Report No. 15 (April 2016 to May 2017)

Prepared for:
Village of Bald Head Island

Prepared by:
Olsen Associates, Inc.
2618 Herschel Street
Jacksonville, FL 32204
(904) 387-6114
(Fax) 384-7368
olsen-associates.com
C-1468

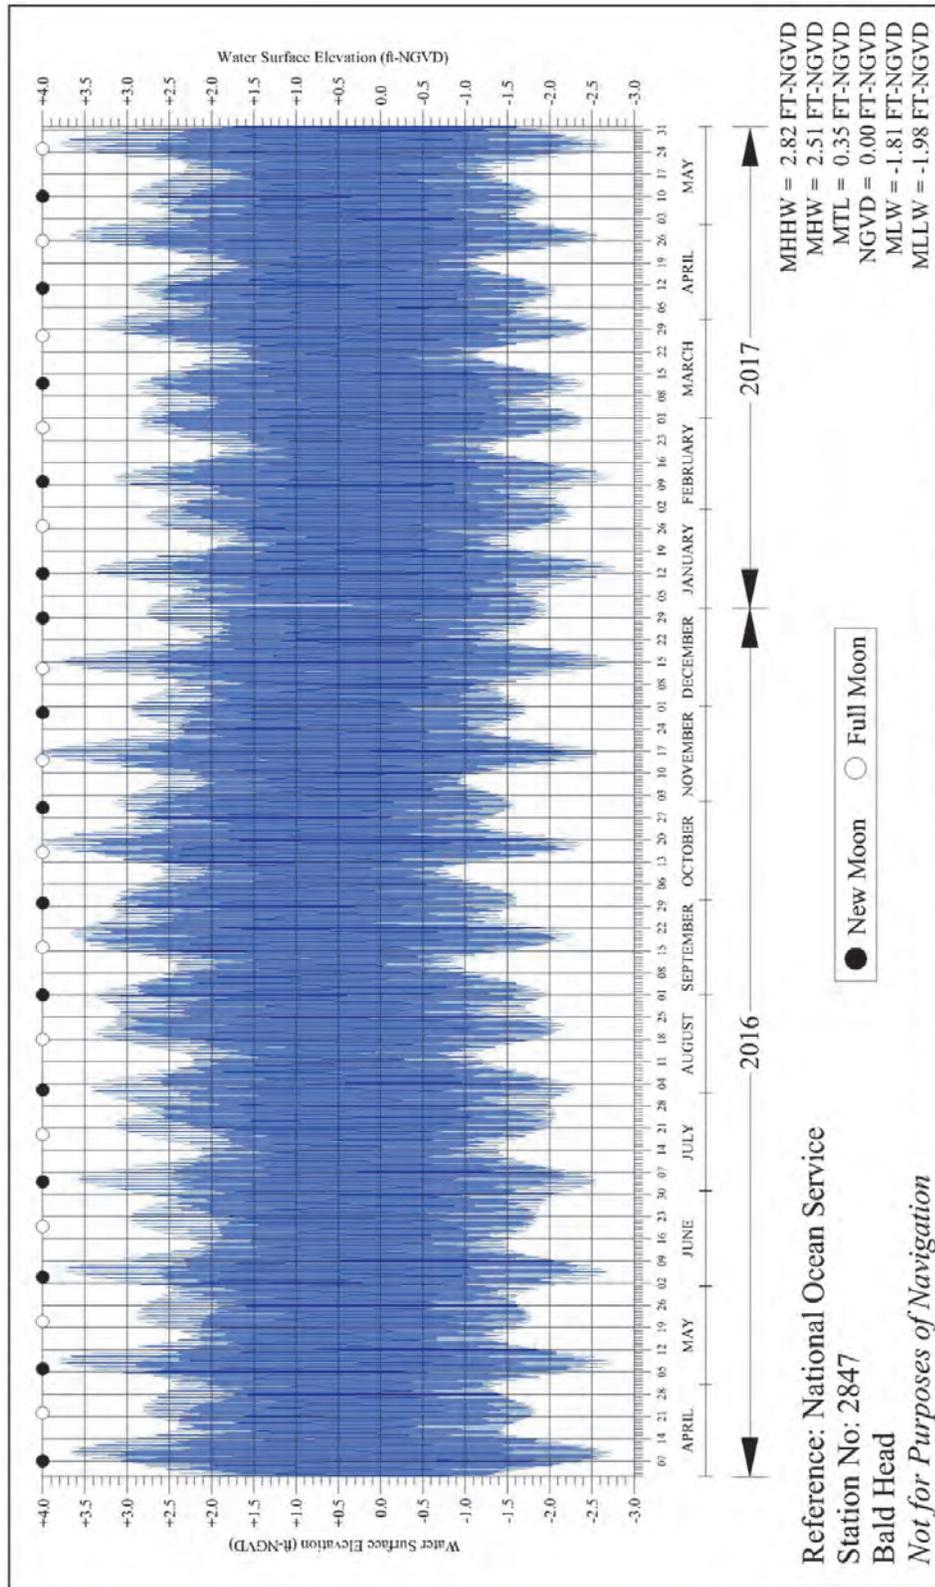
Figure 1.2: April 2016 through May 2017 predicted astronomical tides, Bald Head Island, North Carolina.

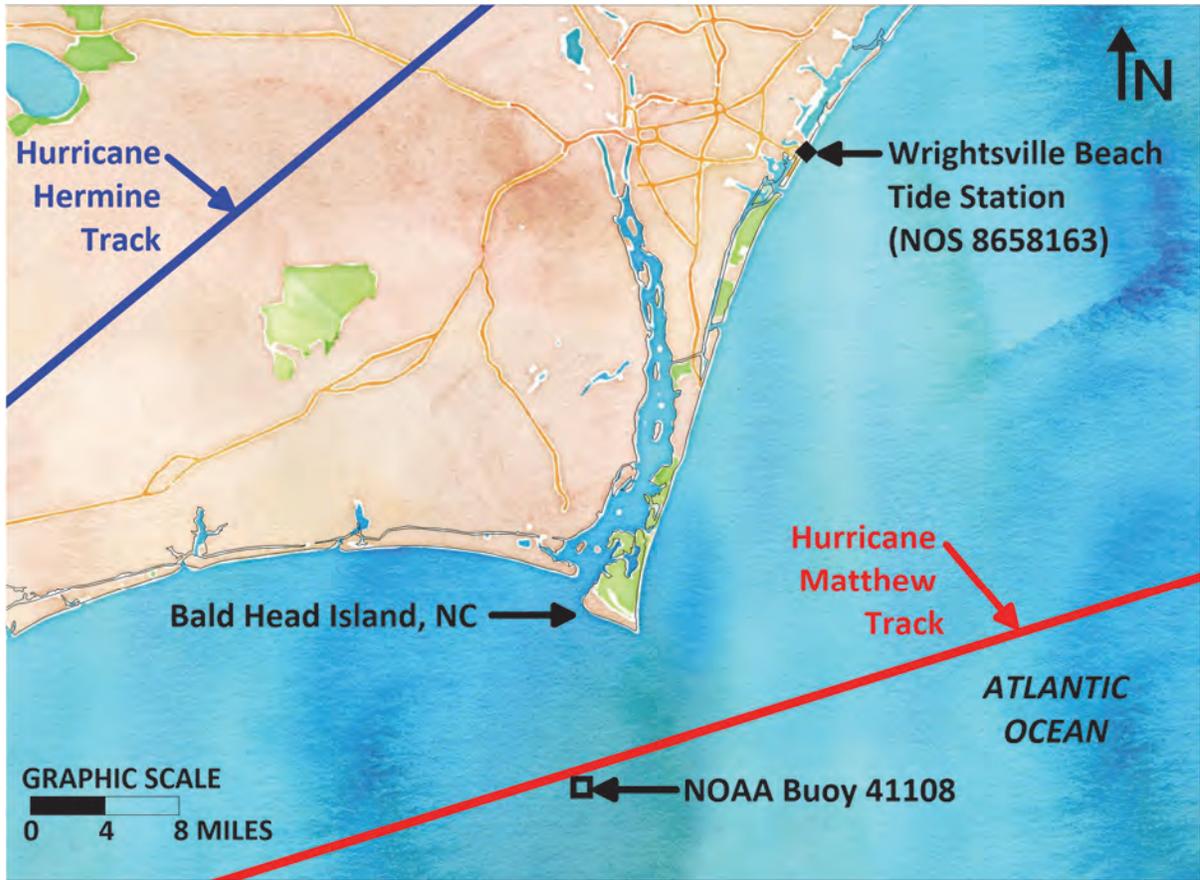
Figure 1.4: Storm tracks of Hurricane Hermine and Matthew in the vicinity of Bald Head Island showing the location of NOAA Buoy 41108 and the Wrightsville Beach, NC tide station (NOS 8658163). Track available from the National Hurricane Center.

Figure 1.4 plots the track of both storms in the vicinity of Bald Head Island. The figure also displays the location of NOAA Buoy 41108, located roughly 9 miles south of Bald Head Island in approximately 42 feet of water. The buoy was deployed in March 1988 and has been collecting data nearly continuously for 29+ years except for an approximate 5 year period between April 1992 and May 1997. The data collected by the buoy includes significant wave height (average of the highest one-third of all waves in a 20-minute sampling period), wave period, wave direction, wind speed and other standard meteorological data.

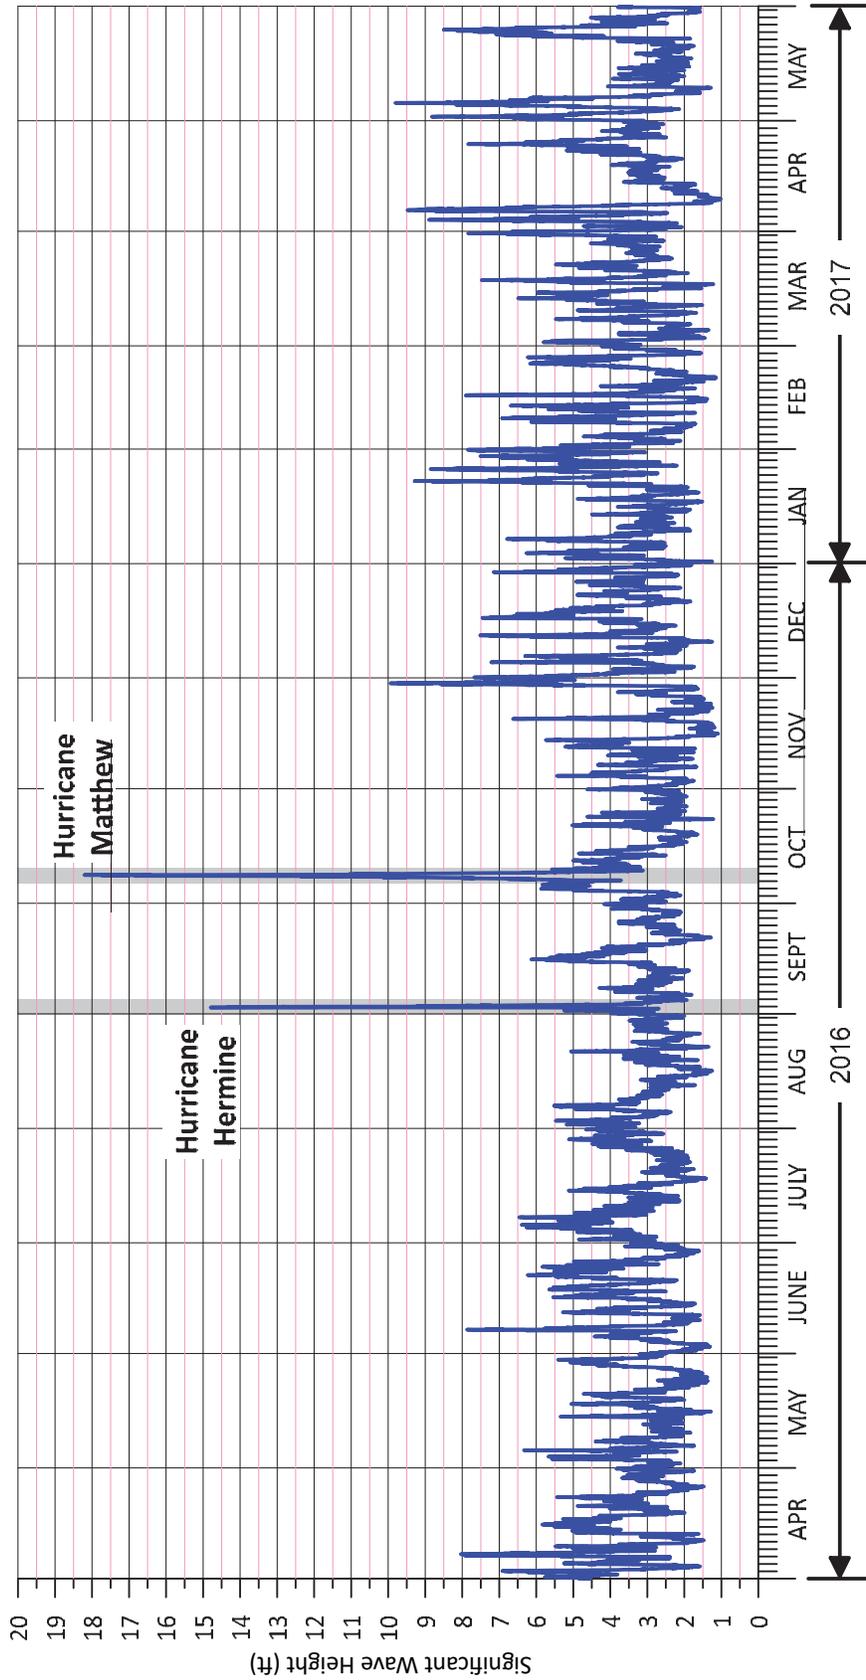
Figure 1.5: Significant wave heights recorded by NOAA Buoy 41108 during the 2016-17 monitoring period (Wilmington Harbor, NC).

Figure 1.5 displays a time series of significant wave heights measured at NOAA Buoy 41108 from April 2016 through May 2017. **Figure 1.6** depicts the time series measured at the buoy during the passage of Hurricane Hermine (upper panel) and Matthew (lower panel). While the buoy is located offshore in unprotected waters, the wave conditions measured can generally be related to nearshore conditions along the monitored area. Additionally, some fraction of the waves measured at the buoy are directed offshore. All wave statistics mentioned in this section will be from measurements at Buoy 41108.

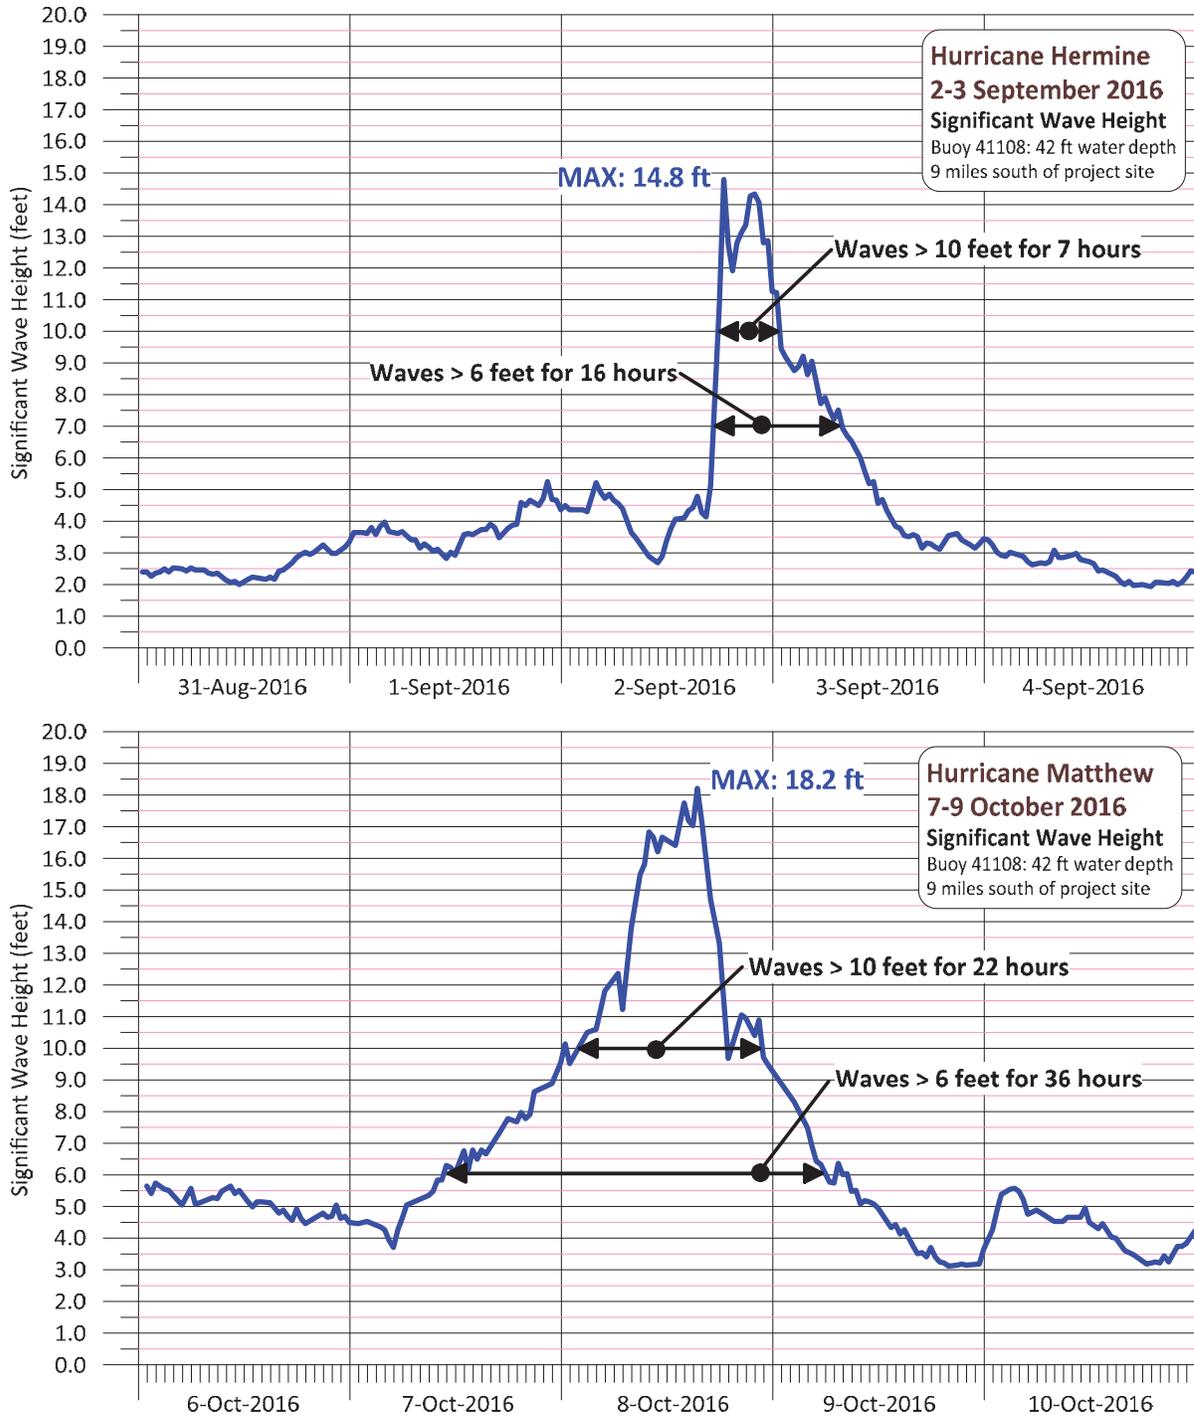
Figure 1.6: Time series of significant wave heights measured at NOAA Buoy 41108 as Hurricanes Hermine and Matthew moved by Bald Head Island, NC. The buoy is located approximately 9 miles south of Bald Head Island in 42 feet of water.

During Hurricane Hermine, significant wave heights peaked at 14.8 feet on the evening of September 2nd, as the storm's center was approximately 40 miles northwest of the wave buoy. It is noted that these measurements reflect the significant wave height, or the average of the highest 1/3rd of waves passing the buoy during a 20 minute sampling period. There are waves that passed during the storm that were larger in height – some waves may have been as much as twice as high. Large waves persisted along the coast for a significant duration of time with significant wave heights greater than 10 feet lasting for more than 7 hours and waves greater than 6 feet for 16 hours. The dominant wave period peaked at about 12 seconds during this time.

During Hurricane Matthew, significant wave heights peaked at 18.2 feet on the afternoon of October 8th, as the storm's center neared the wave buoy. Large waves persisted along the coast for a significant duration of time with significant wave heights greater than 10 feet lasting for more than 22 hours and waves greater than 6 feet for 36 hours. The dominant wave period peaked at about 13 seconds during this time.

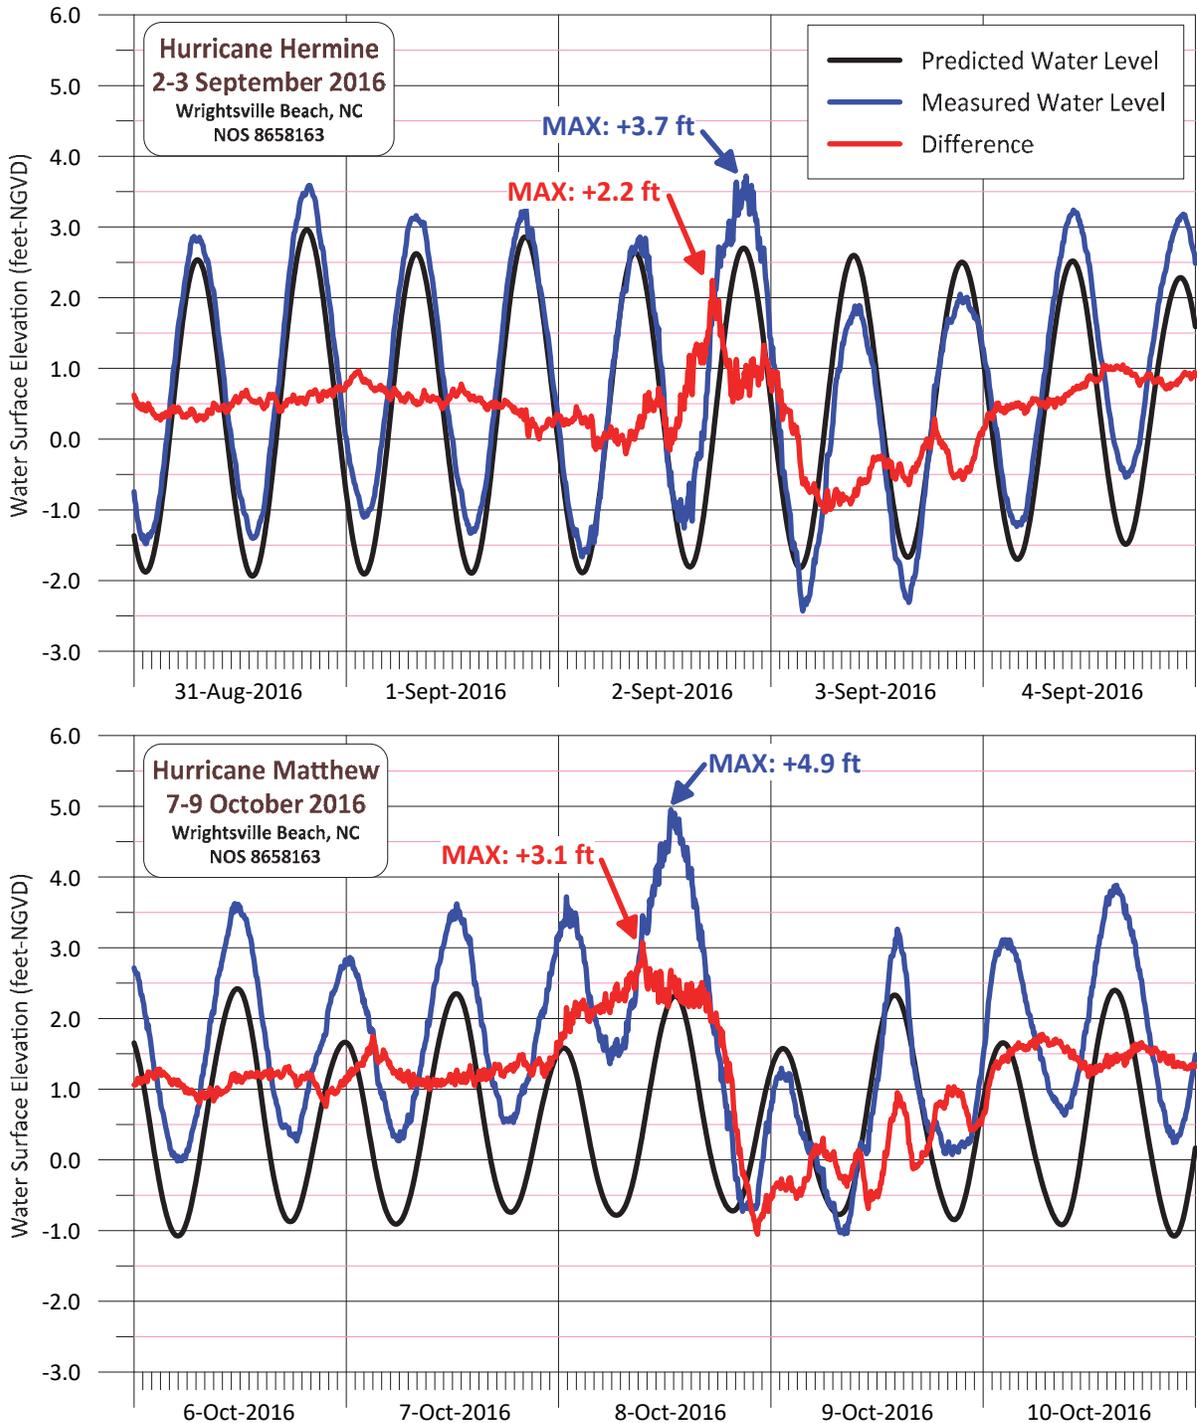
Figure 1.7: Time series of water levels measured at the Wrightsville Beach NOAA tide gage (NOS 8658163) located along the open Atlantic Coast, as Hurricanes Hermine and Matthew passed. The center of Hurricane Matthew passed approximately 30 miles offshore of the station, compared to 7 miles offshore of Bald Head Island. As such, water levels reported here are likely to be somewhat lower than those experienced along the open coastline of Bald Head Island.

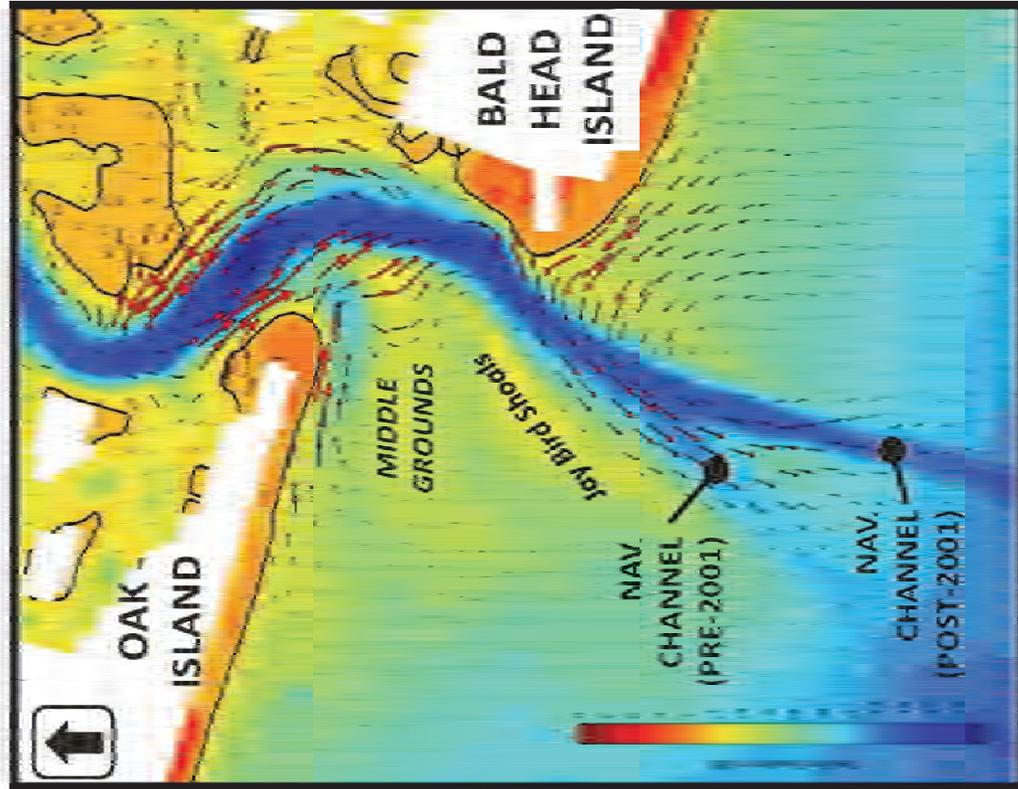
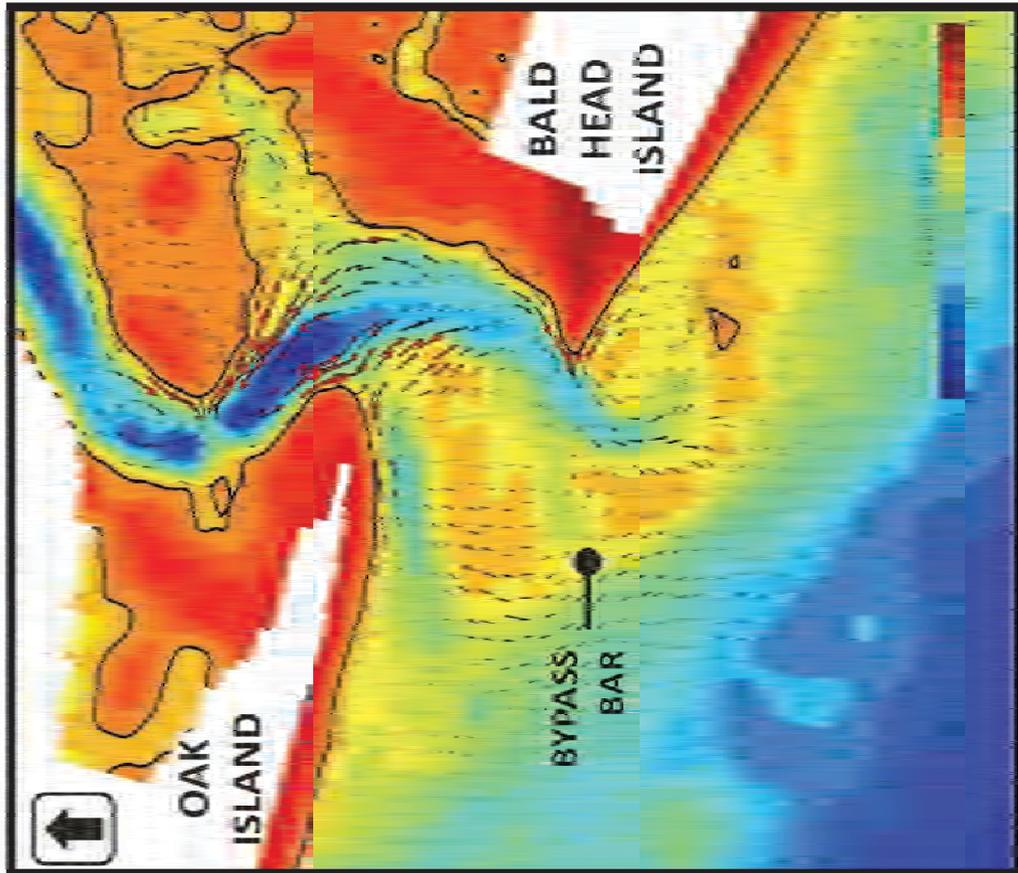
2005/06 (Post-Navigation Project)

1865 (Pre-Navigation Project)

Figure 1.8: Navigation Project induced morphological changes at the Cape Fear River Entrance.

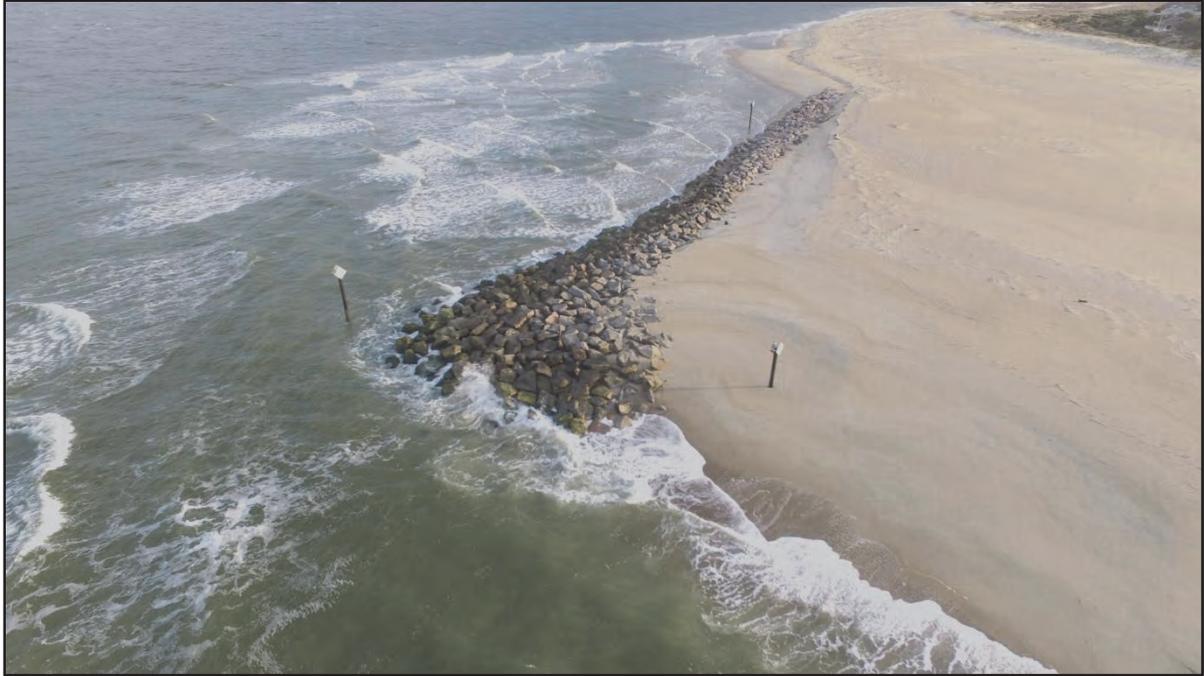
Figure 1.9: Bald Head Island terminal groin (Photo Date: March 21, 2017)

“template” for fill material placed eastward thereof on South Beach. The terminal groin was designed as a “leaky” structure (*i.e.* semi-permeable) so as to provide for some level of sand transport to West Beach and portions of the Point (located northward of the proposed groin). It is the Village’s position that the construction of the structure may have direct benefits to the abutting navigation channel. The structure was to be constructed in 2 phases. Phase I, constructed in 2015 is approximately 1,300 ft in length. Phase II will only be initiated after some period of monitoring of the groin’s post-construction performance and the determination that some level of additive structure is warranted.

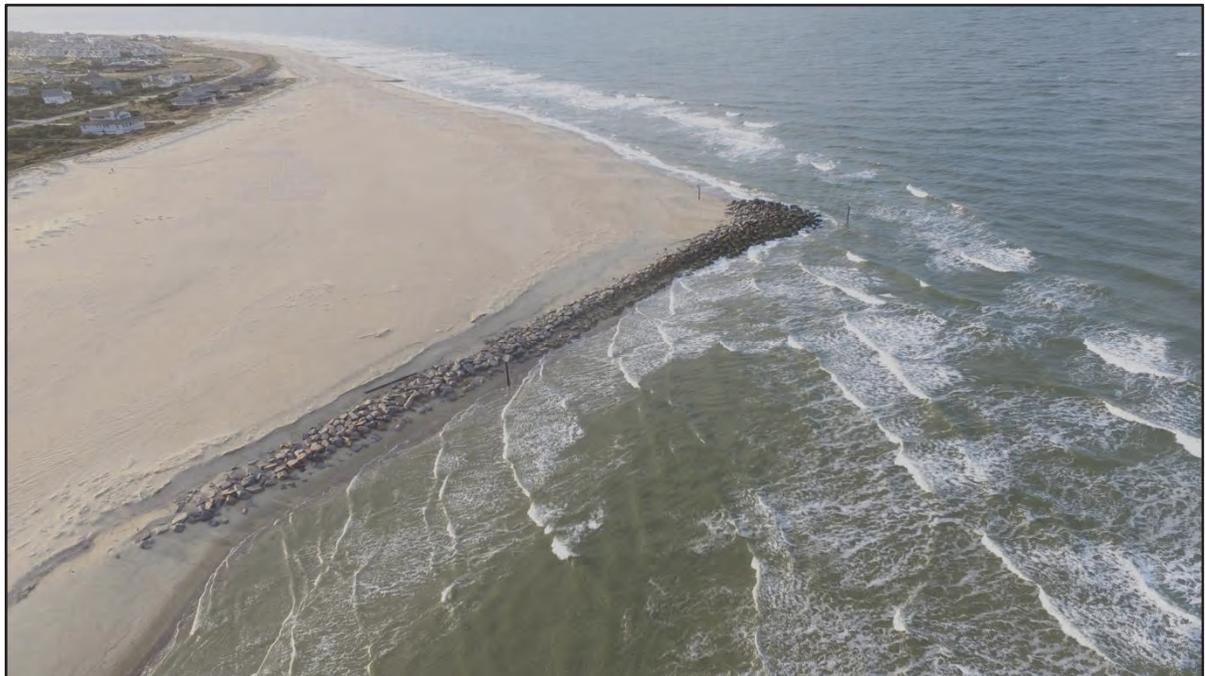
Figure 1.10: Bald Head Island terminal groin (Photo Date: March 21, 2017)

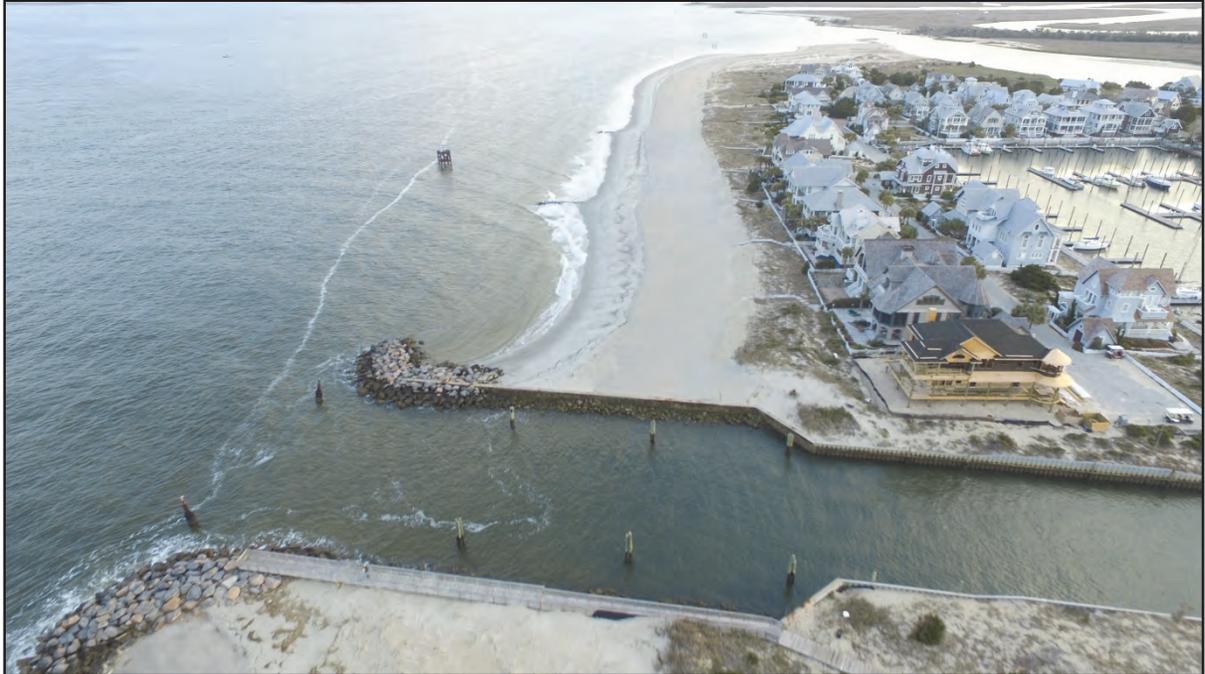
Figure 1.11: View looking *northward* from the marina jetties along the recently filled Row Boat Row shoreline. (Photo Date: March 21, 2017)

Each rock jetty extension was placed on Tensar marine mattresses for purposes of minimizing future maintenance requirements due to scour and settlement. All work was performed by barge. Since project completion, no maintenance dredging has been required. The 2016 Shore Stabilization Project constructed by Marcol Dredging (see **Section 1.6.1**) was predicated primarily upon the need to place sand along the Row Boat Row shorefront due to post-jetty extension erosion and shoreline recession at that location. The purpose of that fill project was to reconstruct the shoreline prior to the placement in 2017 of two (2) small detached breakwaters intended to reduce the daily effects of barge and ferry wake. Photographs depicting shoreline conditions on both the north and south side of the jetties are included as **Figures 1.11** and **1.12**.

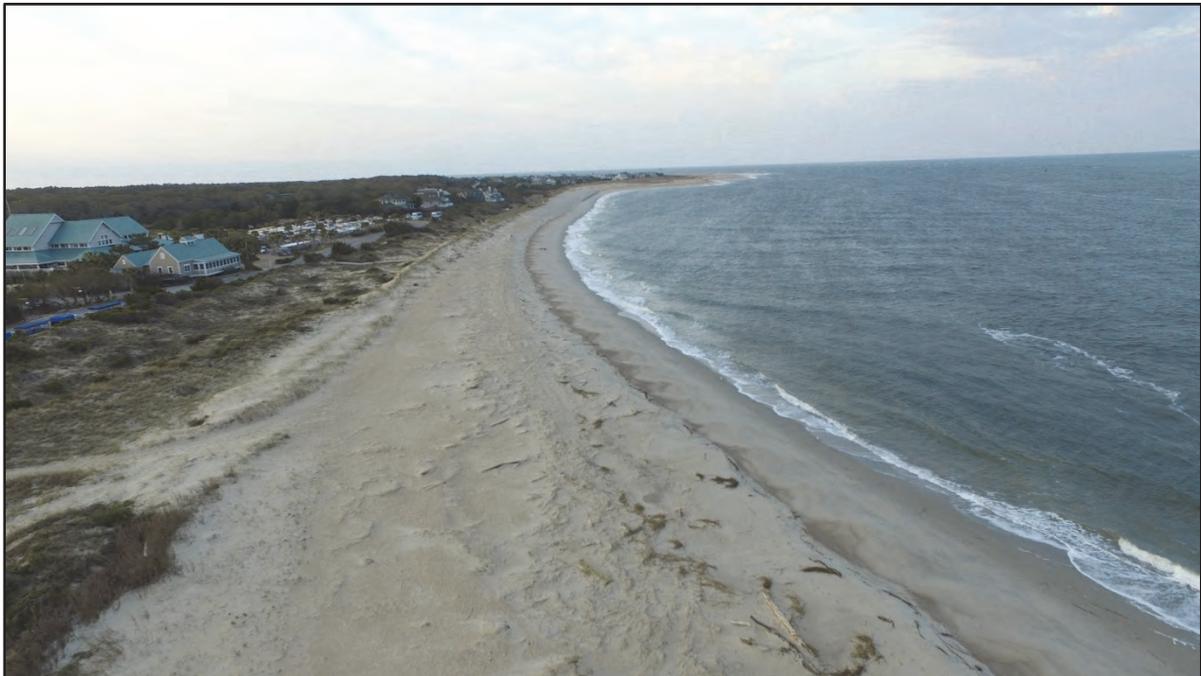
Figure 1.12: View looking *southward* from the marina jetties along the West Beach shoreline. (Photo Date: March 21, 2017)

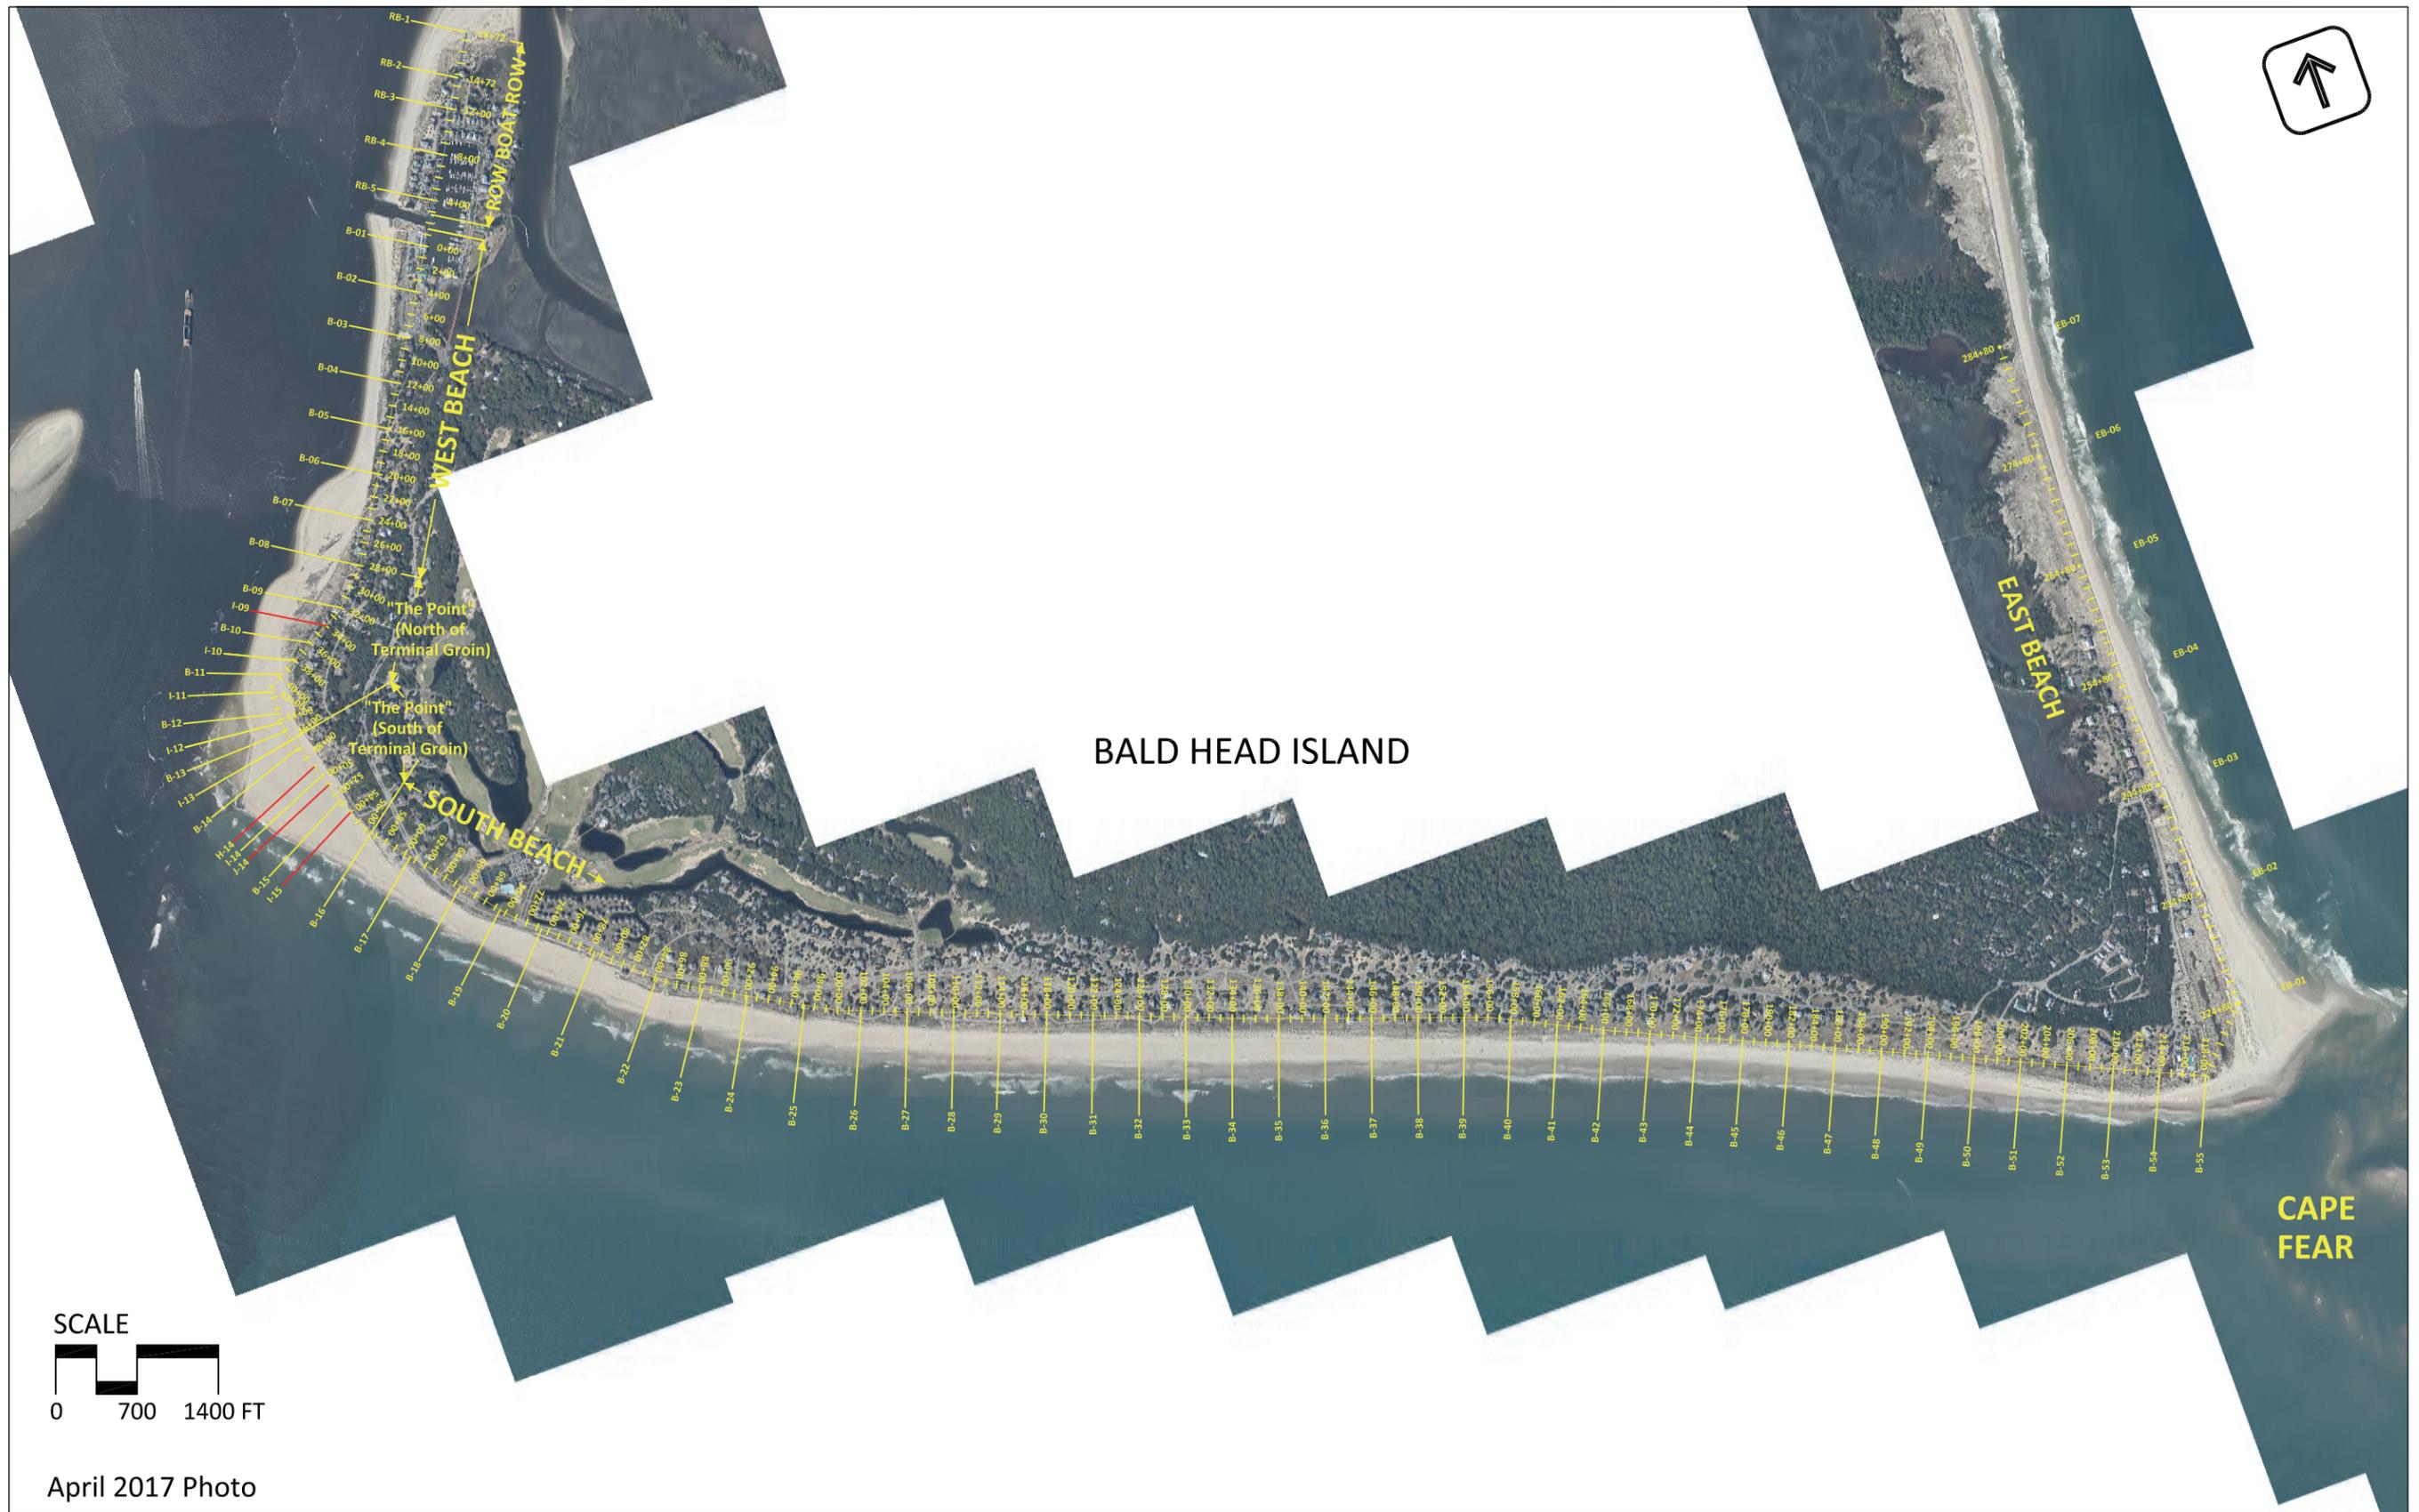
Figure 2.1:
Island-wide beach monitoring baseline.

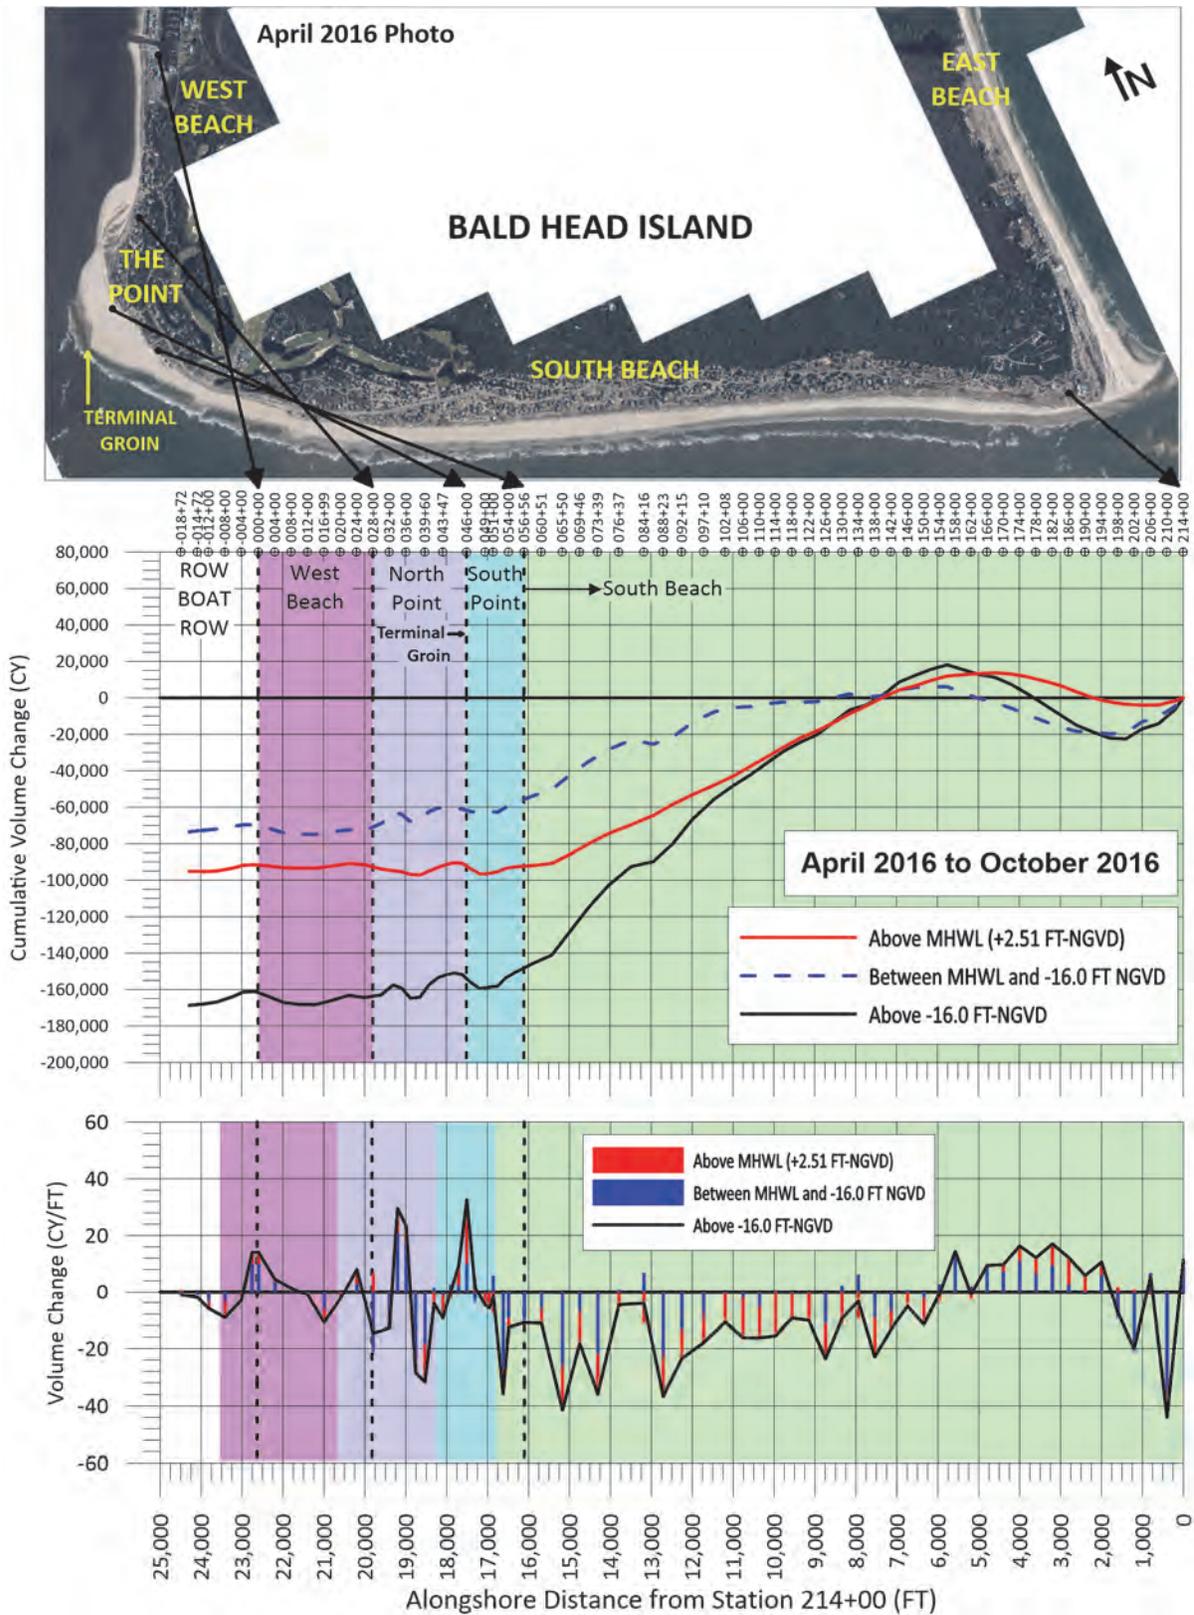
Figure 3.1: Volume change along the Bald Head Island shoreline between April 2016 and October 2016 (Post-Matthew).

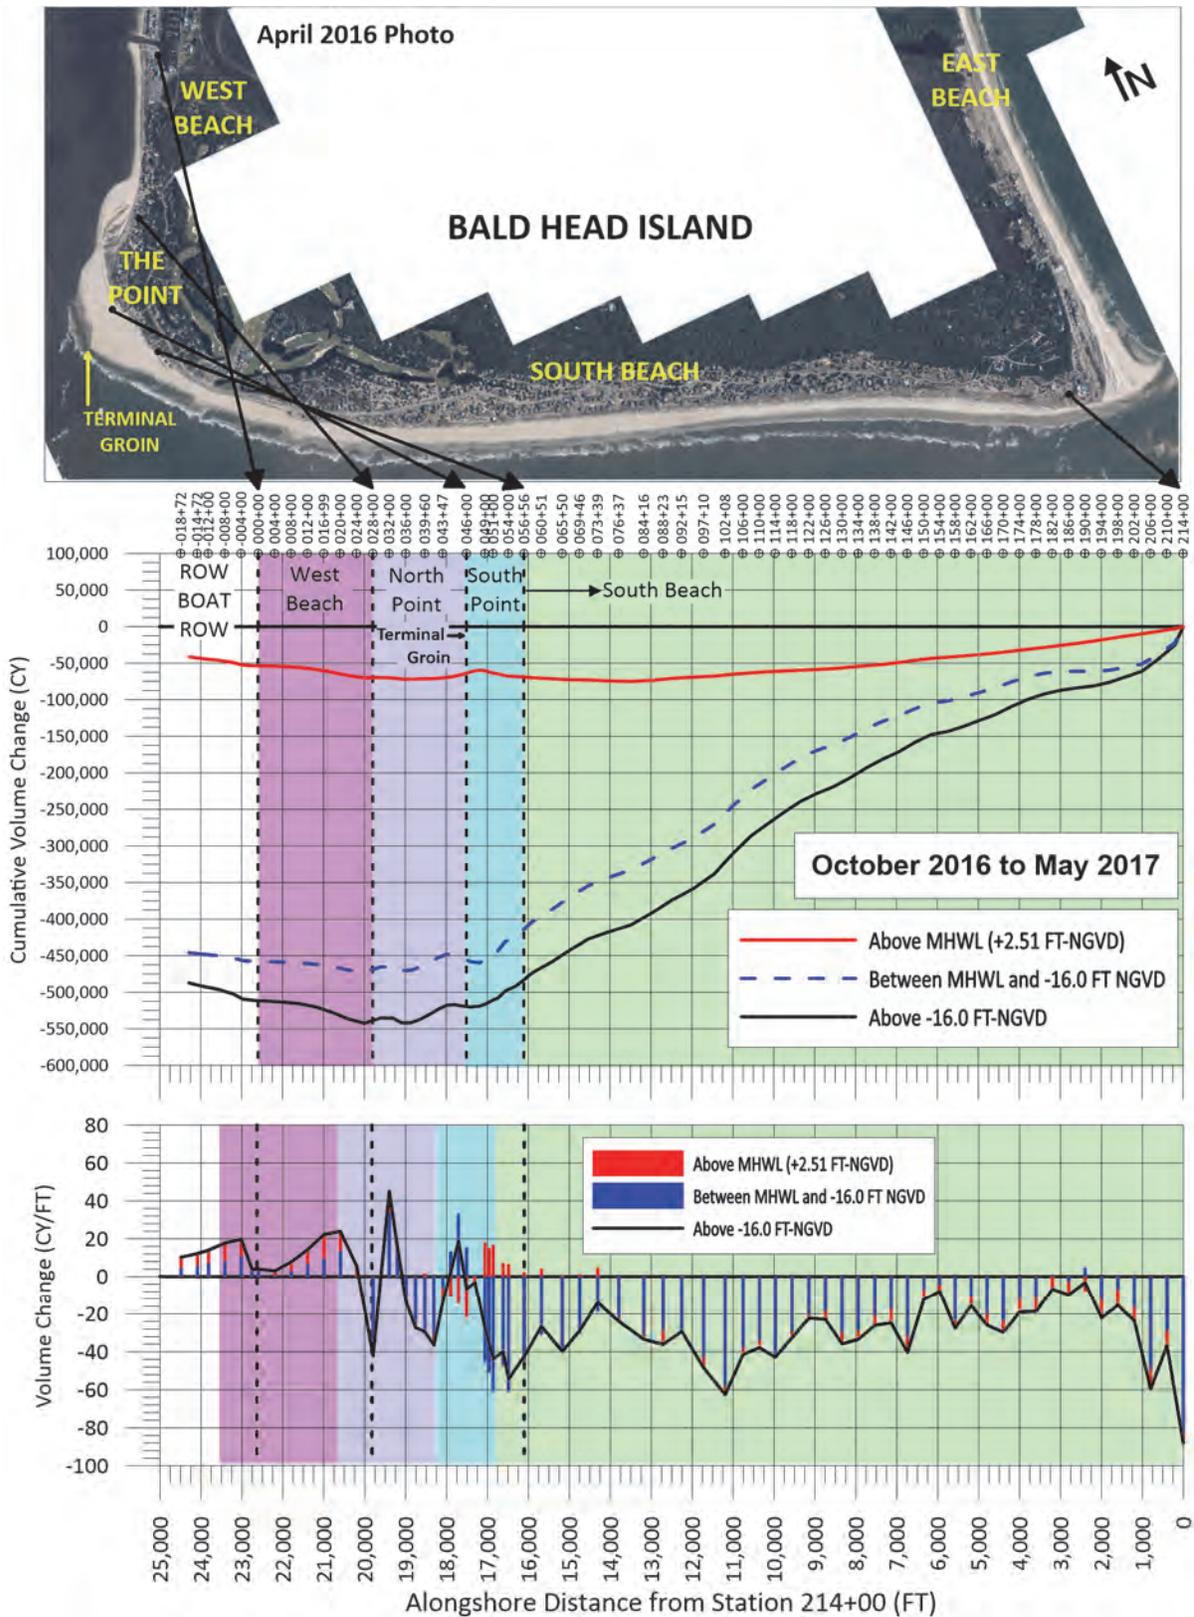
Figure 3.2: Volume change along the Bald Head Island shoreline between October 2016 & May 2017.
