Bald Head Island, N.C. Beach Monitoring Program

Monitoring Report No. 15 (April 2016 to May 2017)

Prepared for:
Village of Bald Head Island

Prepared by:
Olsen Associates, Inc.
2618 Herschel Street
Jacksonville, FL 32204
(904) 387-6114
(Fax) 384-7368
olsen-associates.com
C-1468

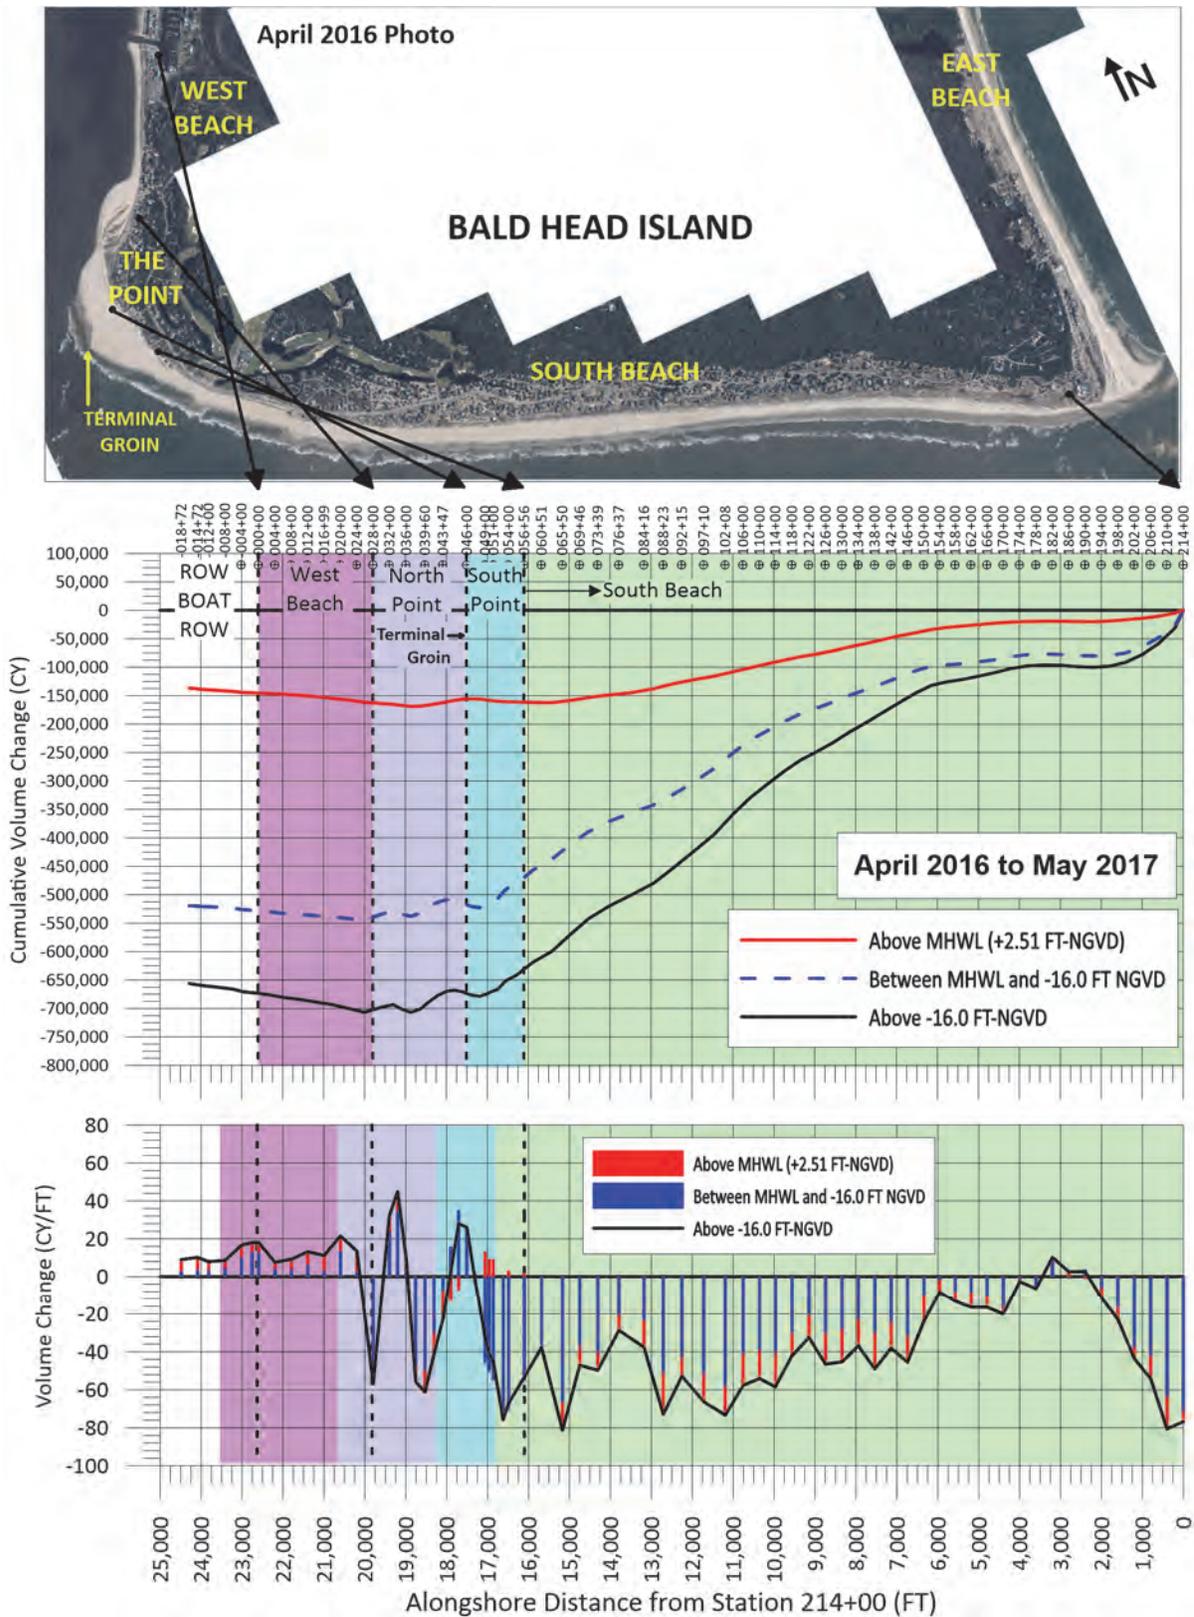
Figure 3.3: Volume change along the Bald Head Island shoreline between April 2016 and May 2017.

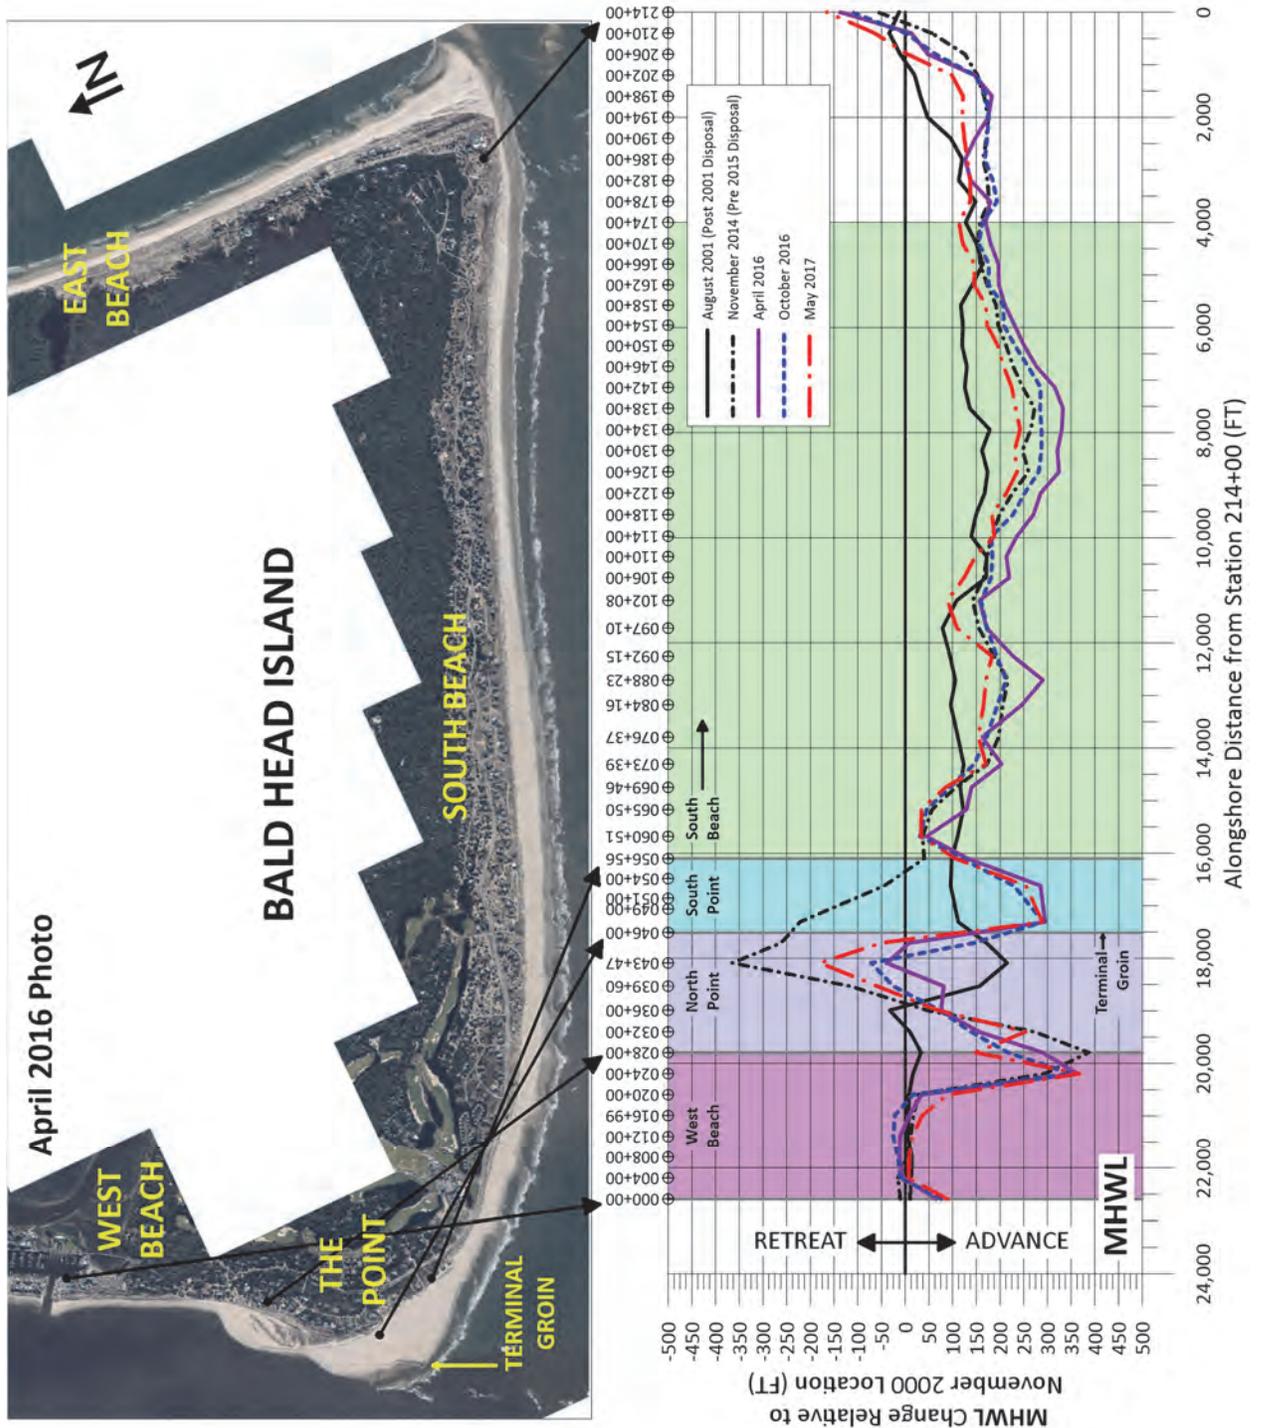
Figure 3.4: Location of the MHWL (+2.51 ft-NGVD) relative to the Nov. 2000 (pre-2001 fill) location.

Volume changes between condition surveys were computed using the average end-area method above the mean high water line (MHWL; +2.51 ft-NGVD) and the assumed typical depth of closure (-16.0 ft-NGVD). **Tables 3.1** through **3.3** list the computed changes along the Bald Head Island shoreline for the April 2016 – October 2016 – May 2017 survey intervals. **Figures 3.1, 3.2** and **3.3** depict the cumulative and local volume changes for the same intervals. Changes in shoreline position at each station were computed at the MHWL and the seaward edge of berm (+6 ft-NGVD contour). The results are summarized in **Tables 3.4** and **3.5** and graphically depicted in **Figures 3.4** and **3.5** (relative to their November 2000 pre-disposal locations).

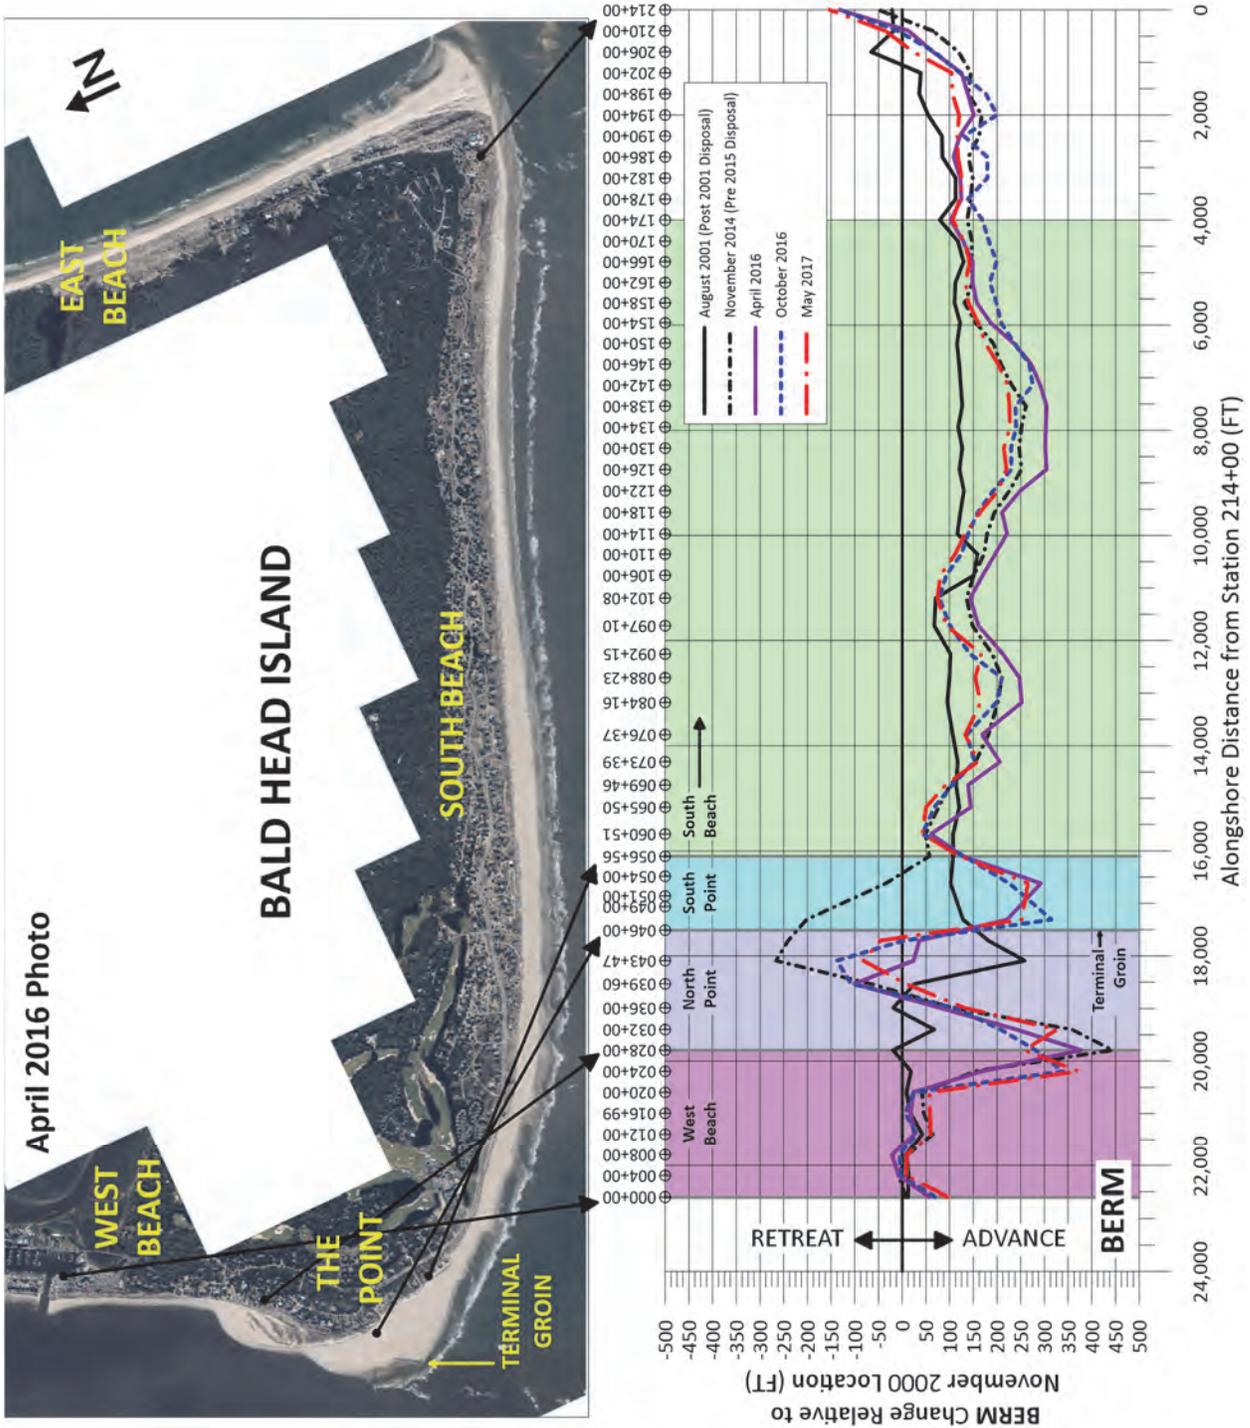
Figure 3.5: Location of the BERM (+6.00 ft-NGVD) relative to the Nov. 2000 (pre-2001 fill) location.

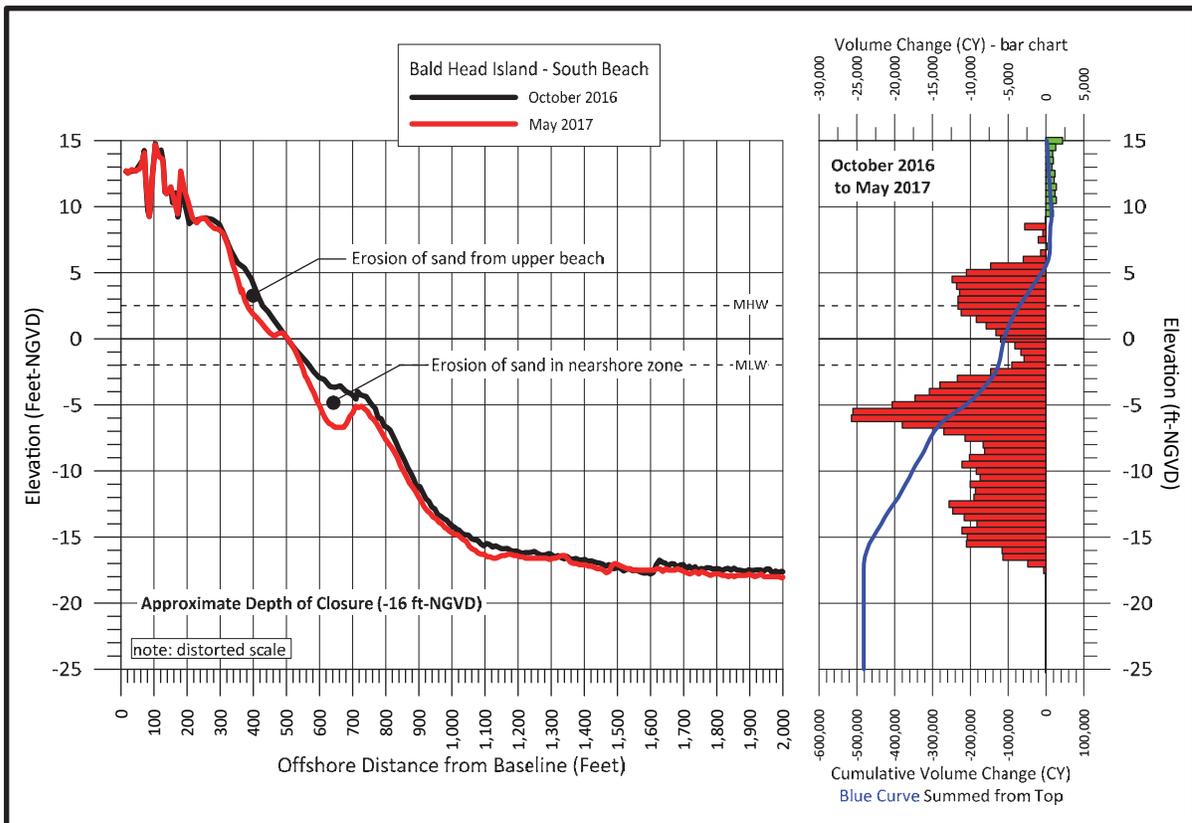
South Beach was net erosional during the period, losing roughly -69,900 cy (-4.3 cy/ft) above the MHWL and -473,200 cy (-29.4 cy/ft) above -16 ft-NGVD. All 38 monitoring stations along South Beach were net erosions. **Figure 3.6** depicts the measured volume changes in half foot vertical increments measured along the South Beach shoreline during this period. The figure indicates that losses were observed across all elevations of the beach profile below +9 ft-NGVD with the largest losses occurring between -4 and -7 ft-NGVD.

During this period, The berm and MHWL receded by averages of -27 ft and -38 ft, respectively. Consistent with the volume losses, all but 2 of the 38 monitoring stations experienced MHWL recession. Similarly, all but 3 of the 38 monitoring stations experienced berm recession.

Figure 3.6: Vertical distribution of volume changes for the South Beach shoreline of Bald Head Island (Sta. 56+56 to Sta. 214+00) from October 2016 to May 2017. The graph on the right depicts the volume changes measured at 0.5 ft vertical intervals (bar chart), as well as a summation of the total volume change measured from the dunes seaward to survey closure (blue curve). The example beach profiles depicted in the left panel are from Sta. 134+00..

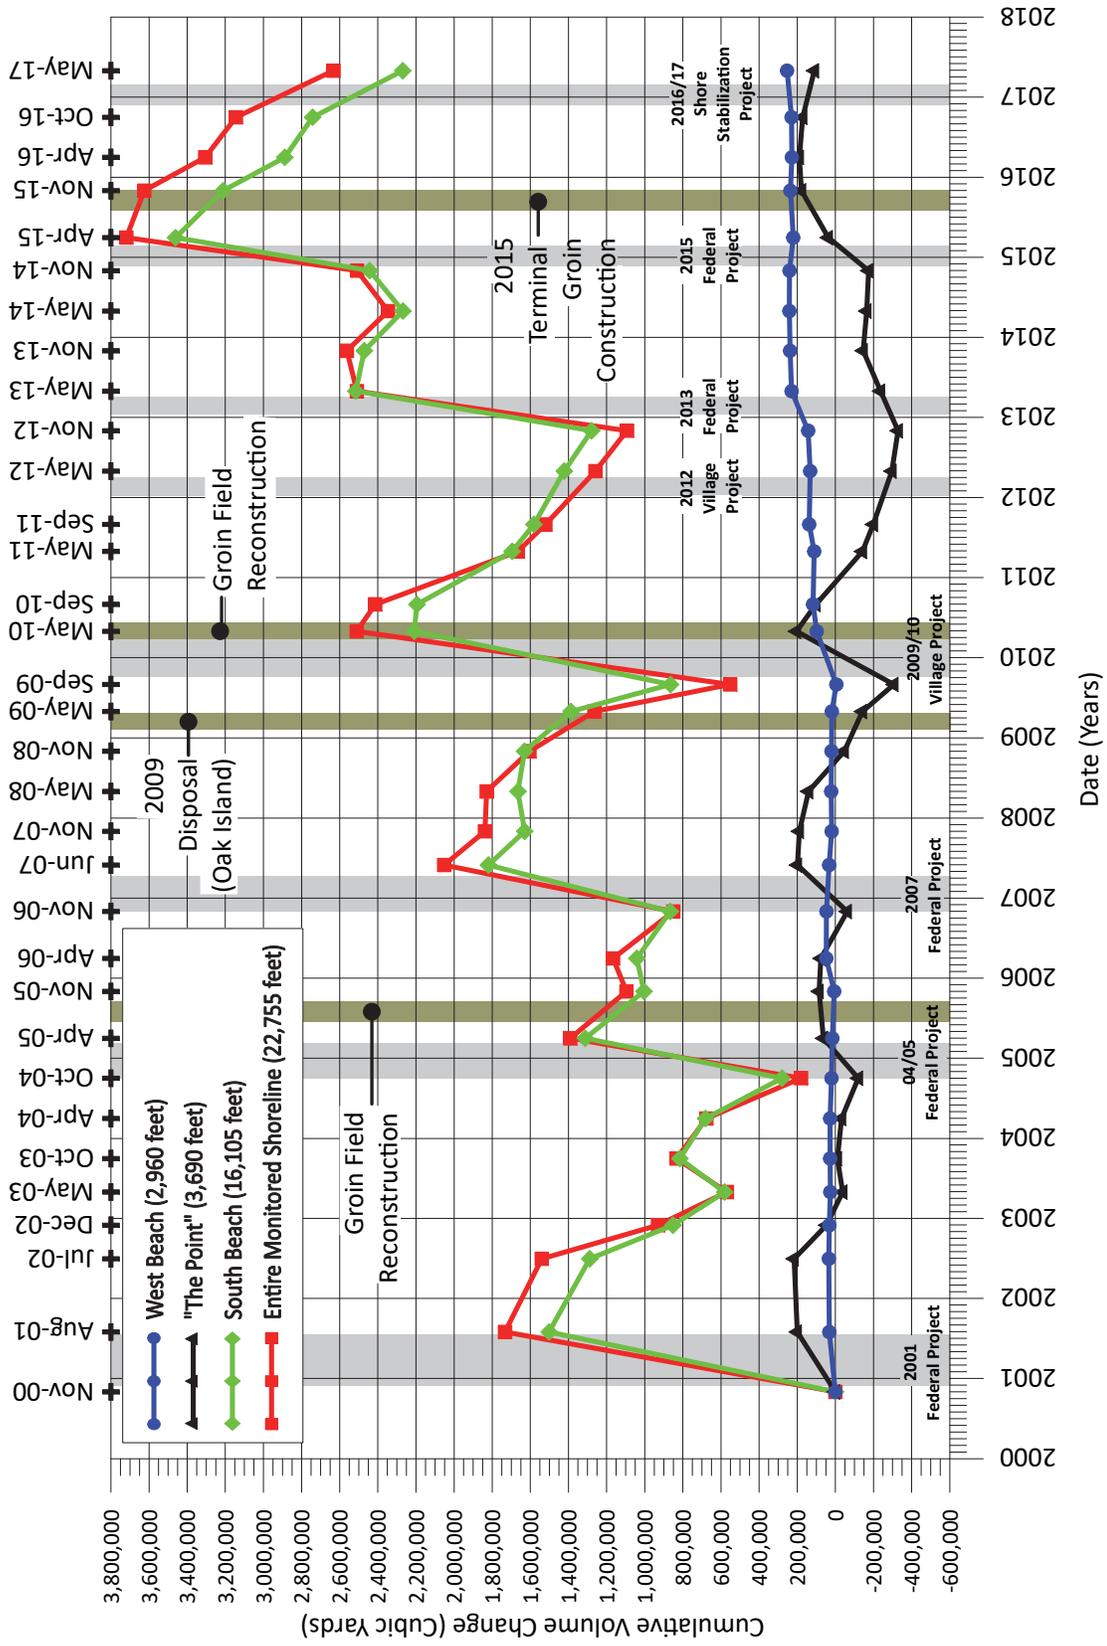
Figure 3.7: Cumulative volume change (above -16 ft-NGVD) relative to November 2000 conditions.

For purposes of tracking gross sand placement performance, **Figure 3.7** plots a time history of cumulative volume change relative to November 2000 conditions. **Figure 3.8** presents net volumetric change (alongshore above -16 ft NGVD) for the maximum period of comparison to date (*i.e.* November 2000 and May 2017). In both figures the effects of direct sand placement are included. As with other similar analyses over the last decade, East Beach, Cape Fear and Row Boat Row are excluded from this analysis.

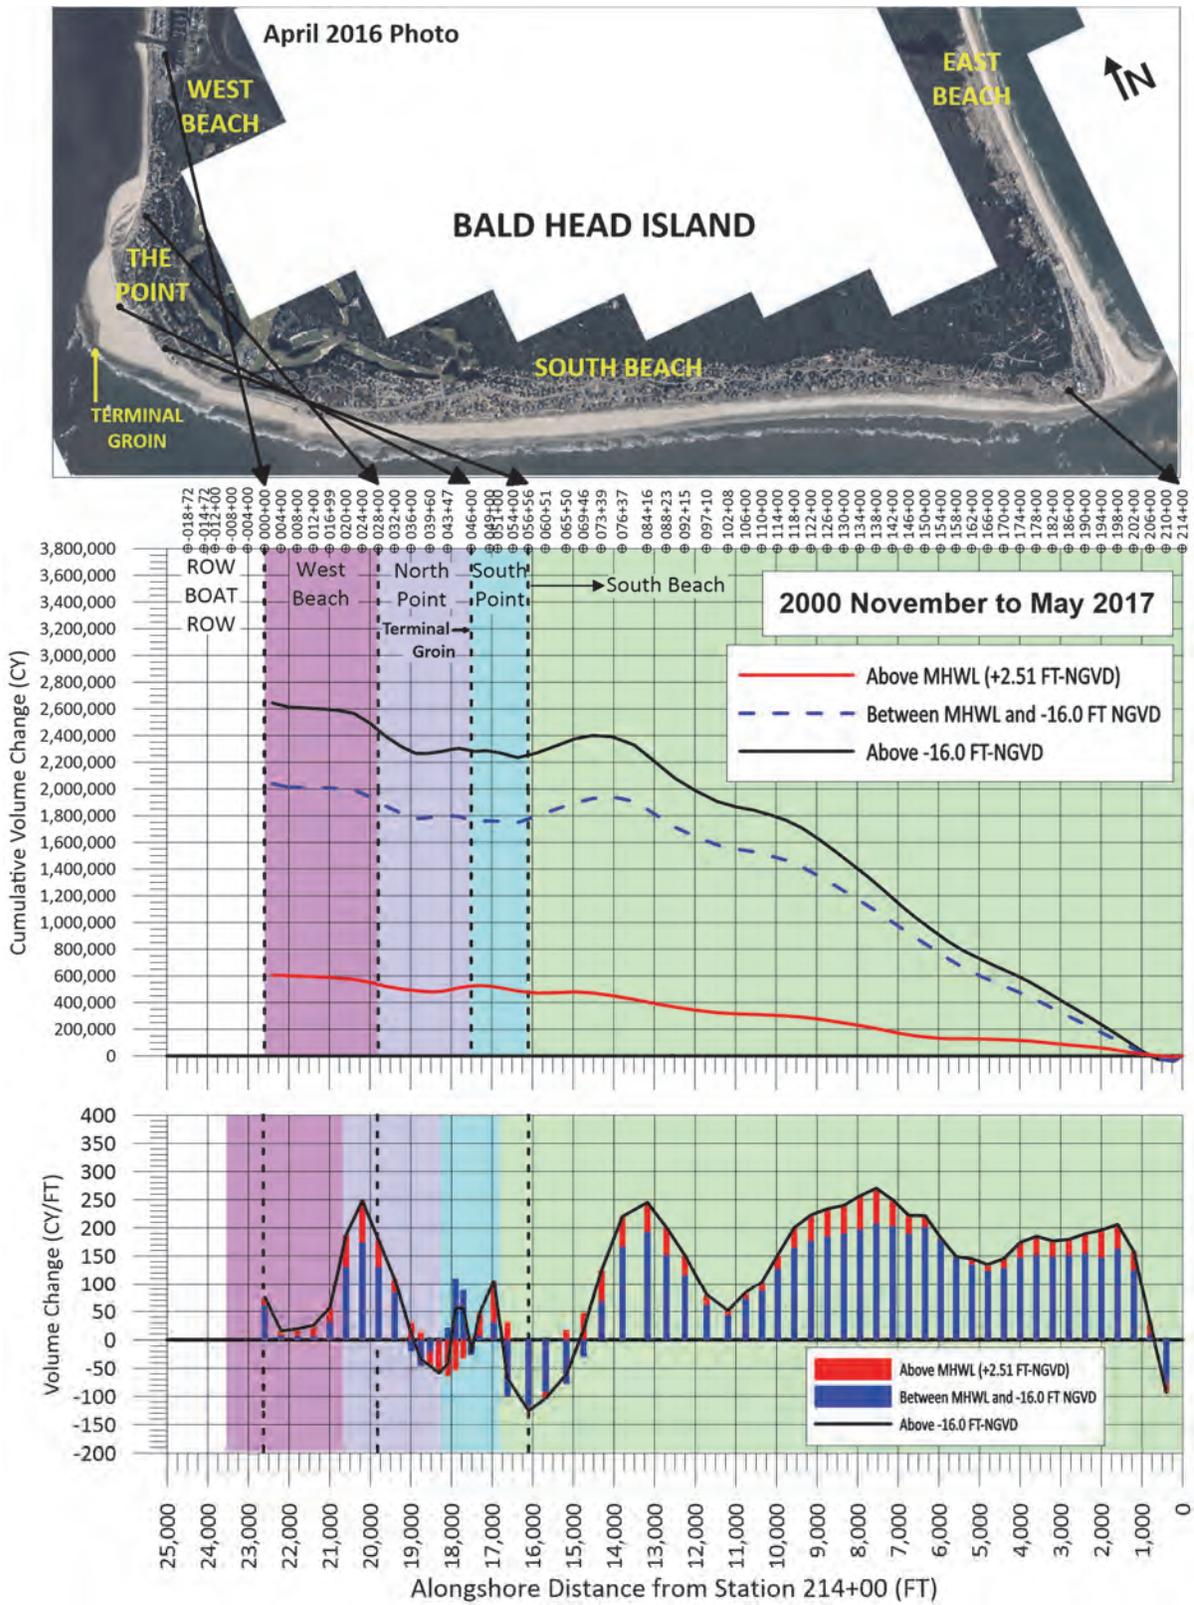
Figure 3.8: Volume change along the Bald Head Island shoreline between November 2000 and May 2017.

Accordingly, any future reformulation of the Wilmington Harbor Sand Management Plan by the Wilmington District, USACOE, it continues to be recommended that they evaluate not only the time history, or “performance” of sand placement on Oak Island and Bald Head Island but also any areas of spatial deficits – particularly relative to the November 2000 benchmark survey as illustrated in **Figure 3.8**.

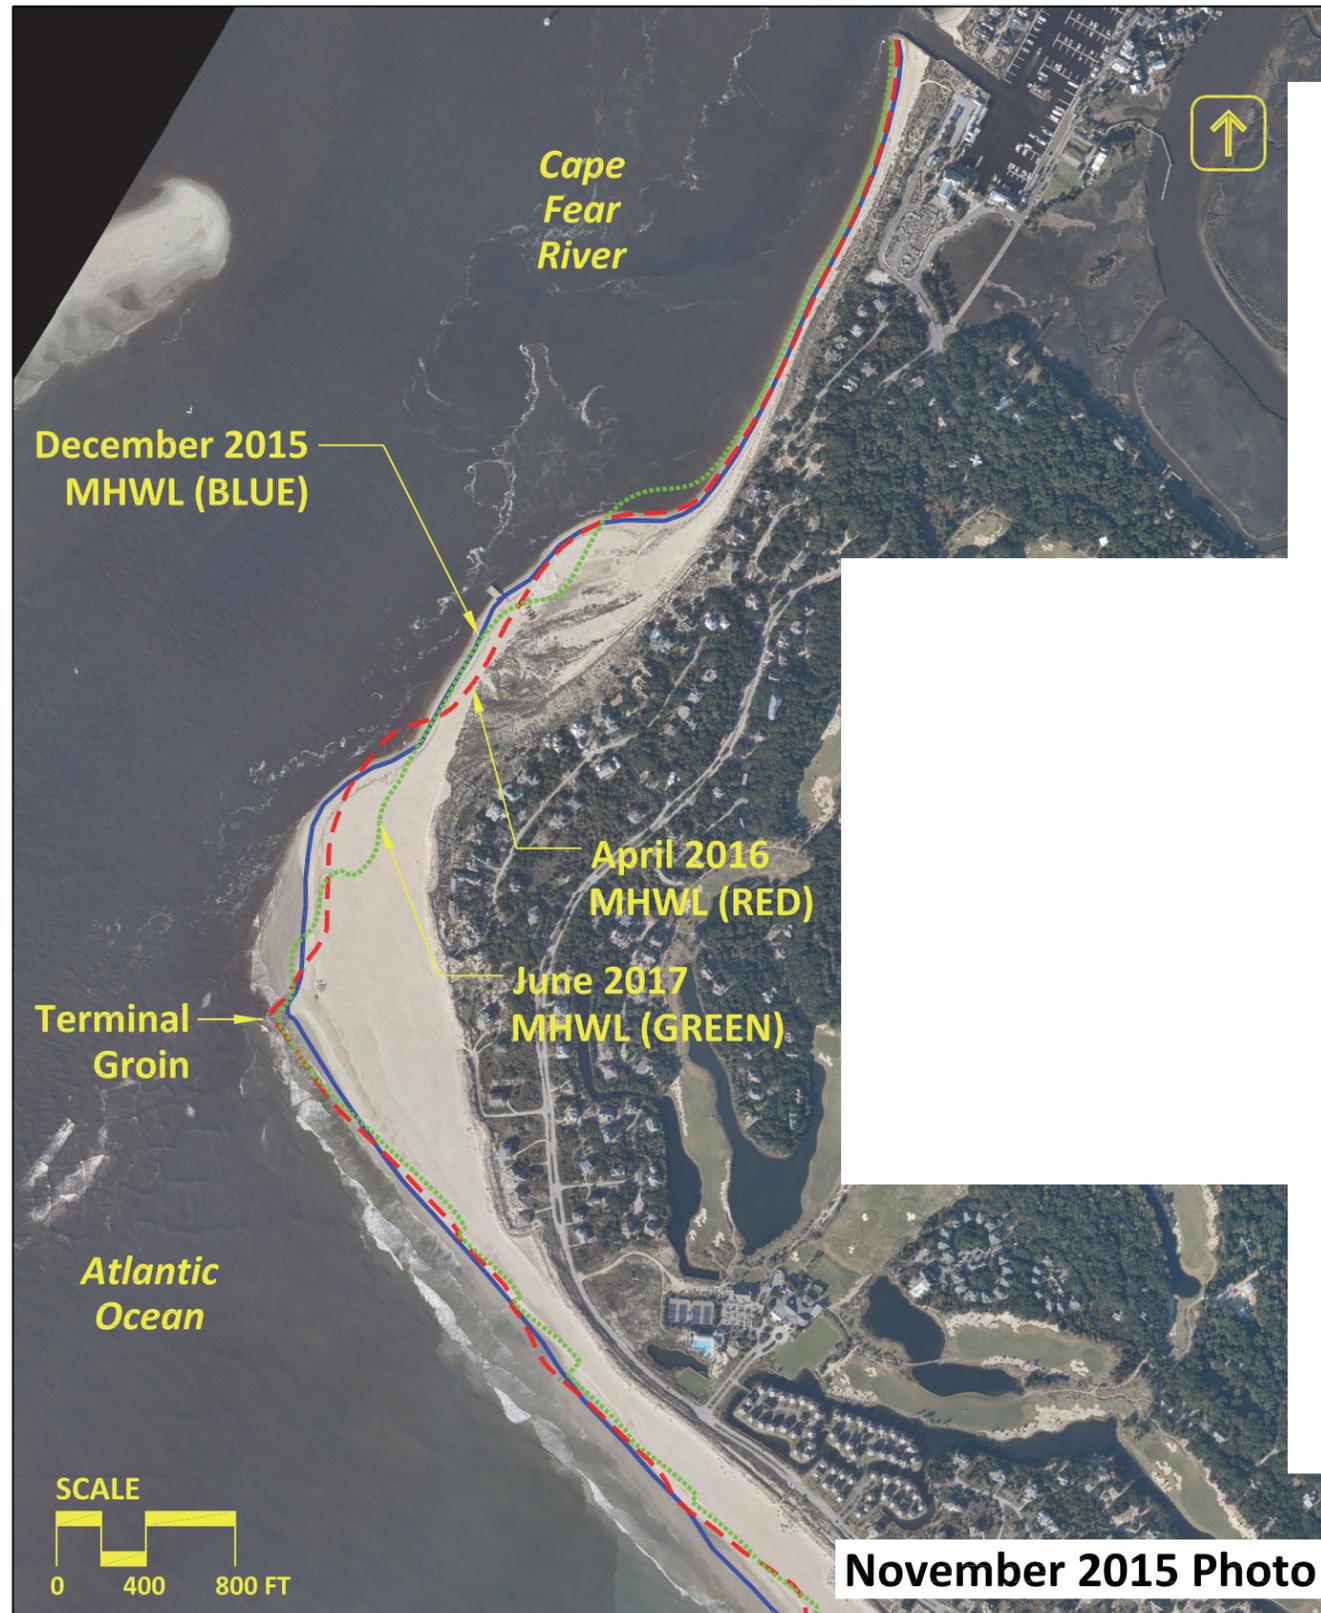
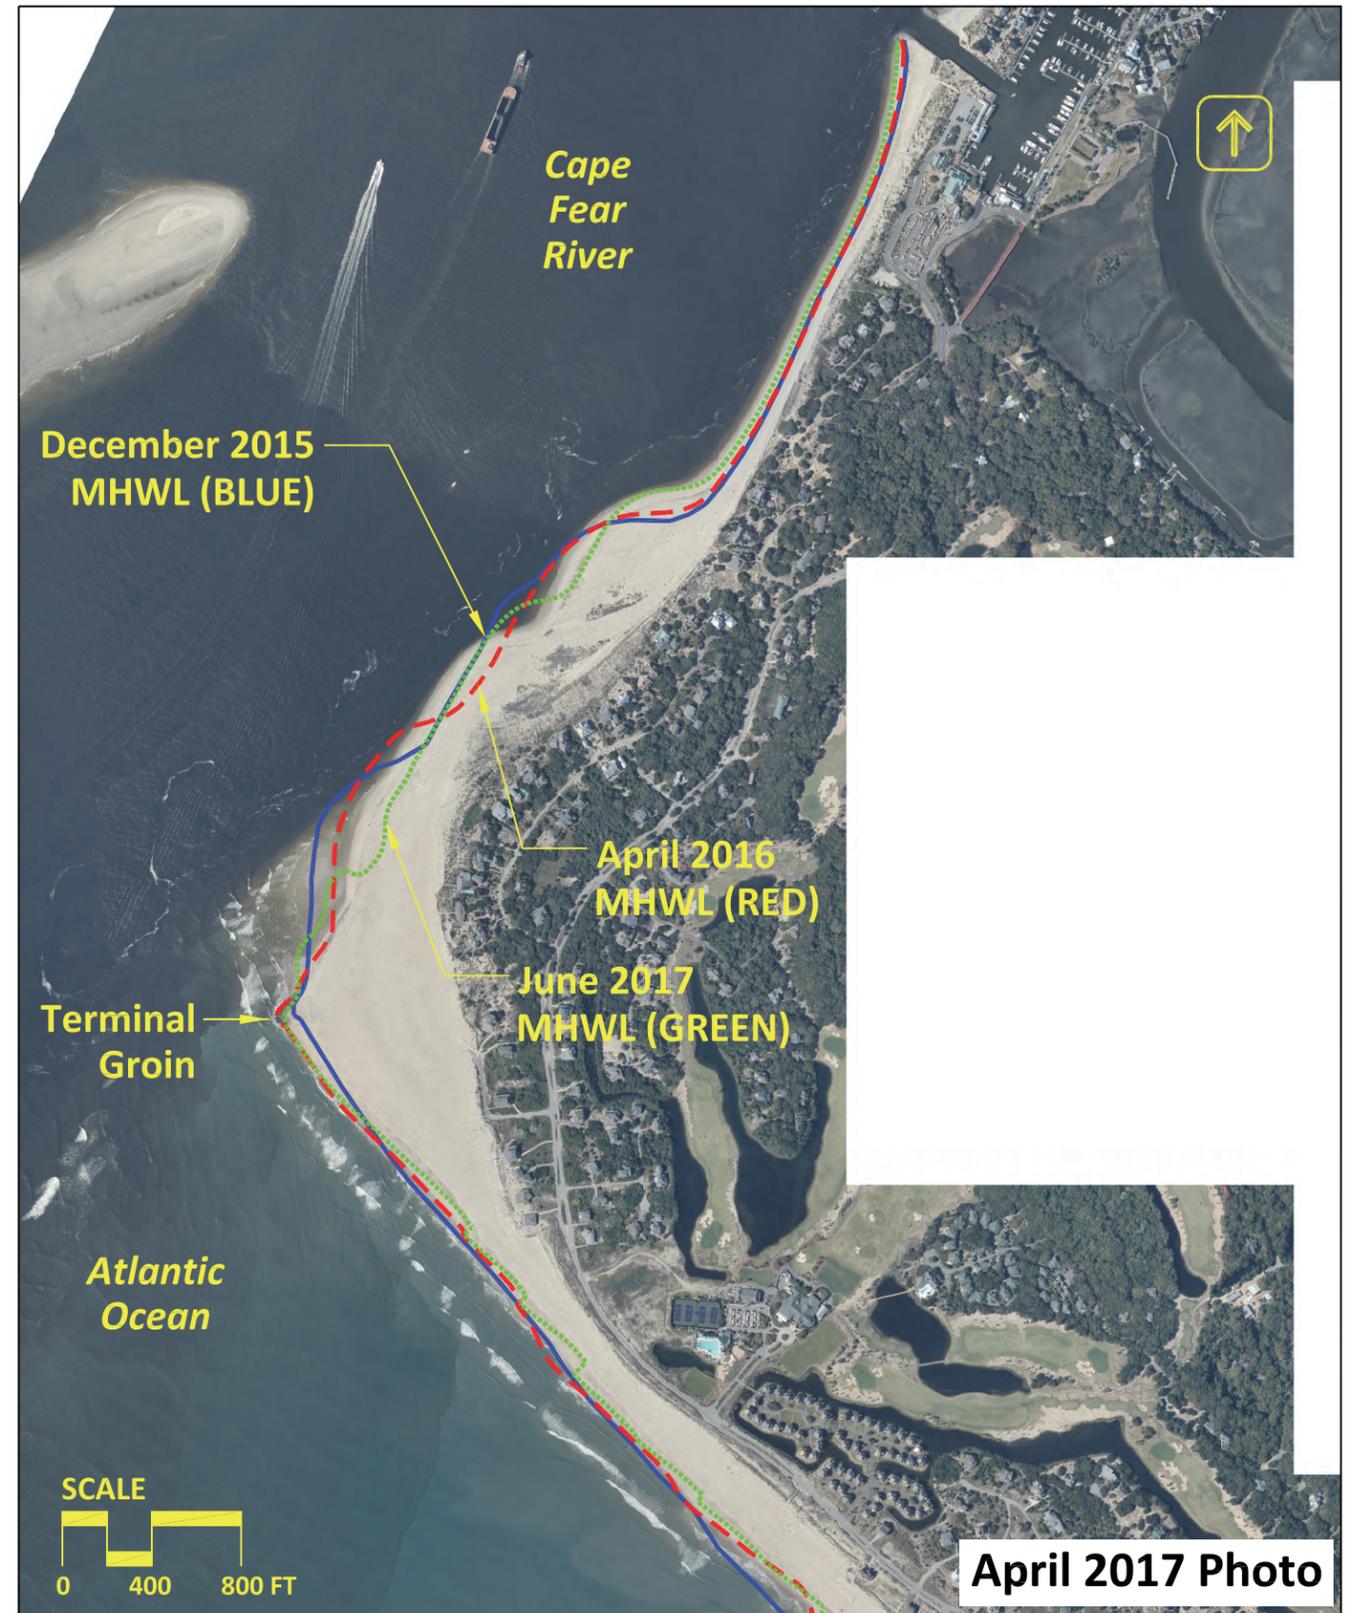
As part of the permit required monitoring for the terminal groin project completed in late 2015, the MHWL was surveyed in December 2015 (post-construction), April 2016 (5 months post-construction) and June 2017 (19 months post-construction). The three surveys completed to date are plotted in **Figure 3.9**. In future monitoring reports, surveys are to be intercompared to assess both updrift fillet conditions and the location of the downdrift shoreline fronting the Cape Fear River.

Figure 3.9:
MHWL positions in the vicinity of the terminal groin Bald Head Island, NC

For the April 2016 to May 2017 monitoring period, the inlet facing shoreline adjacent to the terminal groin continues to recede back (as predicted) and adjust to a new equilibrium condition. An intertidal spit formation remains on the inlet side of the structure as a result of sediment transported from South Beach through or across the structure. Updrift thereof, portions of the historical Point continue to migrate northward as they did prior to terminal groin construction. This is best represented by the surveyed MHWL locations depicted in **Figure 3.9**. It has been noted previously that the majority of the terminal groin was constructed “in the dry” – with only the distal head of the structure evident at completion in late 2015. Since that time, portions of the berm west of the structure are receding as a new equilibrium condition evolves.

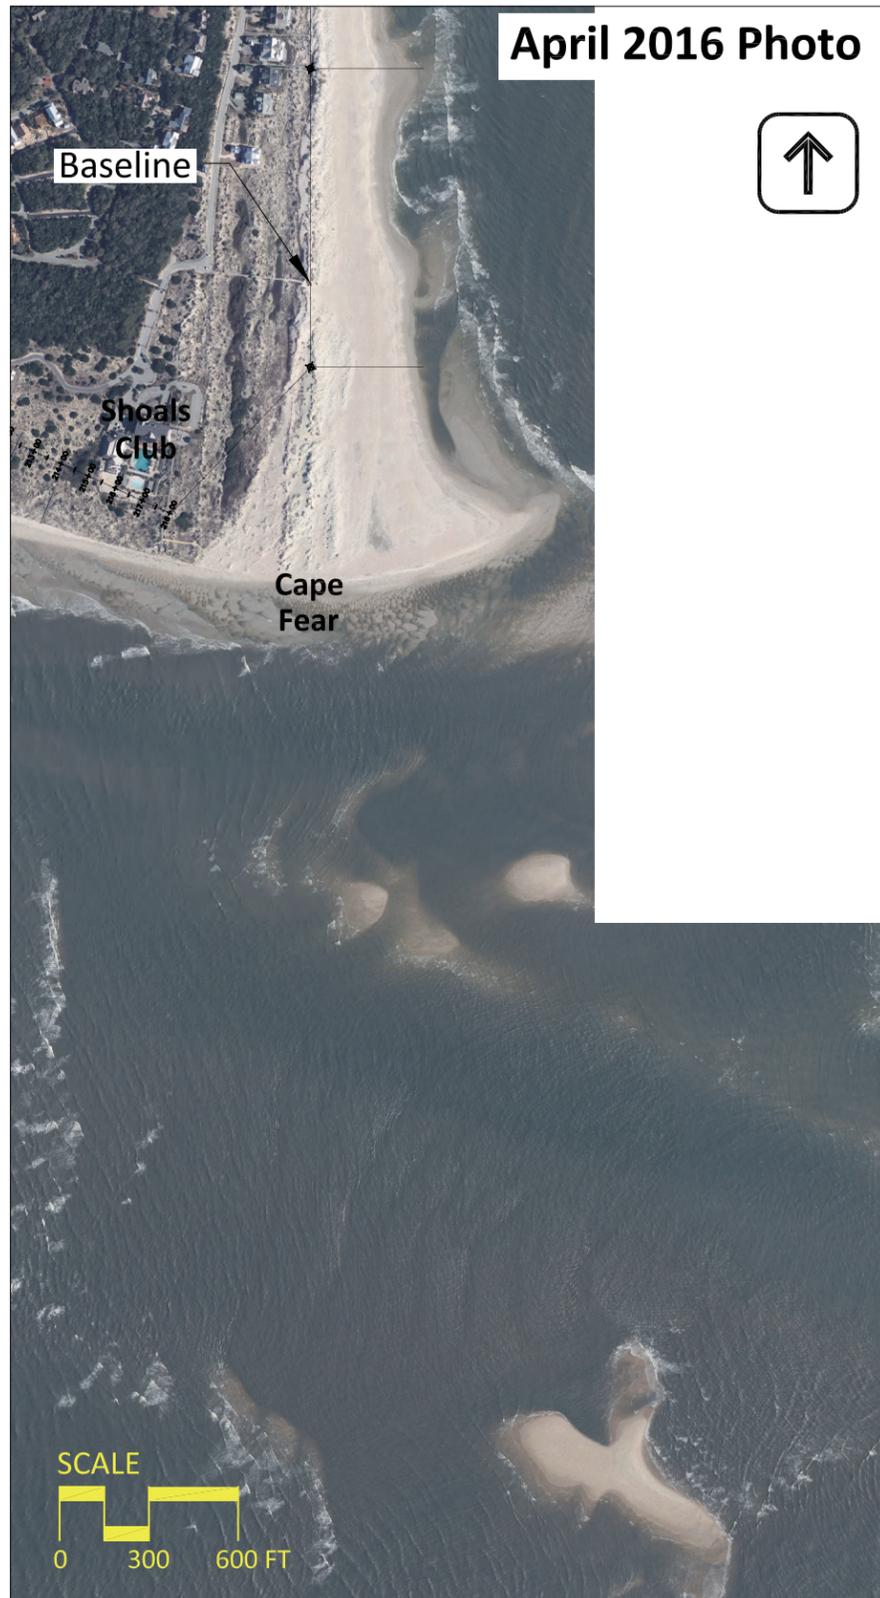
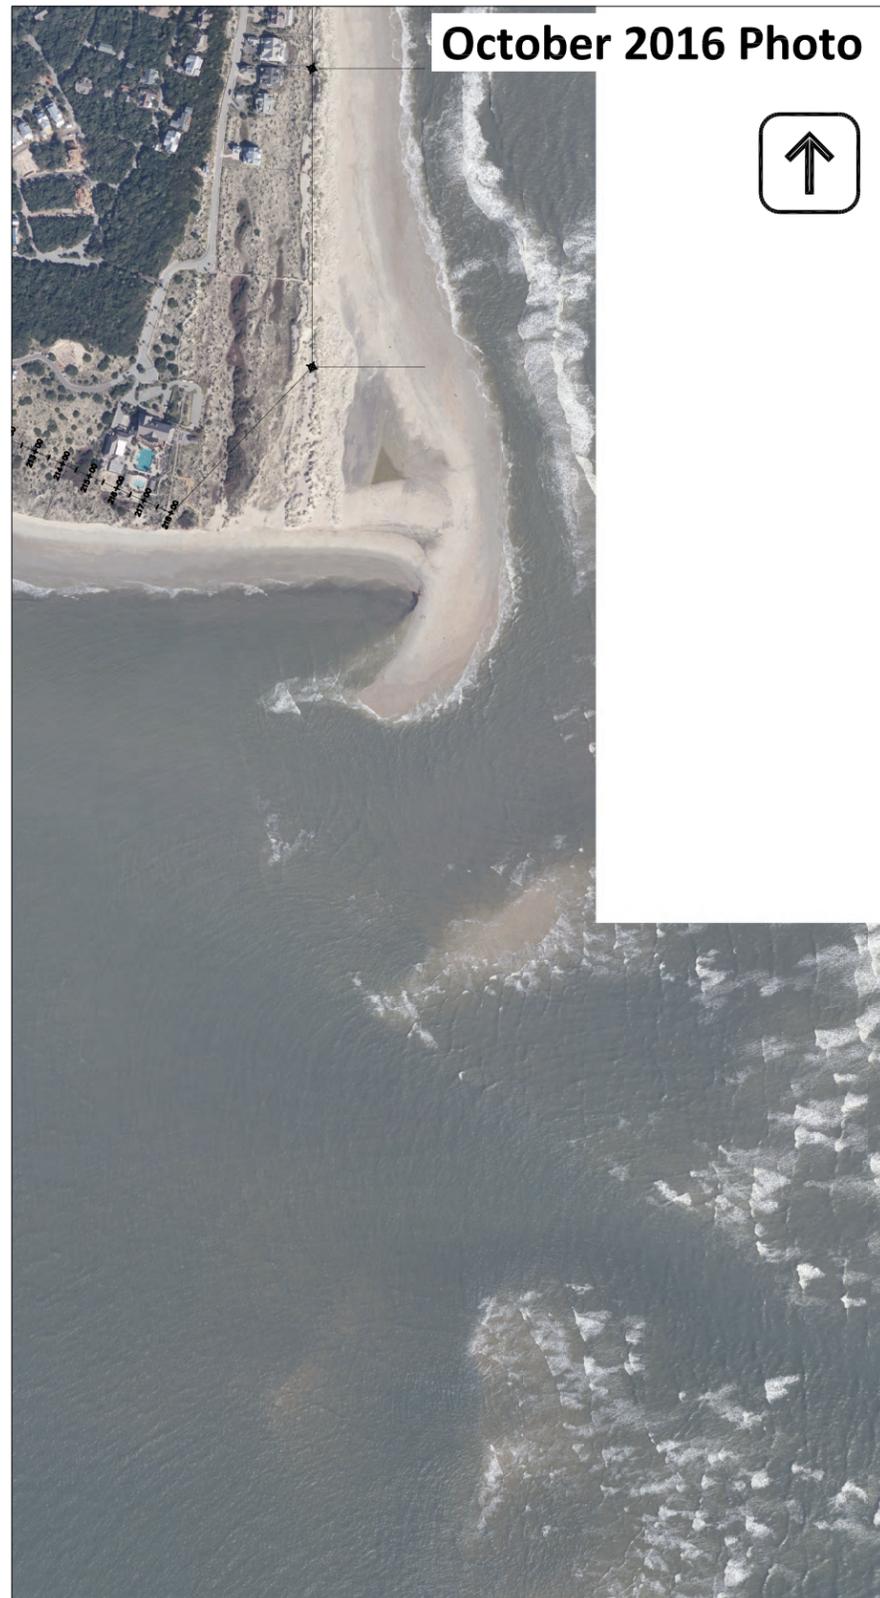
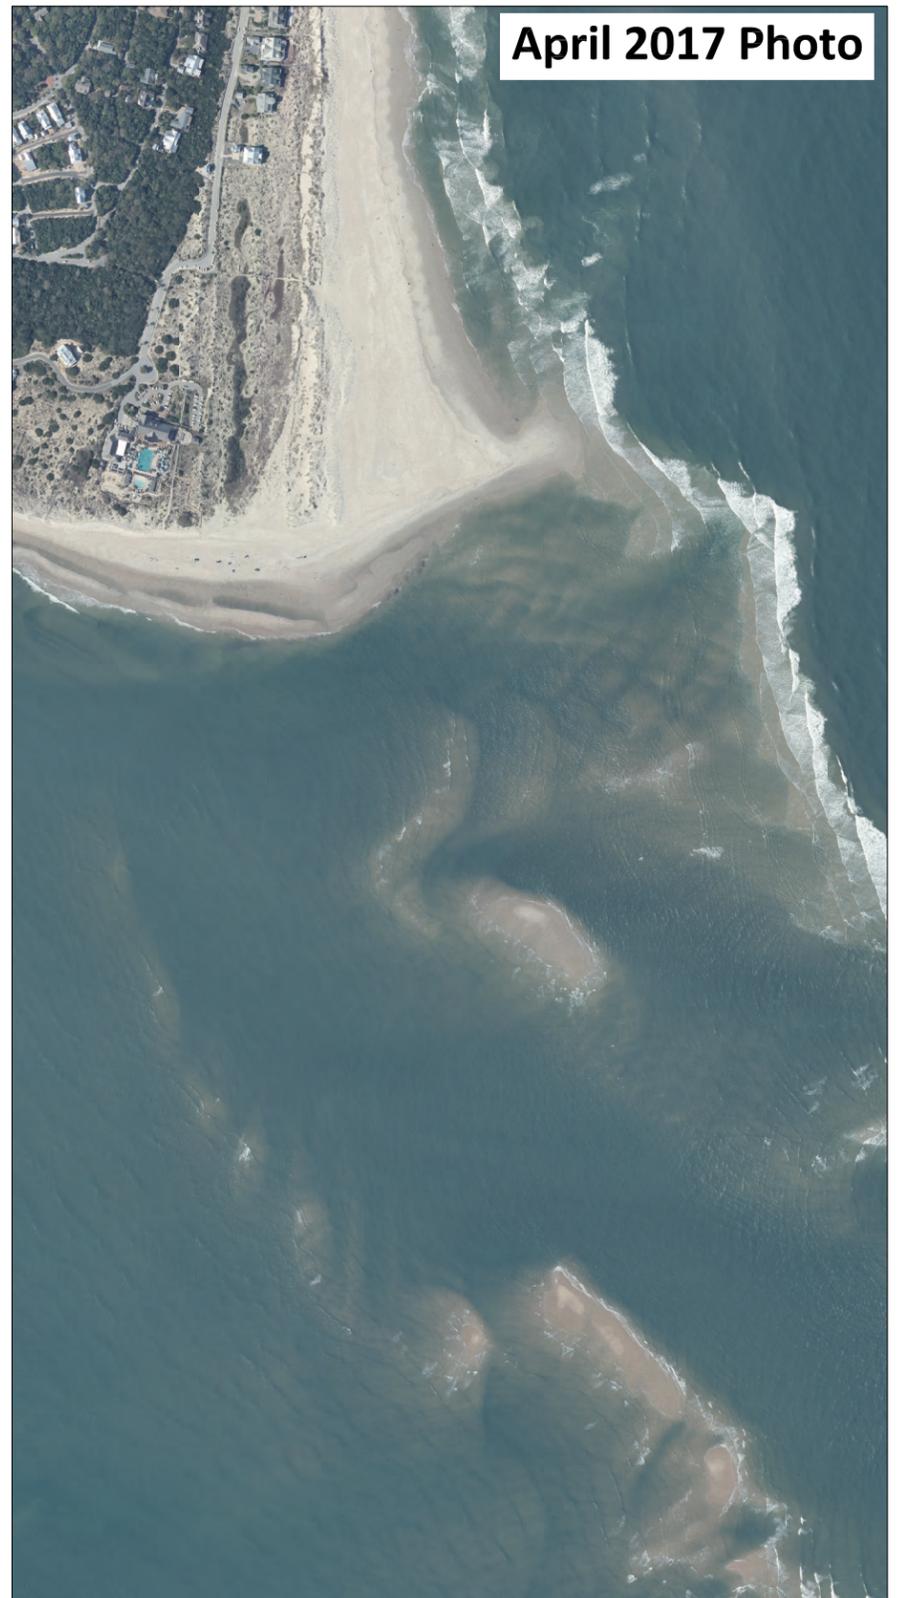
As demonstrated by the survey and photographic data (**Figure 3.10**), it can be reasonably assumed that the condition of East Beach at any one time is, has been and will continue to be highly influenced by the configuration of the depositional spit and shoals associated with the “Cape Fear Point”. Of further interest are the variations in spit size and orientation over the last several years (2008-2017) which are depicted by **Figure 3.11**. In its simplest sense, the Cape Fear spit is a highly dynamic feature which is influenced by sand supply originating from both the west (along South Beach) and the north (along East Beach). The Point is also susceptible to storm waves originating from *both* the west (Atlantic Ocean) and the east (Onslow Bay) and resultant tidal channels which episodically break through and subsequently influence localized patterns of sand deposition (or erosion).

Figure 3.10:
Cape Fear aerial photography
Bald Head Island, NC
