Bald Head Island, N.C. Beach Monitoring Program

Monitoring Report No. 15 (April 2016 to May 2017)

Prepared for:
Village of Bald Head Island

Prepared by:
Olsen Associates, Inc.
2618 Herschel Street
Jacksonville, FL 32204
(904) 387-6114
(Fax) 384-7368
olsen-associates.com
C-1468

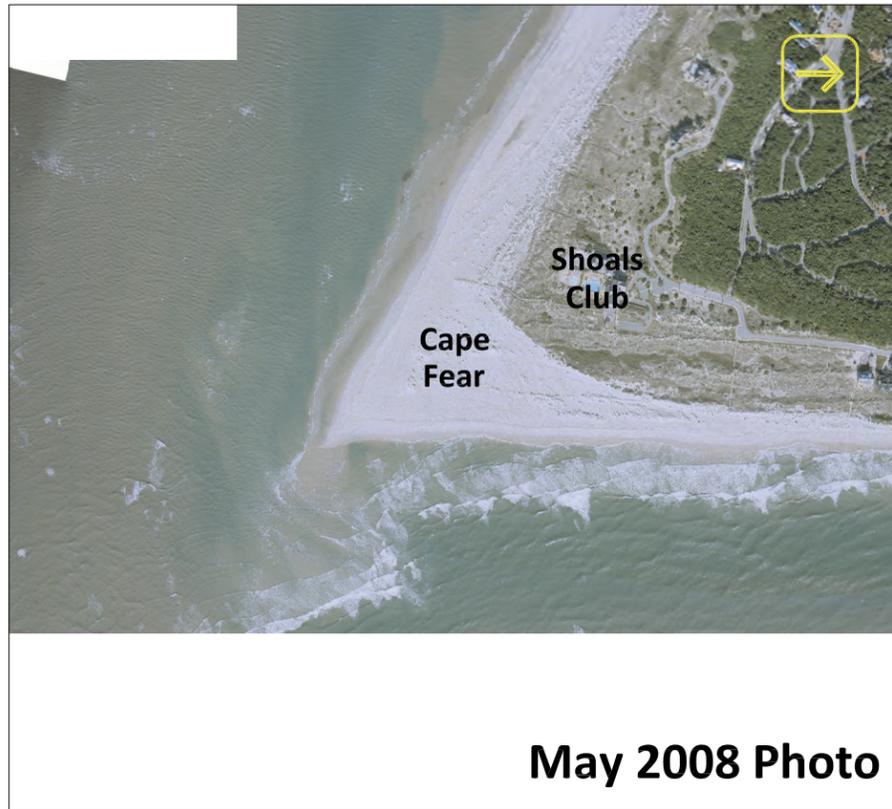
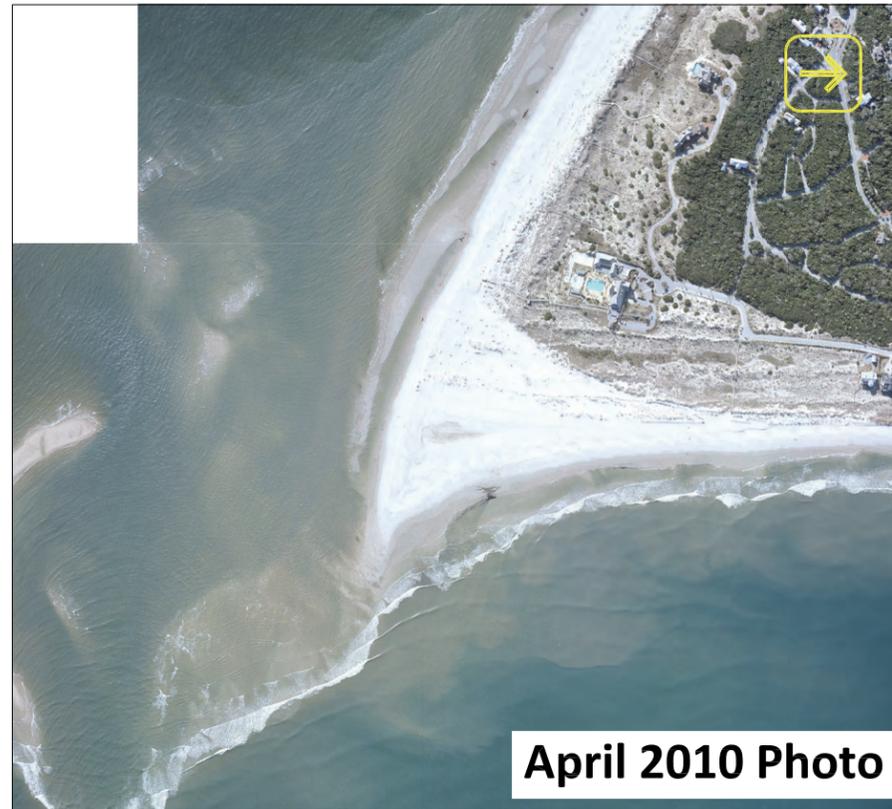
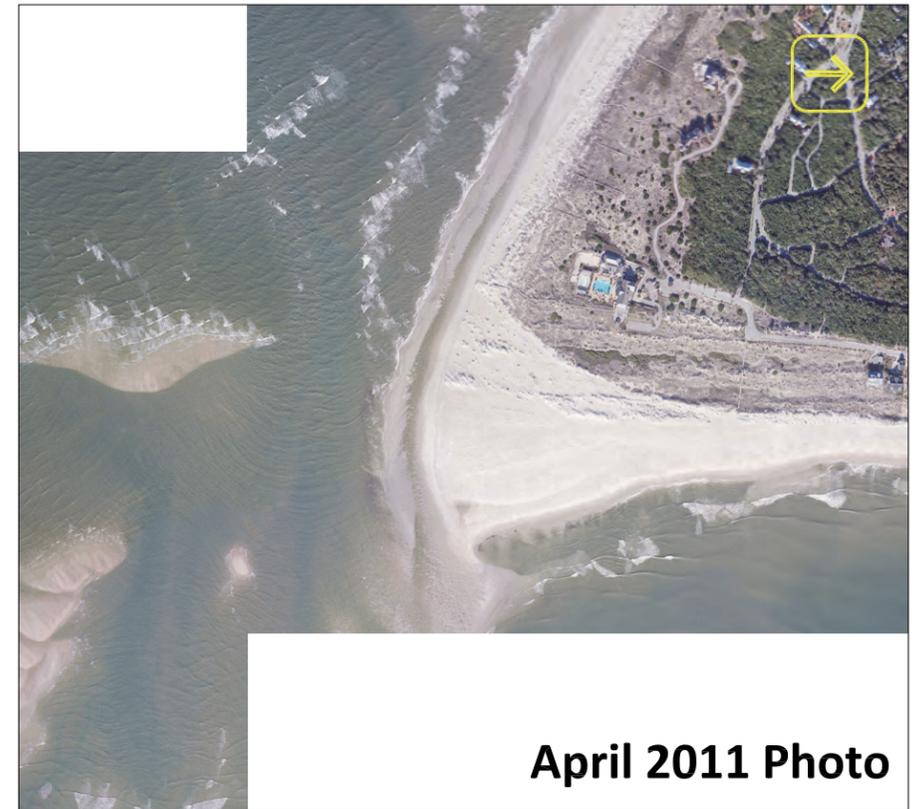
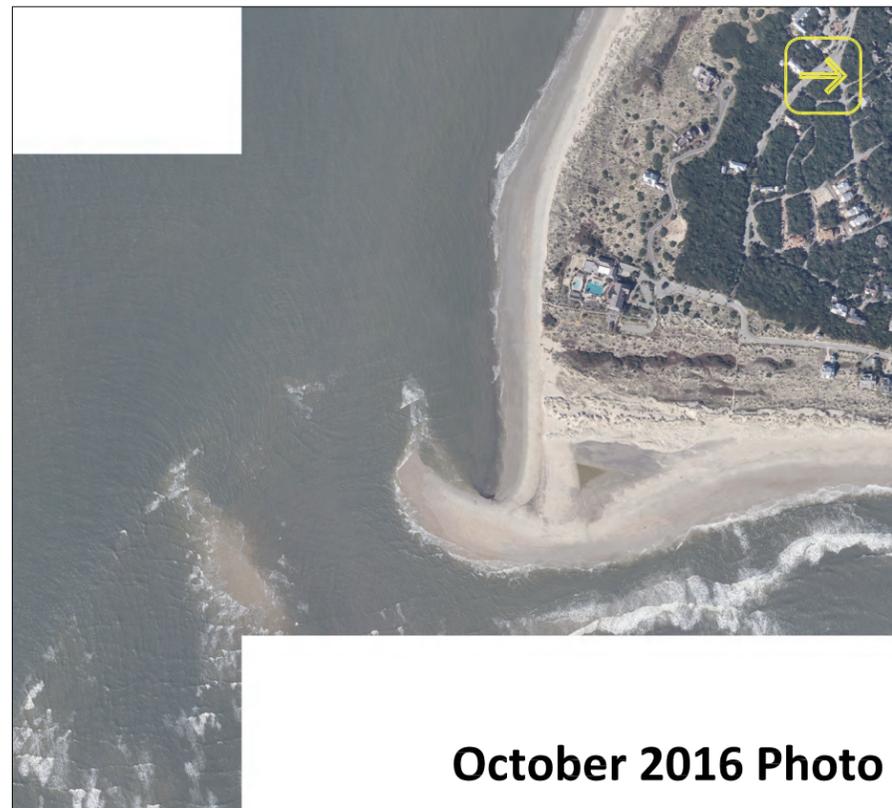
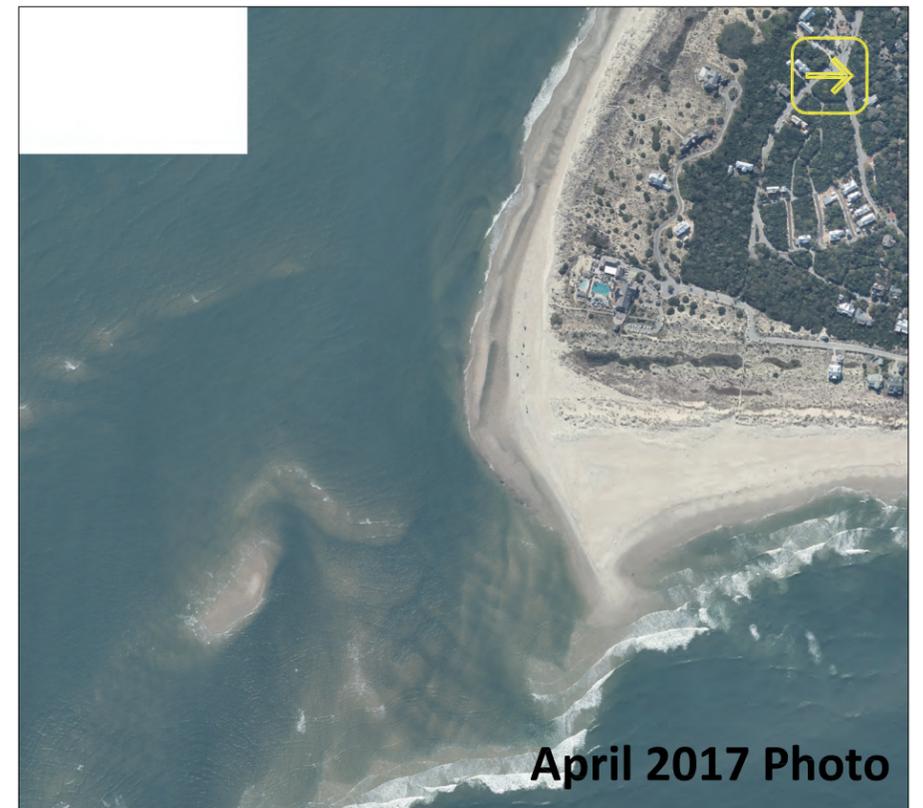
Figure 3.11:
Cape Fear aerial photography
Bald Head Island, NC

Although the location of the Cape Fear spit has been beneficial to East Beach properties, it has caused significant shoreline and dune recession seaward of the South Beach Shoals Club facility. That section of shorefront is monitored via beach profiles B-54 and B-55 (Sta. 214+00 and 218+00). The Shoals Club lies approximately mid-way between these two survey stations. May 2017 shoreline conditions are visually shown by **Figure B-9** (Appendix B – May 2017 Aerial Photography – page B-10). Since November 2000, the MHWL at profile B-54 has receded by -165 ft, or about -10 ft/yr. At B-55, over the same period of time, the MHWL has receded -270 ft, or about -16 ft/yr. More recently however, between November 2014 and May 2017, the MHWL at B-55 had receded by about -80 ft which equates to a rate of -23 ft/yr.

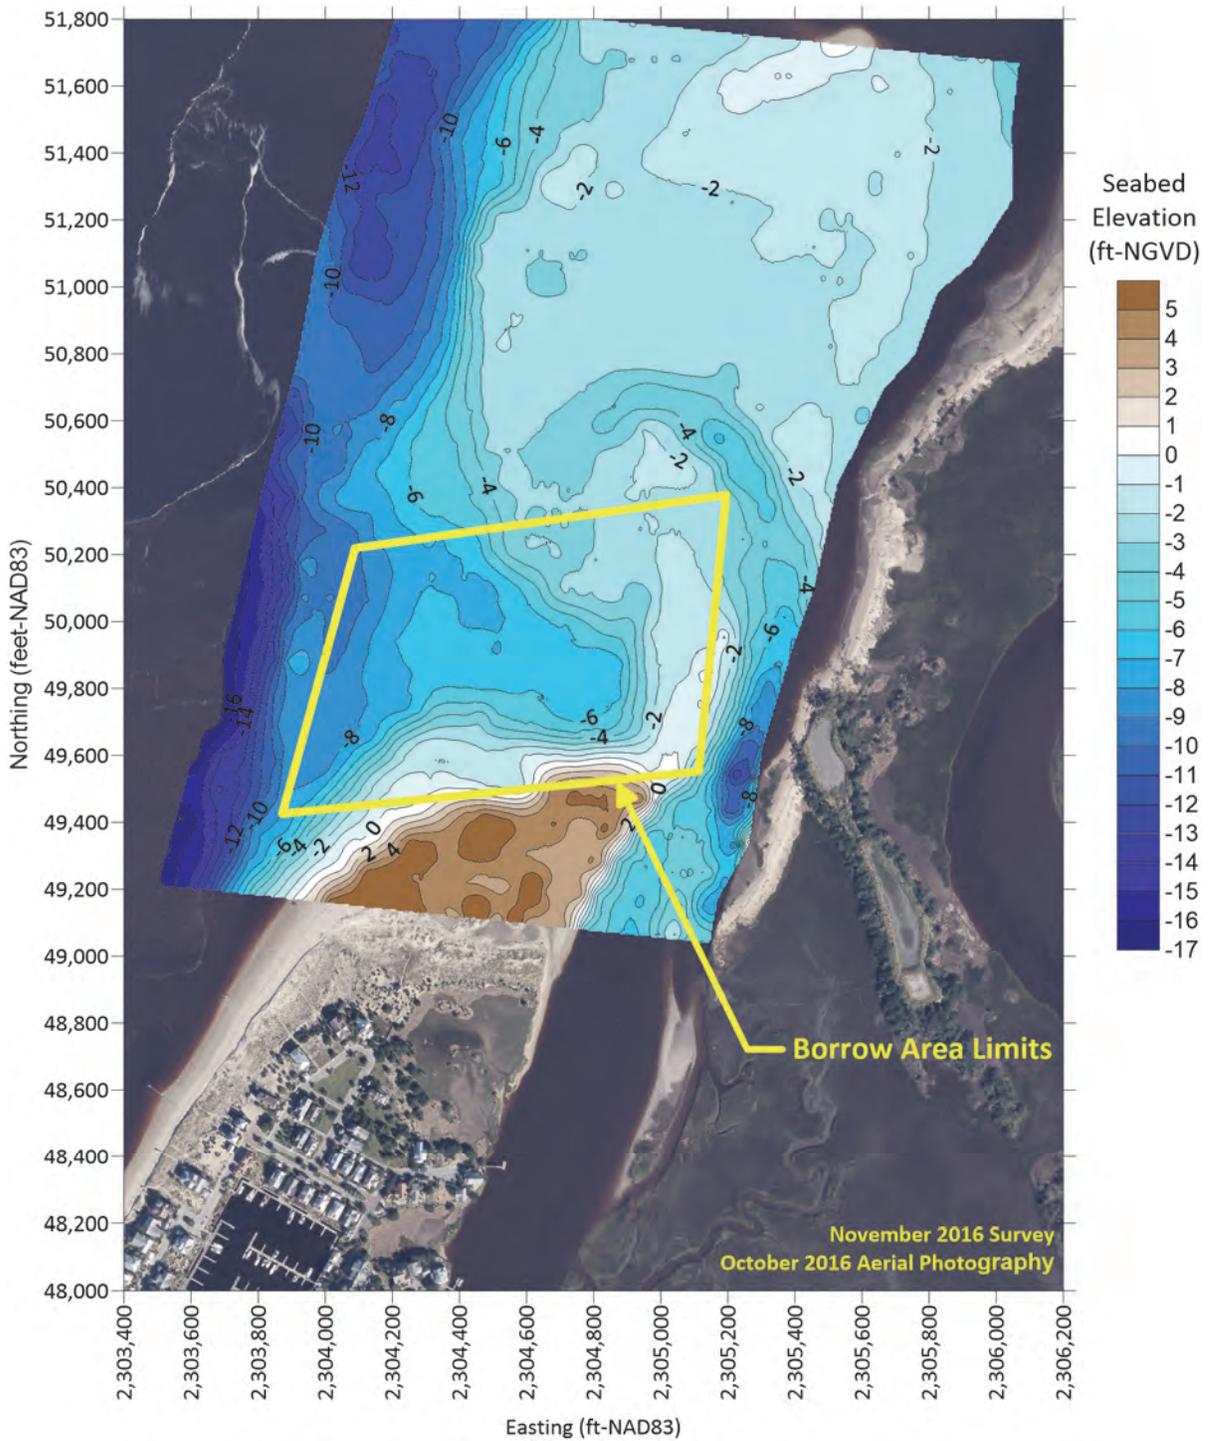
Figure 4.1: Pre-2016/17 project (56 months post-2012 project) Bald Head Creek borrow site conditions (November 2016 survey).

Depictions of the November 2016 (pre-project) and March 2017 (post-project) seabed conditions within the borrow site are provided as **Figures 4.1** and **4.2**, respectively. **Figure 4.3** presents the relative seabed elevation change between the pre- and post-project surveys (November 2016 to March 2017) and **Figure 4.4** presents the seabed elevation change since project completion (March 2010 to March 2017). **Table 4.1** summarizes the volume changes within the permitted borrow site limits between the monitoring surveys conducted to date.

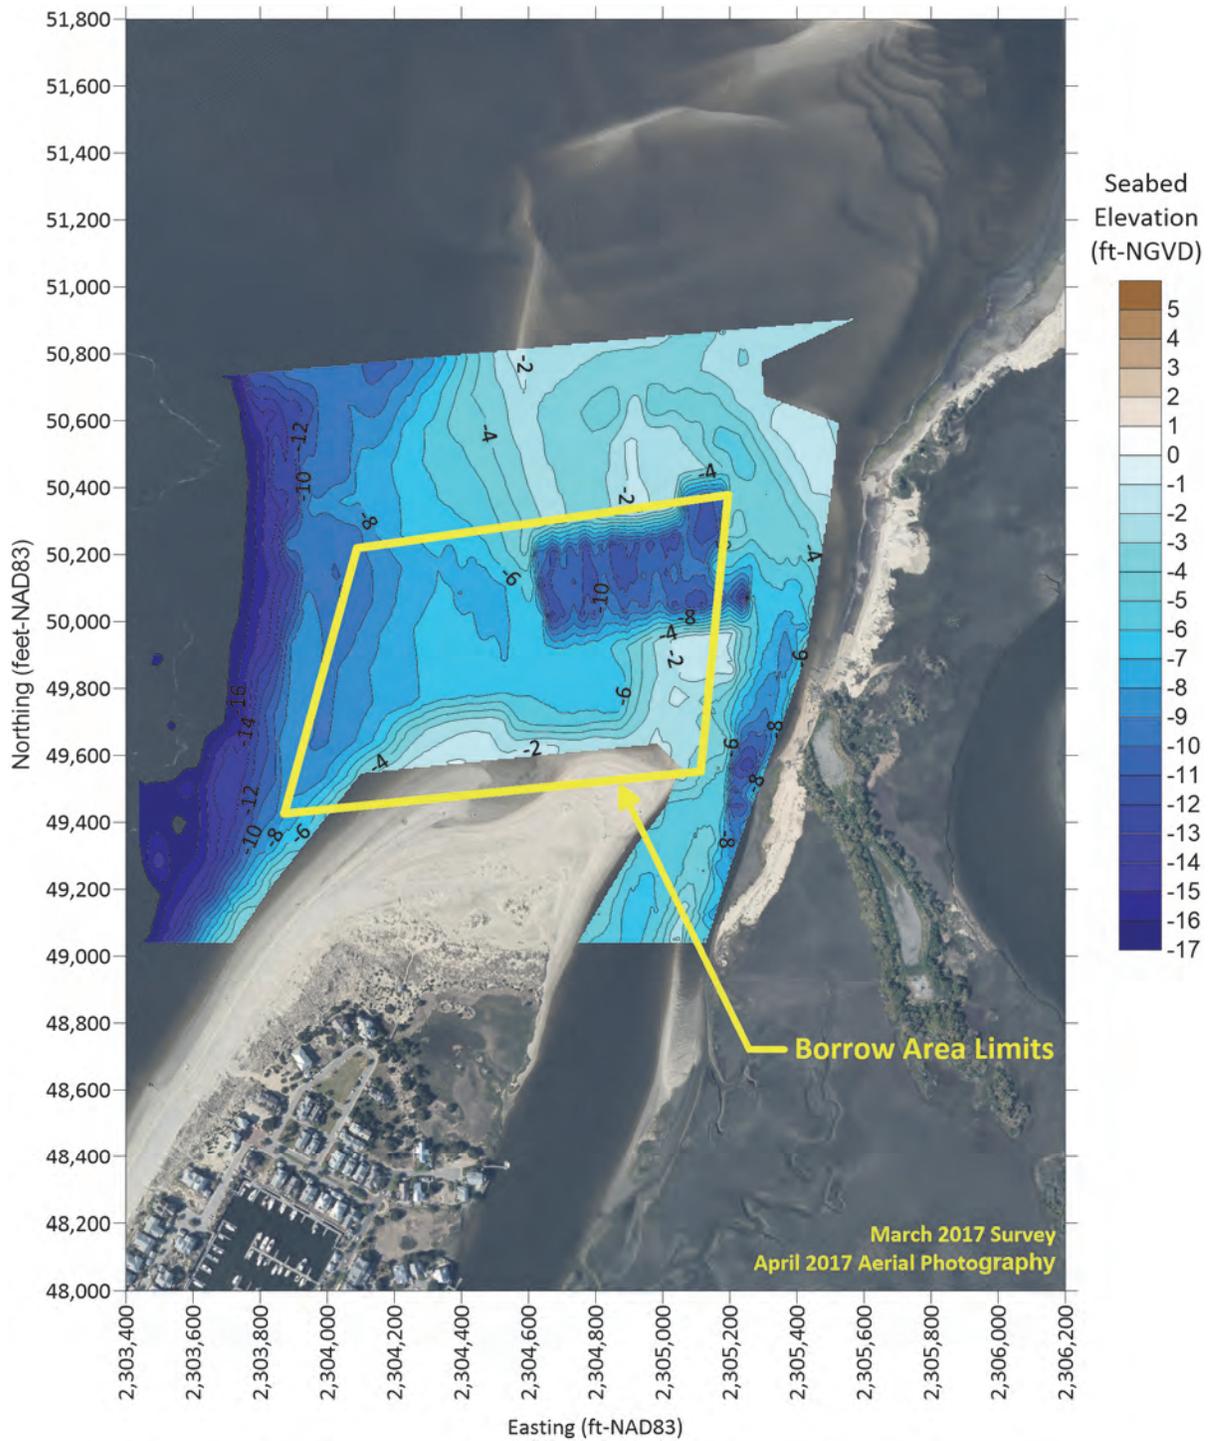
Figure 4.2: Post-2016/17 project (60 months post-2012 project) Bald Head Creek borrow site conditions (March 2017 survey).

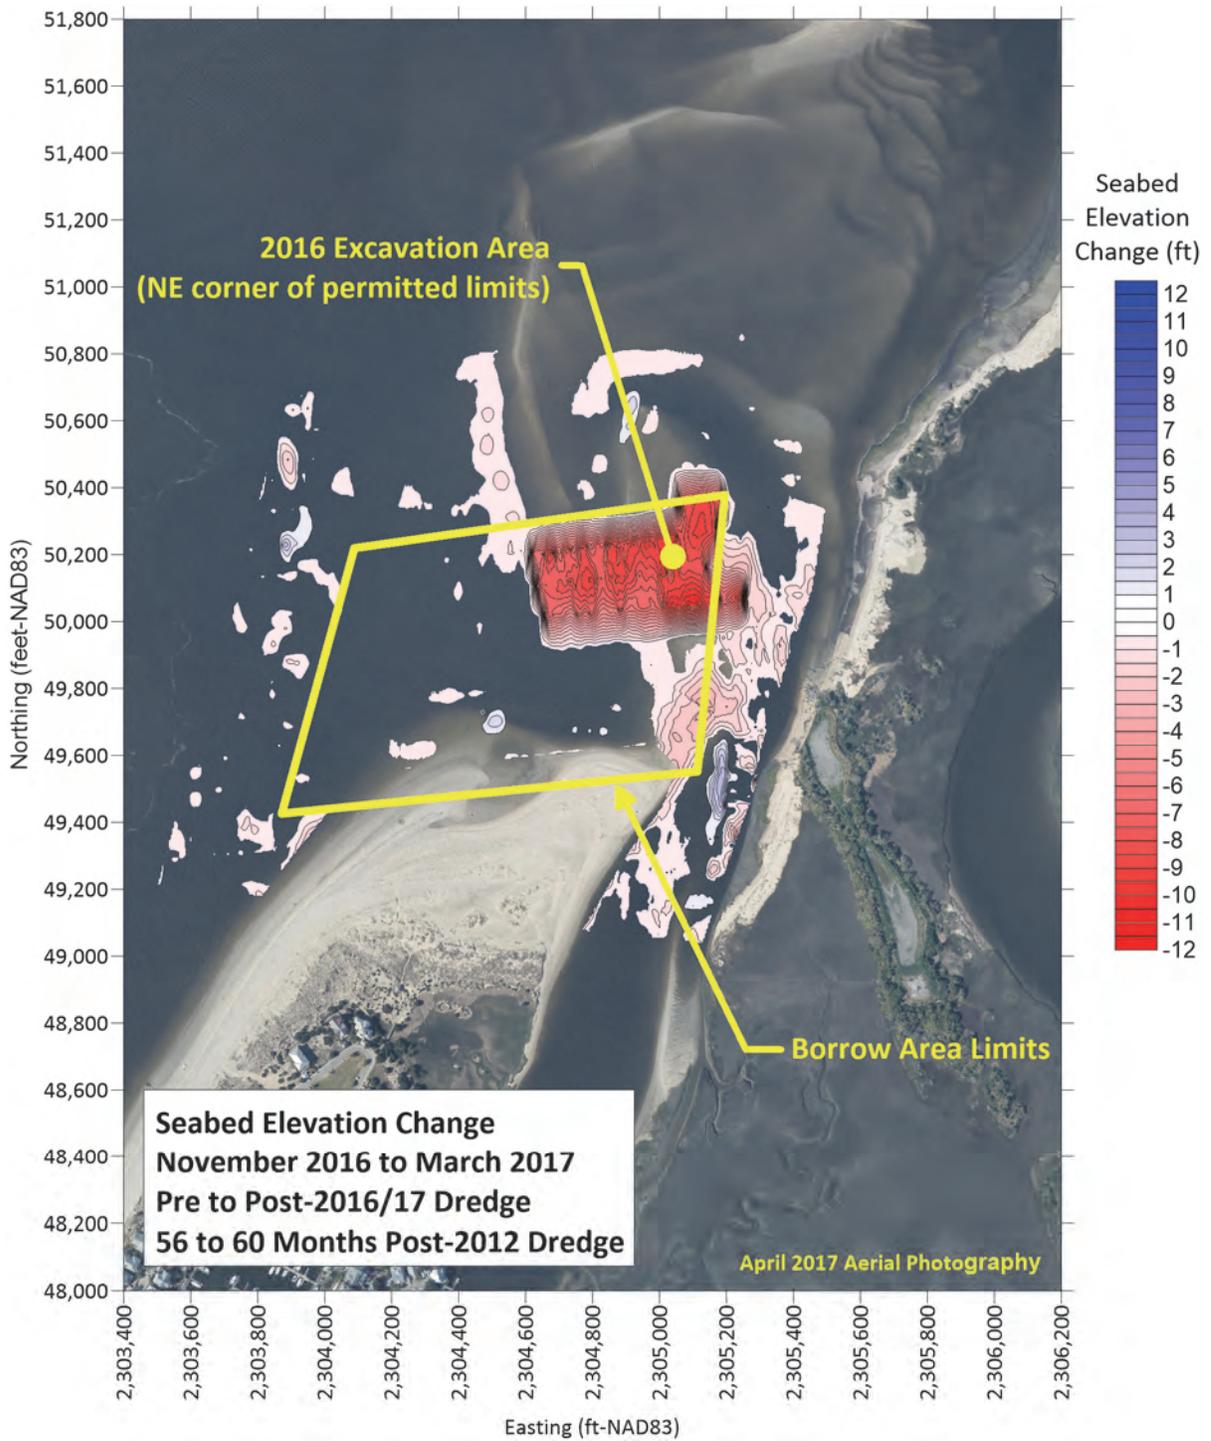
During the pre to post-2016 construction monitoring period (November 2016 to March 2017), the borrow site “lost” approximately -53,200 CY *within the entire permitted area* (both excavated and unexcavated). Within the excavation limits, approximately -48,700 were removed during project construction. In the five years since project completion (March 2012 to March 2017), the permitted borrow site gained roughly +24,500 CY. Most deposition areas this time frame derived from sediment transported from the Row Boat Row shoreline.

Figure 4.3: Bald Head Creek borrow site seabed elevation changes pre- to post-2016/17 project (November 2016 to March 2017).

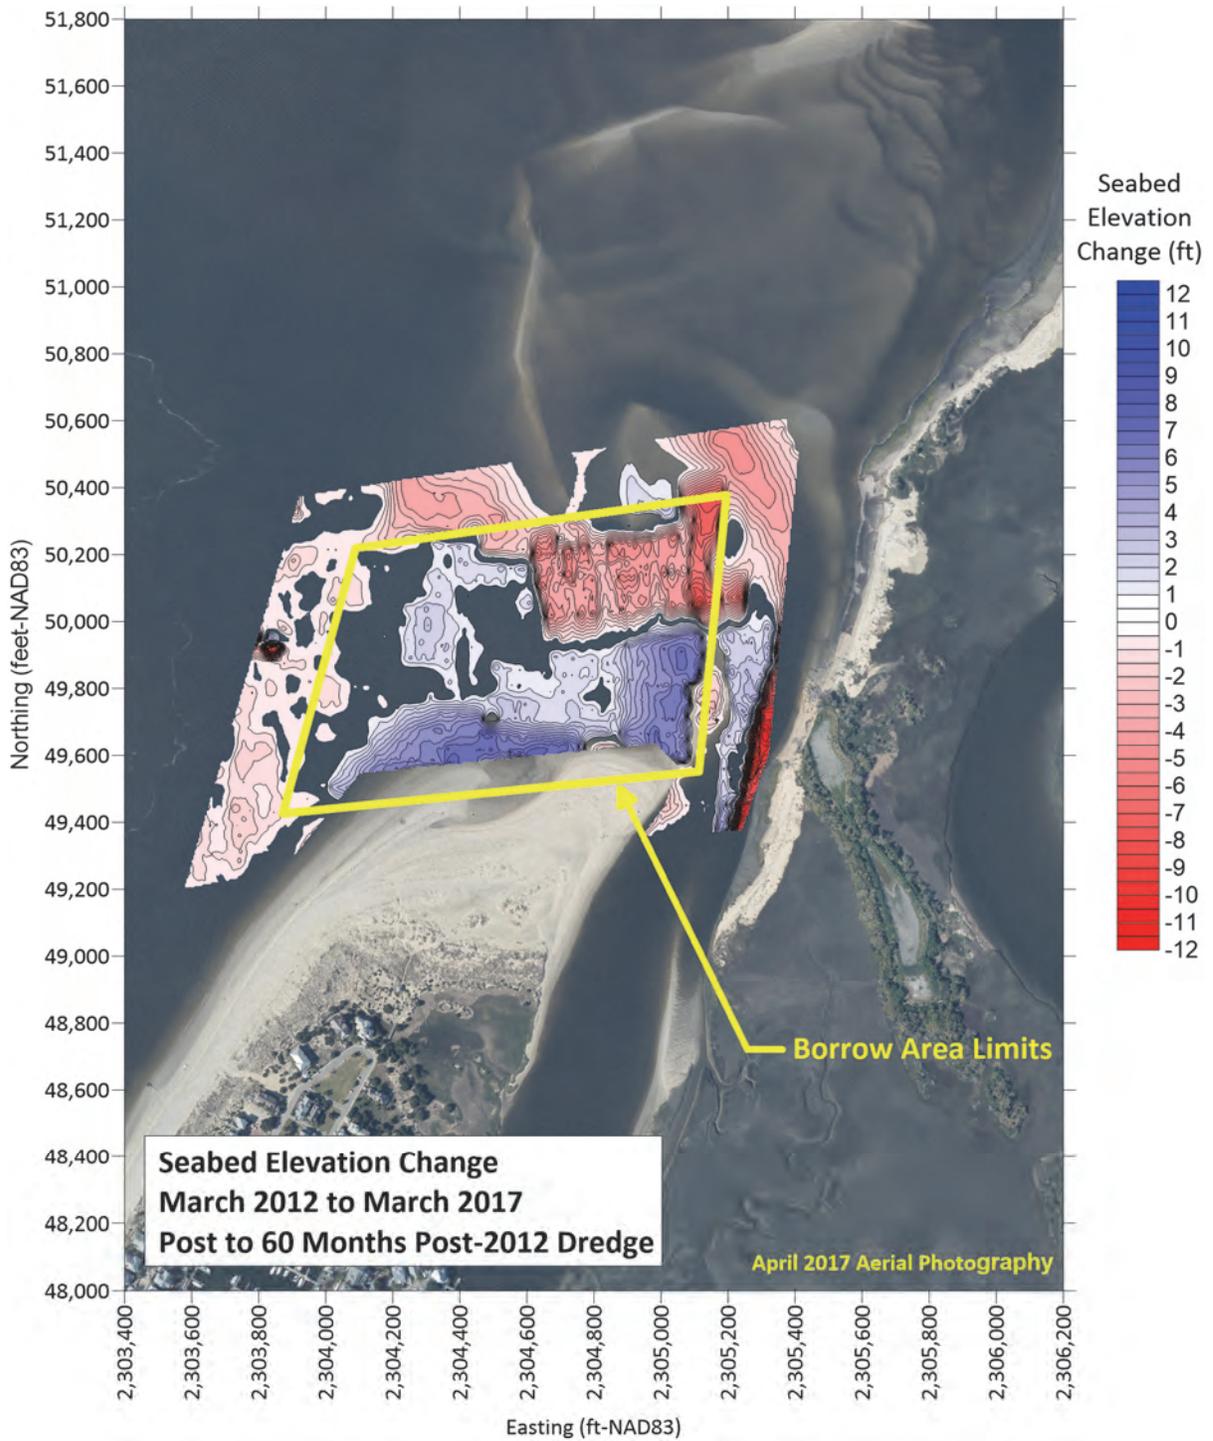
Figure 4.4: Bald Head Creek borrow site seabed elevation changes post-2012 project (March 2012) to March 2017 to post-2016/17 project.

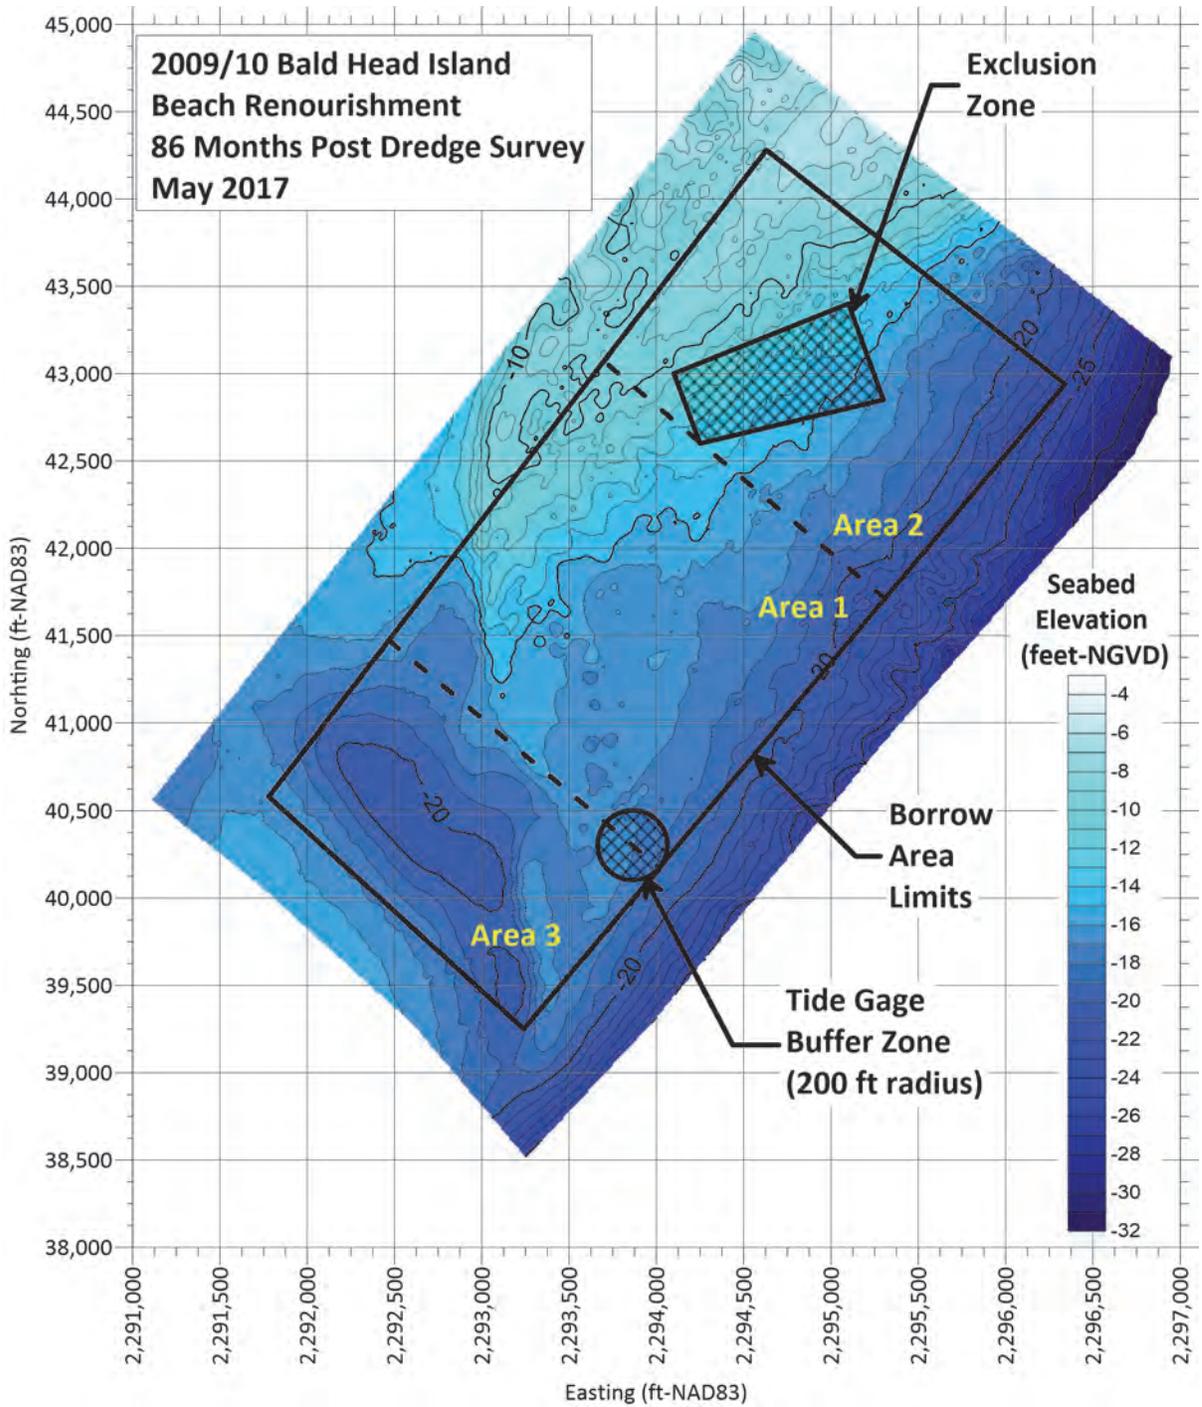
Figure 4.5: 86-months post-dredge (May 2017) Jay Bird Shoal borrow site conditions.

Pursuant to permit requirements, the Jay Bird Shoal borrow site was surveyed in May 2017. **Table 4.2** summarizes the volume changes within the *excavated* borrow site limits²¹ between the monitoring surveys conducted to date. **Figure 4.5** depicts the most recent 7-year post 2009/10 project (86 months) borrow site condition as surveyed in May 2017. **Figure 4.6** depicts the changes between the April 2015 and May 2017 surveys (Years 6 & 7). **Figure 4.7** depicts the changes during the 86 months since project construction (March 2010 to May 2017).

²¹ Excavation occurred with Areas 1 & 3 (minus the exclusion zones) depicted in **Figure 4.5**.

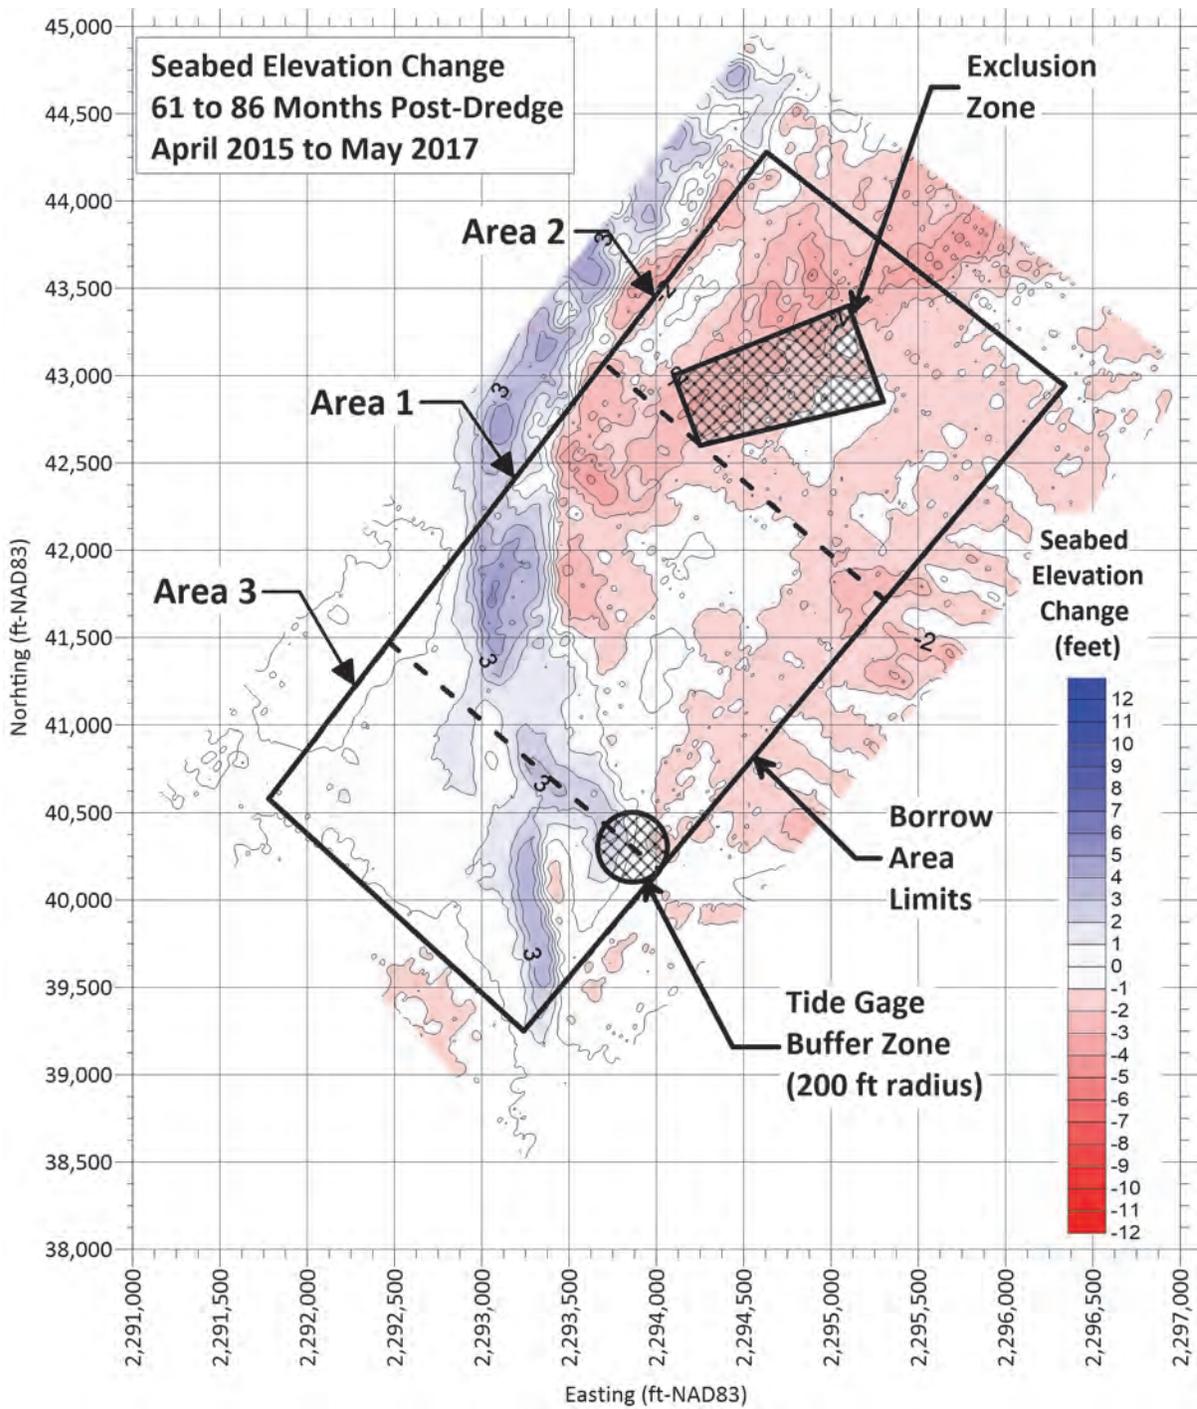
Figure 4.6: Jay Bird Shoals seabed elevation changes 61 to 86 months post-dredge (April 2015 to May 2017).

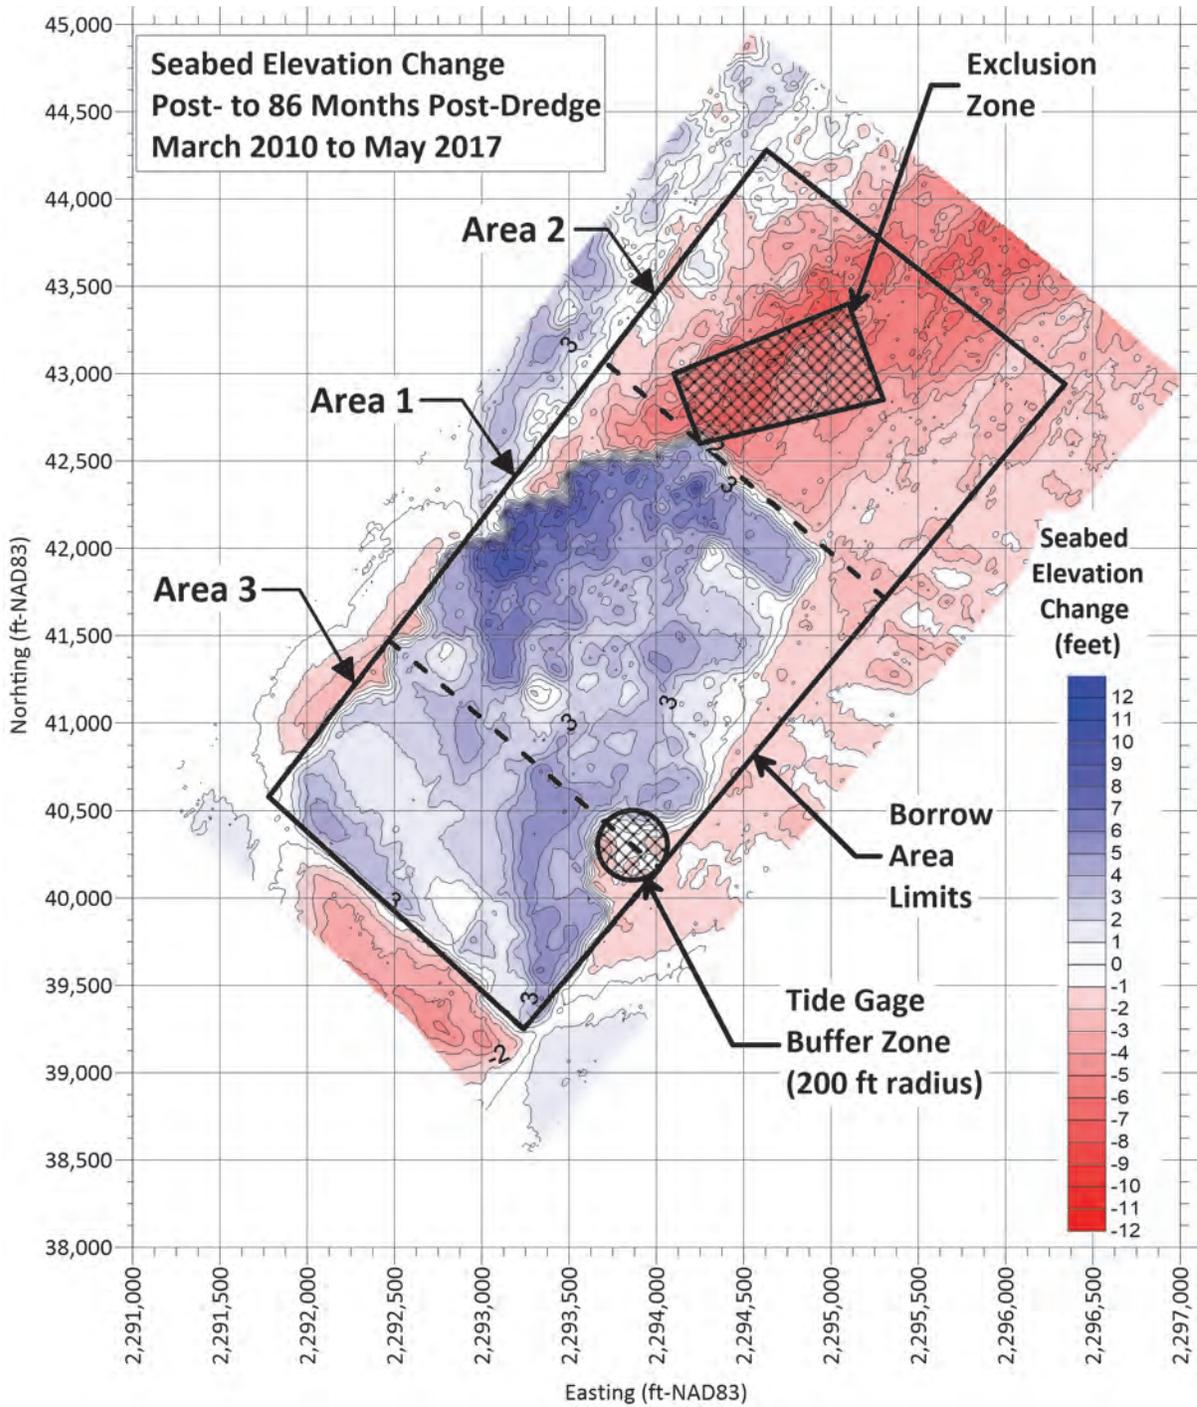
Figure 4.7: Jay Bird Shoals seabed elevation changes since project completion (March 2010 to May 2017).

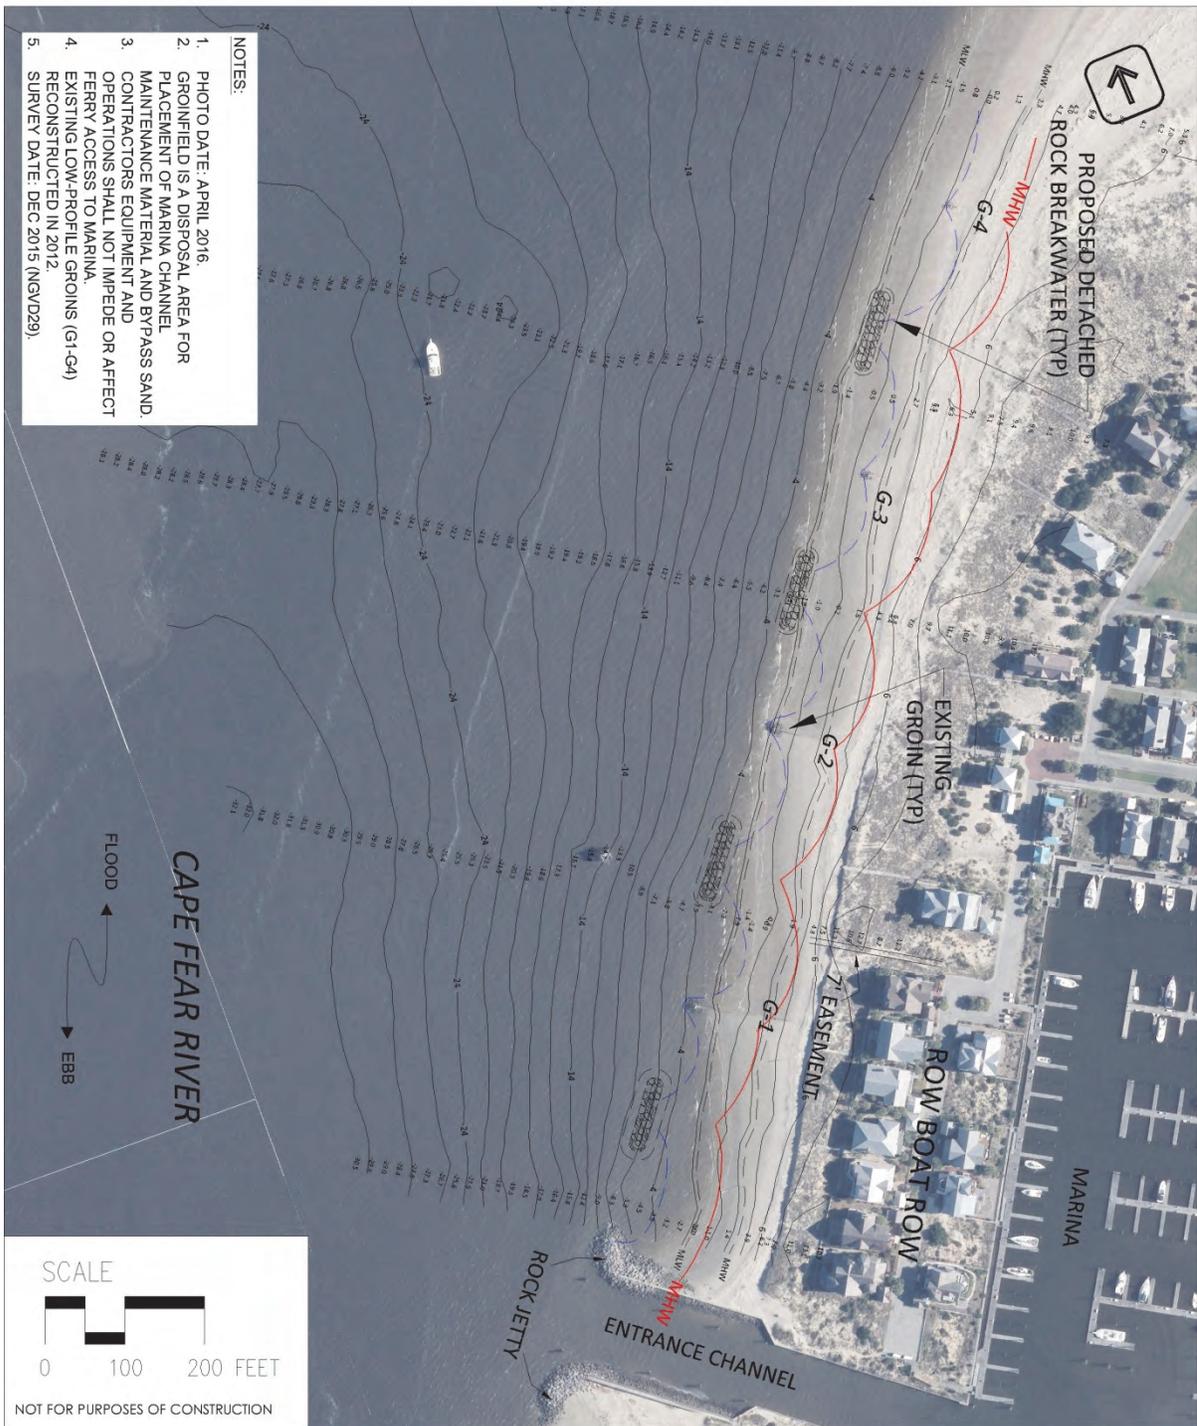
Figure 5.1: Original proposed plan for Row-Boat-Row shoreline detached breakwater project.

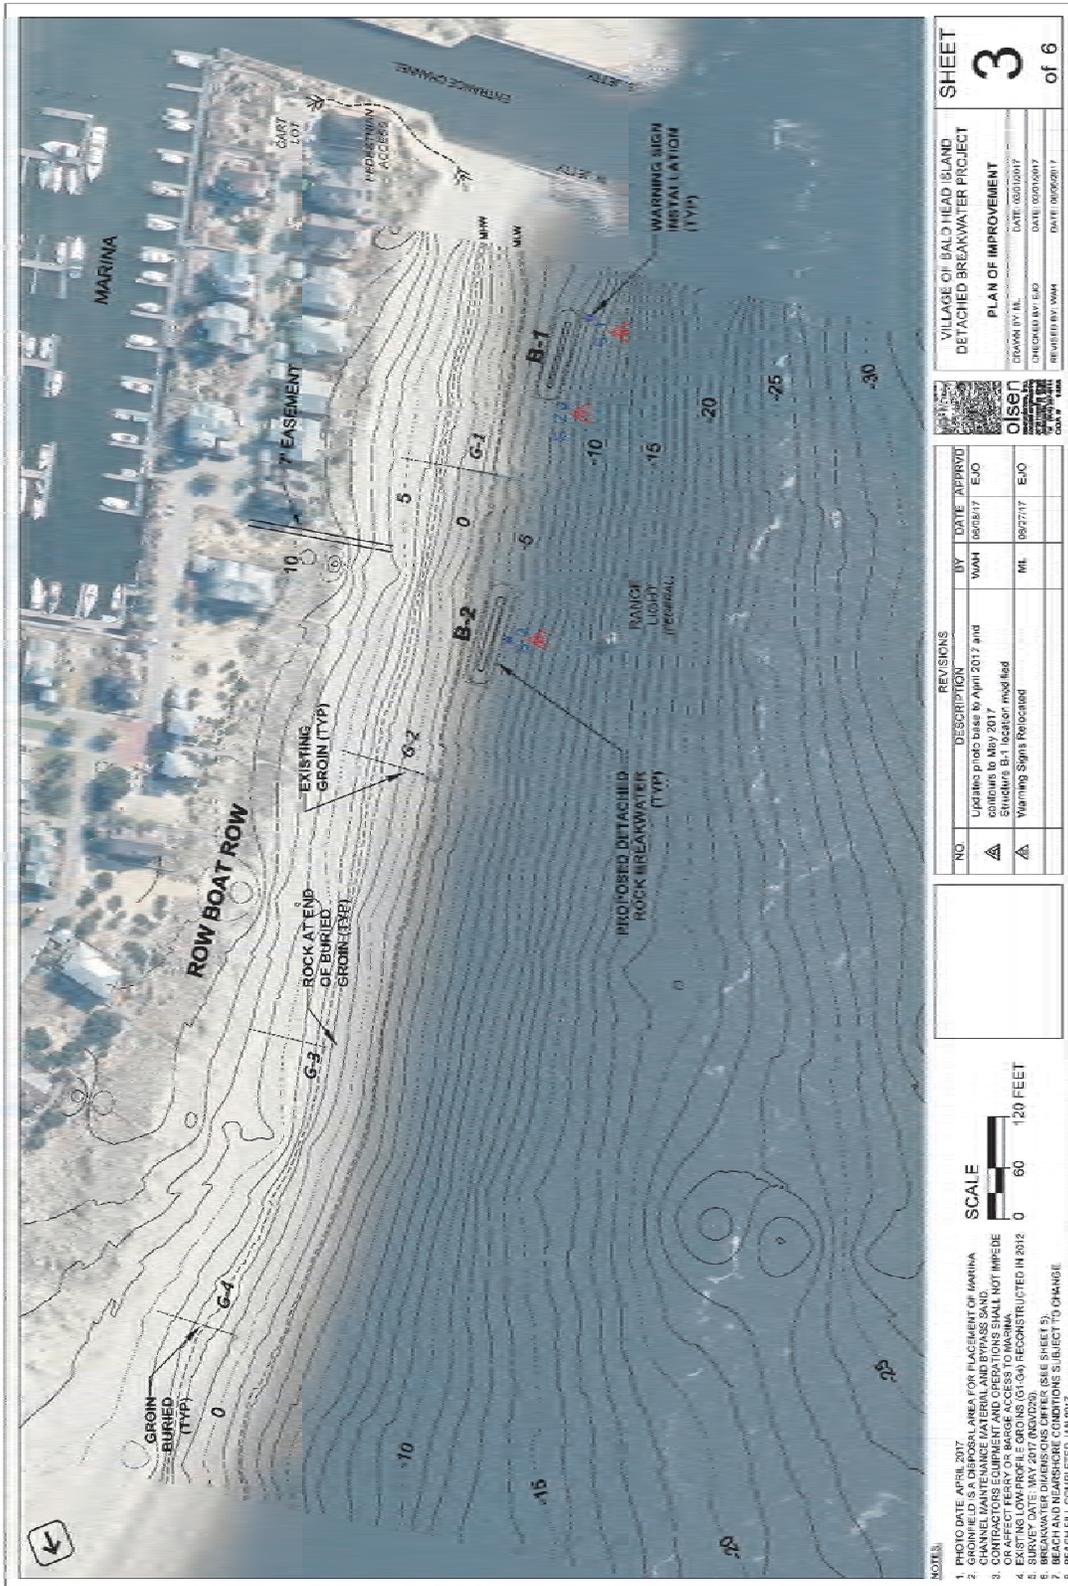
Figure 5.2: Modified plan for Row-Boat-Row shoreline detached breakwater project.

A delay in the issuance of the breakwater permits necessitated that the beach fill be constructed first. As discussed in **Section 3.5**, roughly 26,000 cy of clean sand fill was placed in early 2017 by Marcol Dredging. Similarly, in order to construct the breakwater project in the fair weather months of 2017 – coincident with a State moratorium of such work – the Village agreed to reduce the project scope to include only the two southernmost breakwaters (see **Figure 5.2** for the modified plan). In early 2017, the project was awarded to the firm Intracoastal Marine. Final acceptance of the work is expected in early August 2017. Future monitoring reports will document the residual crenulate beach formations expected to evolve in the lee of the breakwaters and between groin G-1 and G-2.
