# Bald Head Island, N.C. Beach Monitoring Program

## Monitoring Report No. 17 (May 2018 to May 2019)

**Prepared for:**  
Village of Bald Head Island

**Prepared by:**  
Olsen Associates, Inc.  
2618 Herschel Street  
Jacksonville, FL 32204  
(904) 387-6114  
(Fax) 384-7368  
olsen-associates.com  
C-1468

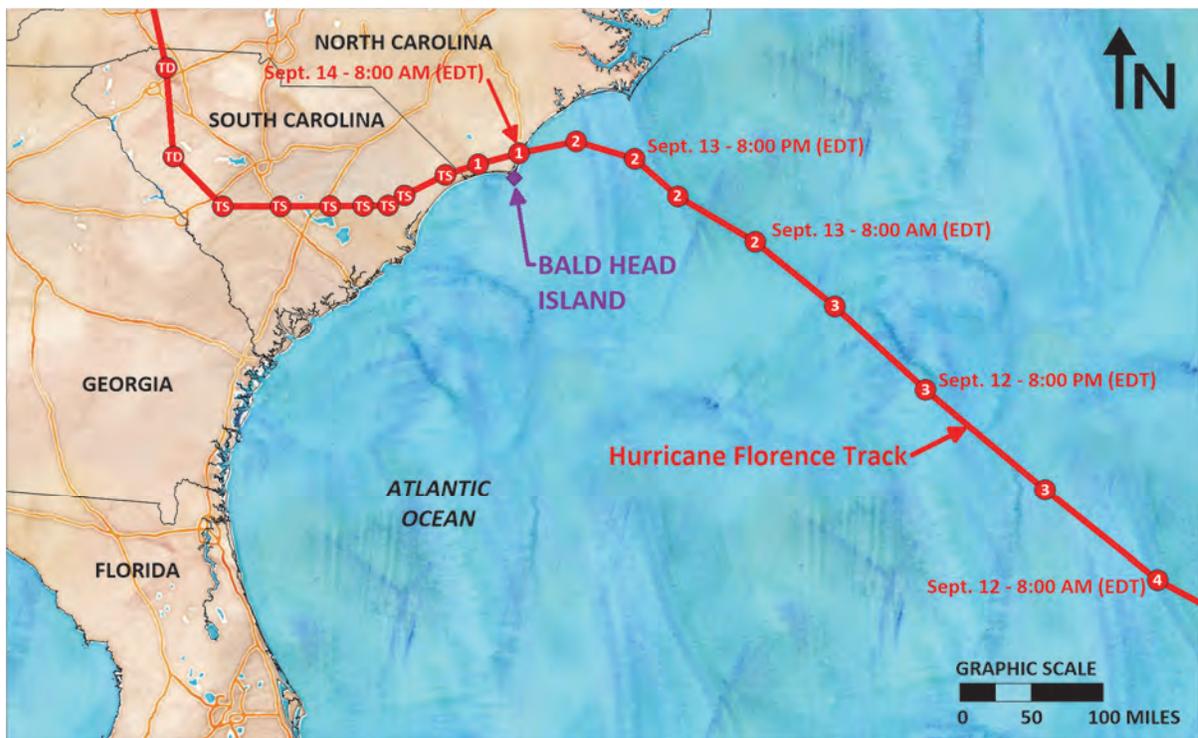
**Figure 1.3:** Hurricane Florence (2018) track as the storm approached the coast of the United States. Track retrieved from the National Hurricane Center (NHC 2019).

During the 12-month monitoring period, Bald Head Island experienced the effects of Hurricane Florence (September 2018). **Figure 1.3** plots the track of Hurricane Florence as the storm approached the east coast of the United States.

Hurricane Florence formed as a tropical depression off of the west coast of Africa on August 30, 2018. The storm moved west and northwest across the Atlantic Ocean, reaching tropical storm strength on September 1. By September 5, Florence had reached Category 4 strength. The strength of Florence fluctuated between tropical storm and Category 4 hurricane as it approached the east coast of the United States. Florence made landfall on the morning of September 14, just south of Wrightsville Beach, North Carolina as a Category 1 hurricane with 90 mph sustained winds. At the closest, the center of then Category 1 Hurricane Florence passed about 18 miles northeast of Bald Head Island, bringing sustained winds of 54 mph and gusts of 67 mph to the monitored shoreline (NOAA 2019).

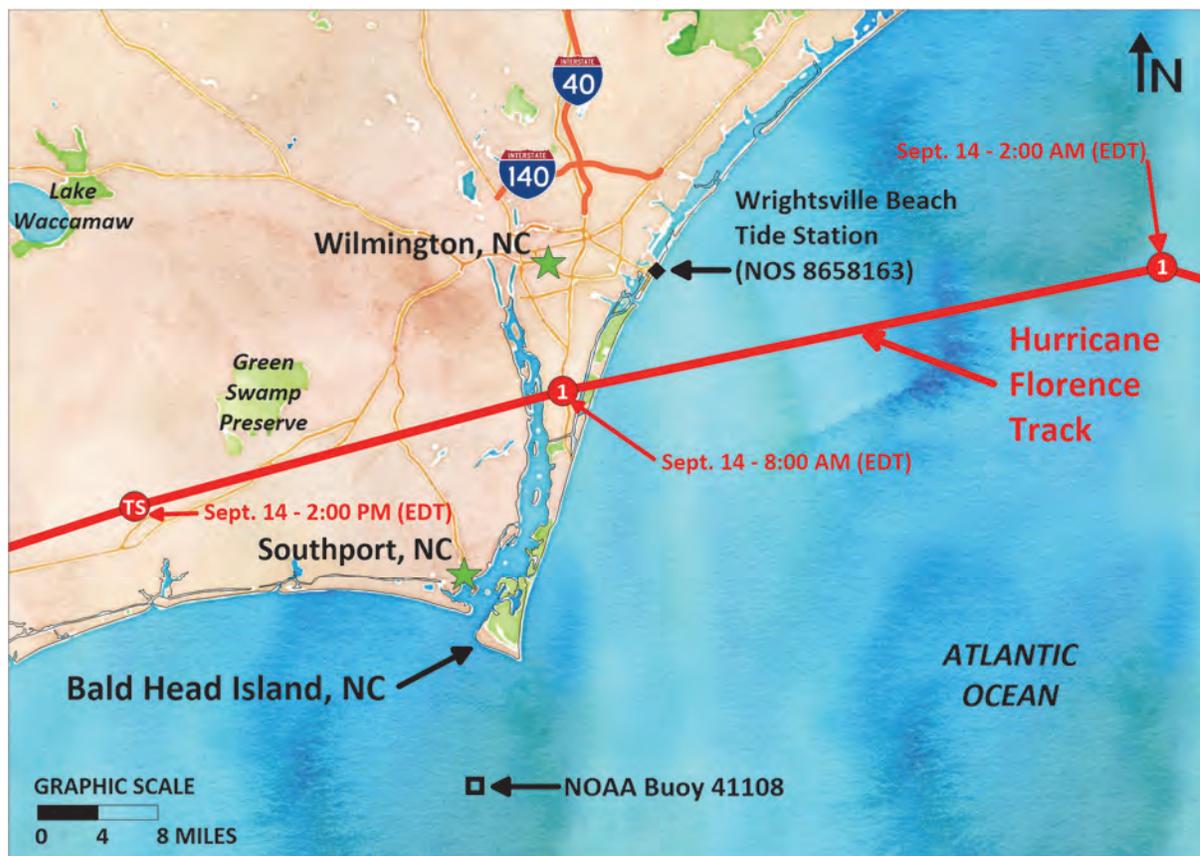
**Figure 1.4:** Track of Hurricane Florence in the vicinity of Bald Head Island showing the location of NOAA Buoy 41108 and the Wrightsville Beach tide station (NOS 8658163). Track retrieved from the National Hurricane Center (NHC 2019).

**Figure 1.4** plots the track of Hurricane Florence in the vicinity of Bald Head Island. The figure also displays the location of NOAA Buoy 41108, located roughly 9 miles south of Bald Head Island in approximately 42 feet of water. The center of Hurricane Florence passed within about 28 miles of the buoy. The buoy was deployed in March 1988 and has been collecting data nearly continuously for 31+ years except for an approximate 5 year period between April 1992 and May 1997. The data collected by the buoy includes significant wave height (average of the highest one-third of all waves in a 20-minute sampling period), wave period, wave direction, wind speed and other standard meteorological data.

Additionally, Figure 1.4 shows the location of the Wrightsville Beach, NC tide station (NOS 8658163), owned and maintained by NOAA’s National Ocean Service (NOS) Water Level Observation Network. The tide station is located at the offshore end of the Johnny Mercers Fishing Pier, approximately 28 miles northeast of the monitored area. In addition to water levels, the station typically collects readings of wind speed, gust speed, atmospheric pressure, and other meteorological data. However, the station did not collect meteorological data during Hurricanes Florence. Hurricane Florence made landfall approximately 10 miles southwest of the station.

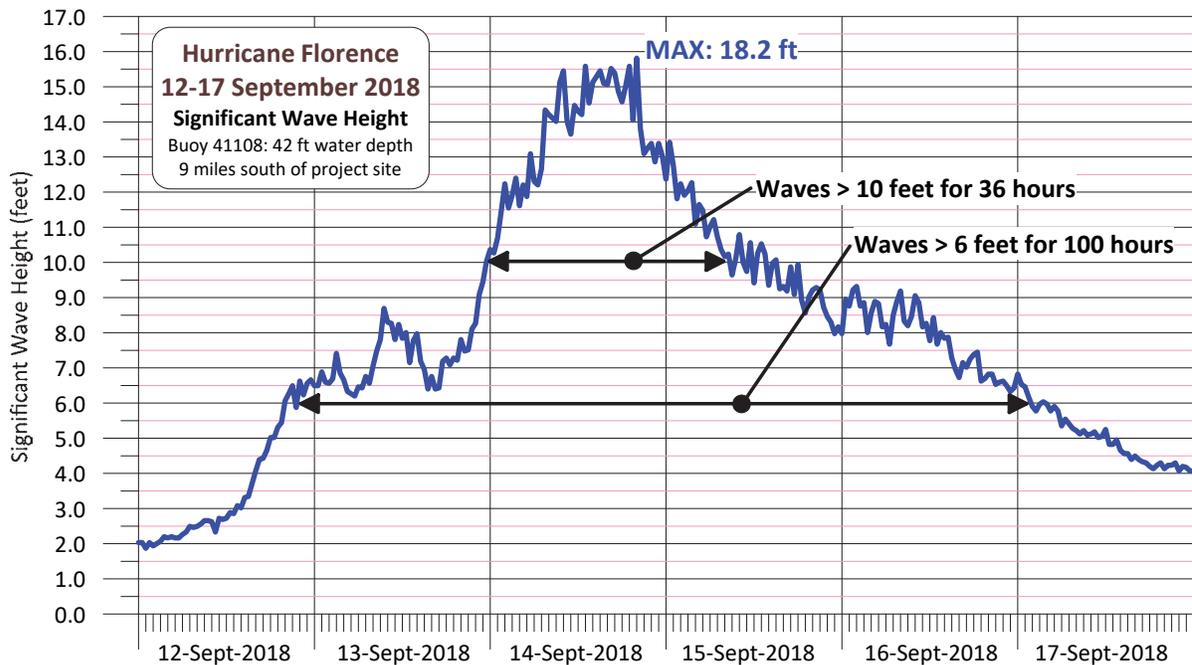
**Figure 1.5:** Time series of significant wave heights measured at NOAA Buoy 41108 as Hurricane Florence moved by Bald Head Island, NC. The buoy is located approximately 9 miles south of Bald Head Island in 42 feet of water.

**Figure 1.5** depicts the time series measured at the buoy during the passage of Hurricane Florence. While the buoy is located offshore in unprotected waters, the wave conditions measured can generally be related to nearshore conditions along the monitored area. Additionally, some fraction of the waves measured at the buoy are directed offshore. All wave statistics mentioned in this section will be from measurements at Buoy 41108.

During Hurricane Florence, significant wave heights peaked at 15.81 feet on the evening of September 14<sup>th</sup>, as the storm’s center was approximately 40 miles northeast of the wave buoy. The dominant wave period peaked at about 9 seconds during this time. It is noted that these measurements reflect the significant wave height, or the average of the highest 1/3<sup>rd</sup> of waves passing the buoy during a 20 minute sampling period. There are waves that passed during the storm that were larger in height – some waves may have been as much as twice as high. Large waves persisted along the coast for a significant duration of time with significant wave heights greater than 10 feet lasting for more than 36 hours and waves greater than 6 feet for 100 hours. For comparison, during Hurricane Matthew (October 2016), wave heights greater than 10 feet lasting for about 22 hours and waves greater than 6 feet for 36 hours.

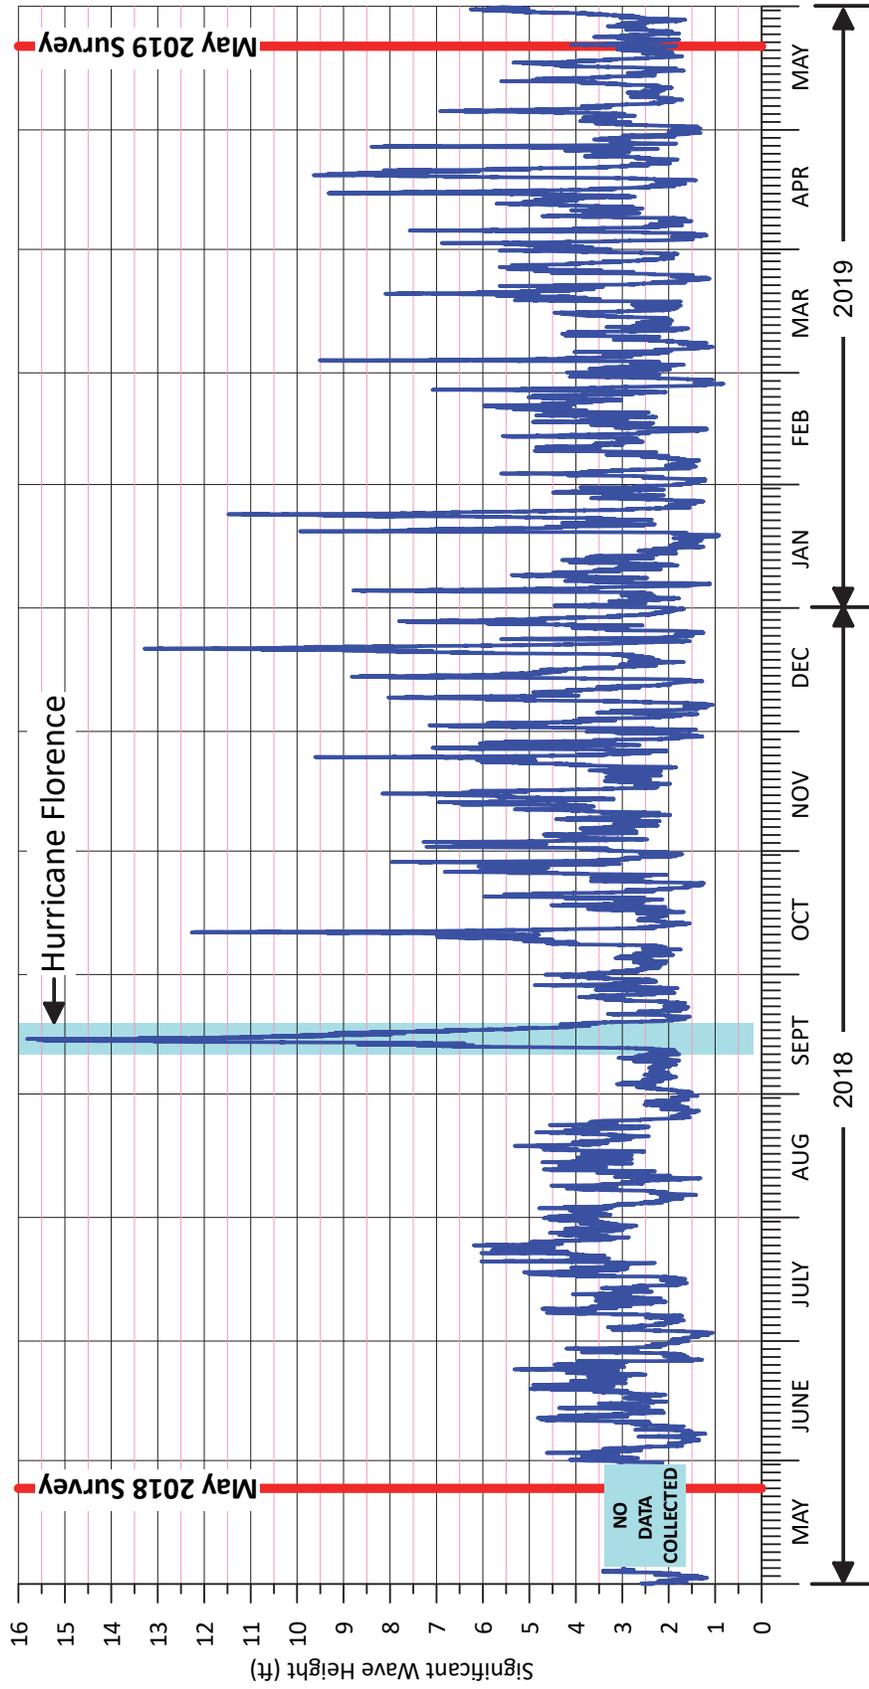
**Figure 1.6:** Significant wave heights recorded by NOAA Buoy 41108 during the 2018-19 monitoring period (Wilmington Harbor, NC).

**Figure 1.6** displays a time series of significant wave heights measured at NOAA Buoy 41108 from May 2018 through May 2019. The average significant wave height<sup>3</sup> at NOAA Buoy 41108 during the Year 18 monitoring period (May 25, 2018 to May 22, 2019<sup>4</sup>) was 3.28 feet with a maximum wave height of 15.81 ft measured during Hurricane Florence. The Year 17 average value is approximately 2 percent higher than the full record average significant wave height of 3.21 feet (March 1988 through May 2019) and 3 percent lower than the Year 16 average wave height (3.43 feet). Note that the Year 18 period included the effects of Hurricanes Florence and while the *average* wave height over the course of Year 18 was slightly lower than Year 17, the maximum wave height experienced that year (15.81 ft) was significantly higher compared to Year 16 (11.61 ft).

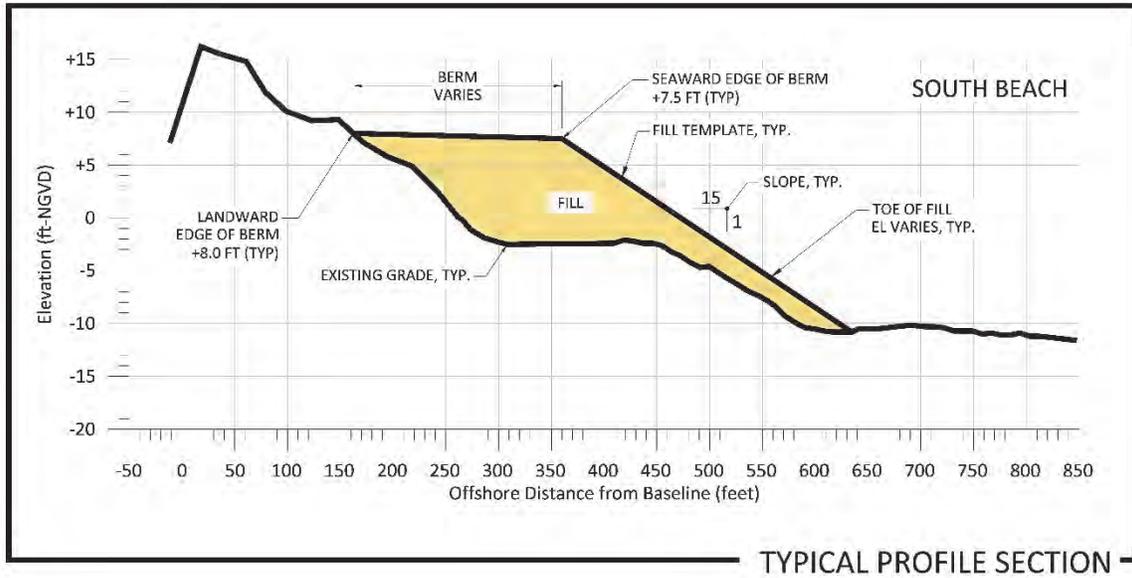
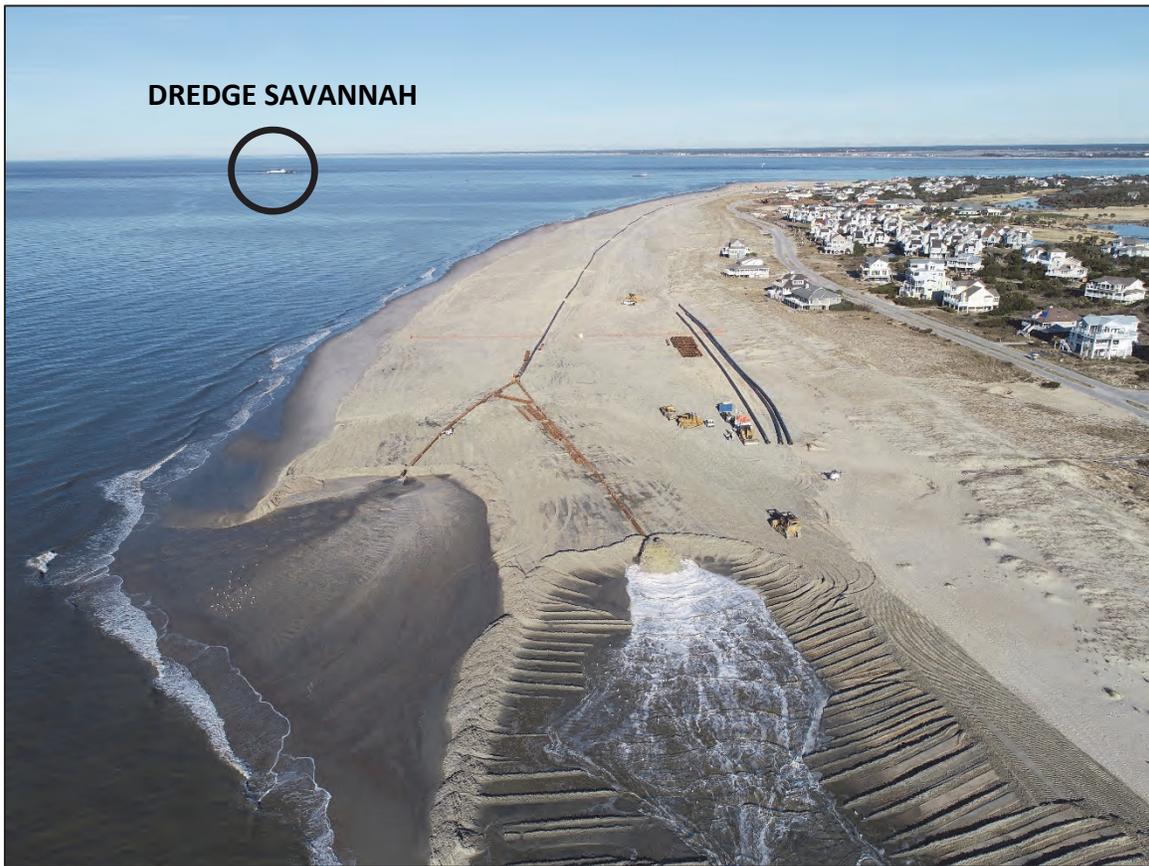
**Figure 2.2:** Beach fill template, as designed and as constructed (width varies).

As depicted by the typical beach fill templates (**Figure 2.2**) seaward of the project dune feature (and vegetation), the upper flat portion of the 2018/19 construction berm was built to an elevation of +8 ft. NGVD and varied in width initially along the length of the project from approximately 75 to 400 ft. (typ) – the fill taper at the eastern end not included. The initial construction slope was set at 1:15. The construction berm was expected to equilibrate (in places), over the first six months post-construction by 50% or less of its initially placed width. Subsequent to the construction of the 2015 terminal groin the greatest shorefront equilibration is expected to be along the western end of South Beach, eastward from the rock groin through a portion of the sand tube groin field where the shoreline curvature is greatest.

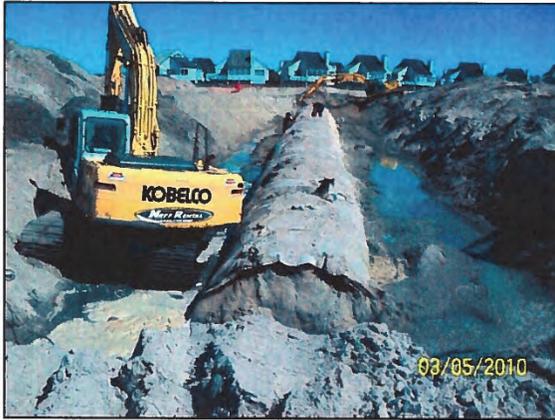
Groin # 8 – Being Removed Prior to Replacement

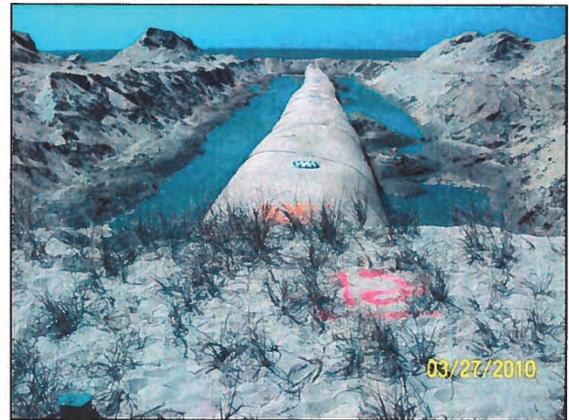
Groin # 12 – Before Back-Fill

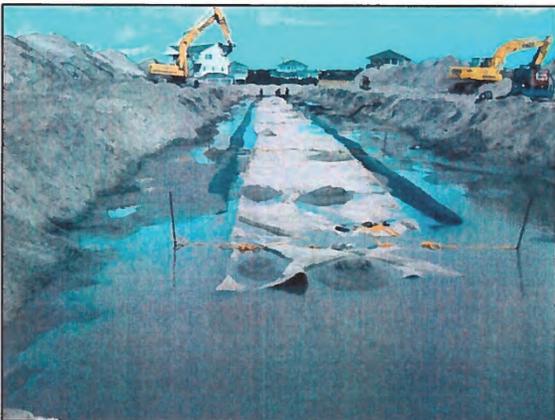
Groin # 2 – Before Fill

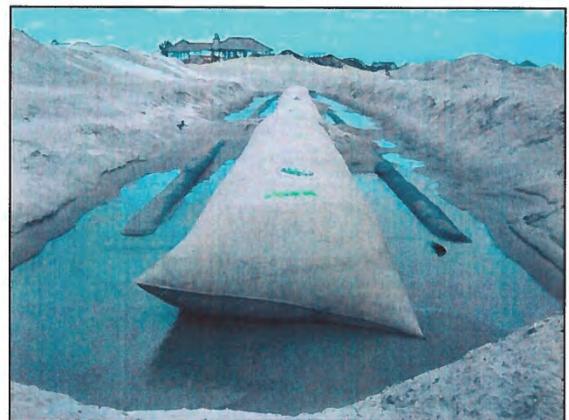
Groin # 1 – After Fill

**Figure 3.1:** Sand tube removal/replacement process.

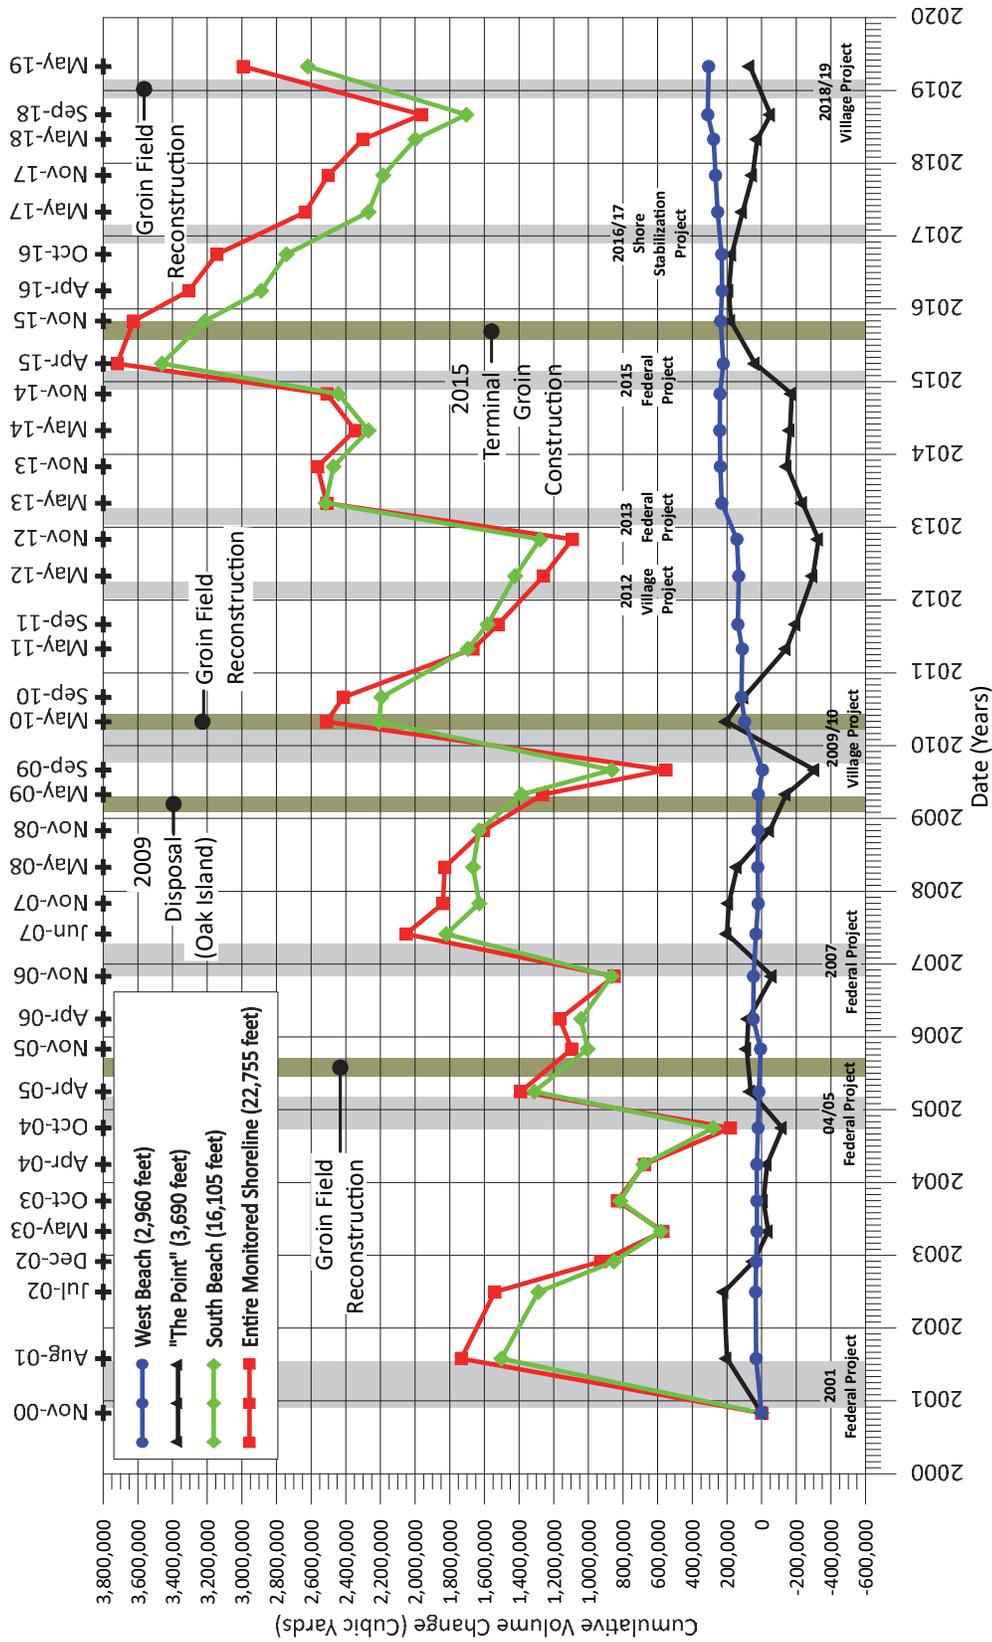
Figure 5.6: Cumulative volume change (above -16 ft-NGVD) relative to November 2000 conditions.

For purposes of tracking gross sand placement performance, **Figure 5.6** plots a time history of cumulative volume change relative to November 2000 conditions. **Figure 5.7** presents net volumetric change (alongshore above -16 ft NGVD) for the maximum period of comparison to date (*i.e.* November 2000 and May 2019). In both figures the effects of direct sand placement over time are included. As with other similar analyses over the last decade, East Beach, Cape Fear and Row Boat Row are excluded from this analysis.

The classic “saw-tooth” effects of episodic sand placement, as reflected in **Figure 5.6**, are indicative of the periodic infusion of sand along South Beach at Bald Head Island associated with the placement of sand during initial construction of the channel deepening project, three (3) subsequent beach disposal operations pursuant to the WHSMP, the proactive beach renourishment project constructed by the Village in 2009/10 and to a smaller degree the emergency fill of 2012. The Village 1.85 Mcy fill was constructed with the knowledge gained through monitoring that certain irreparable large-scale impacts to Bald Head Island would predictably occur as a direct result of the proposed diversion of channel maintenance material in 2009 to Oak Island. *Note – a similar diversion of Federal sand will occur in the summer of 2018.* As a result of the 2018 federal sand disposal at Oak Island, the Village constructed a 1.1 Mcy interim beach fill at South Beach in the fall/winter of 2018/19.

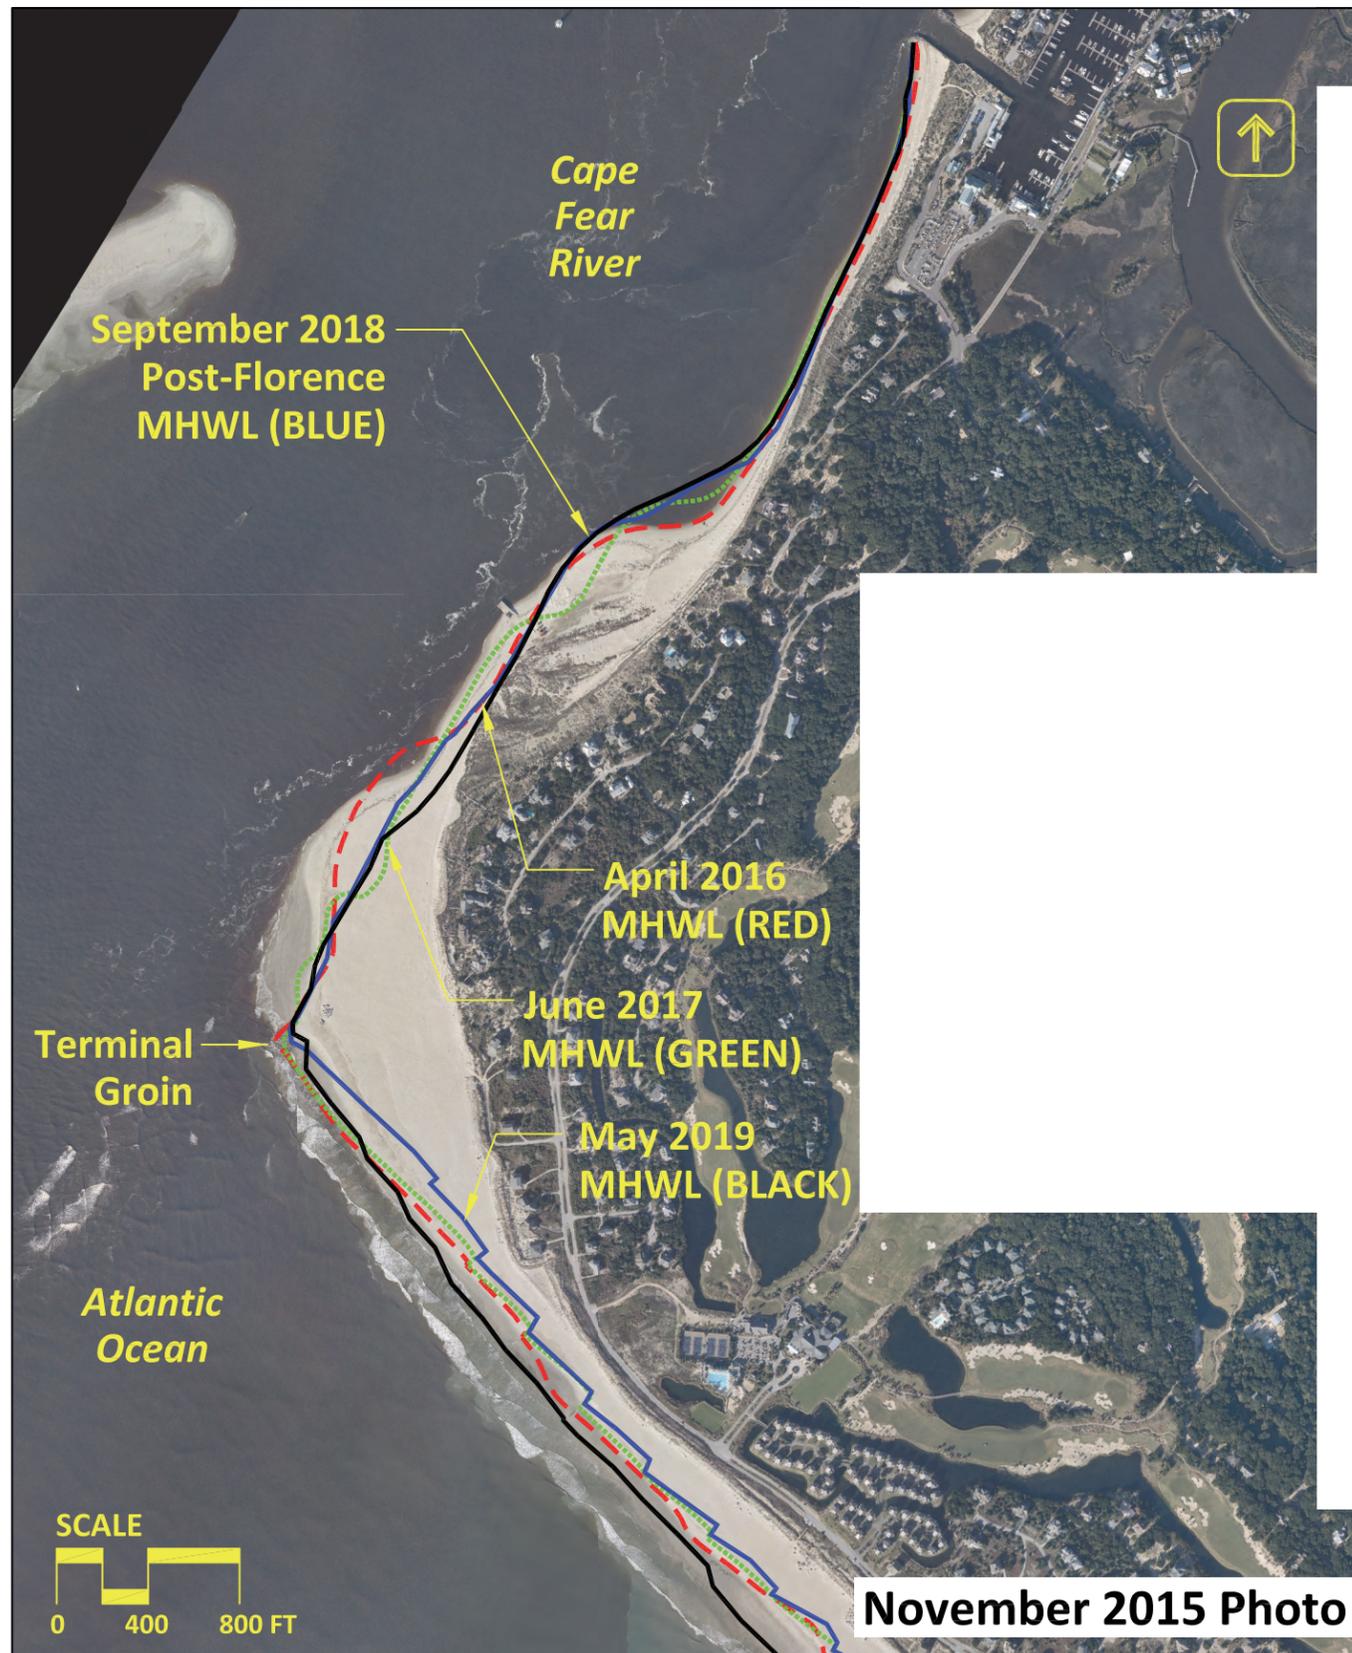
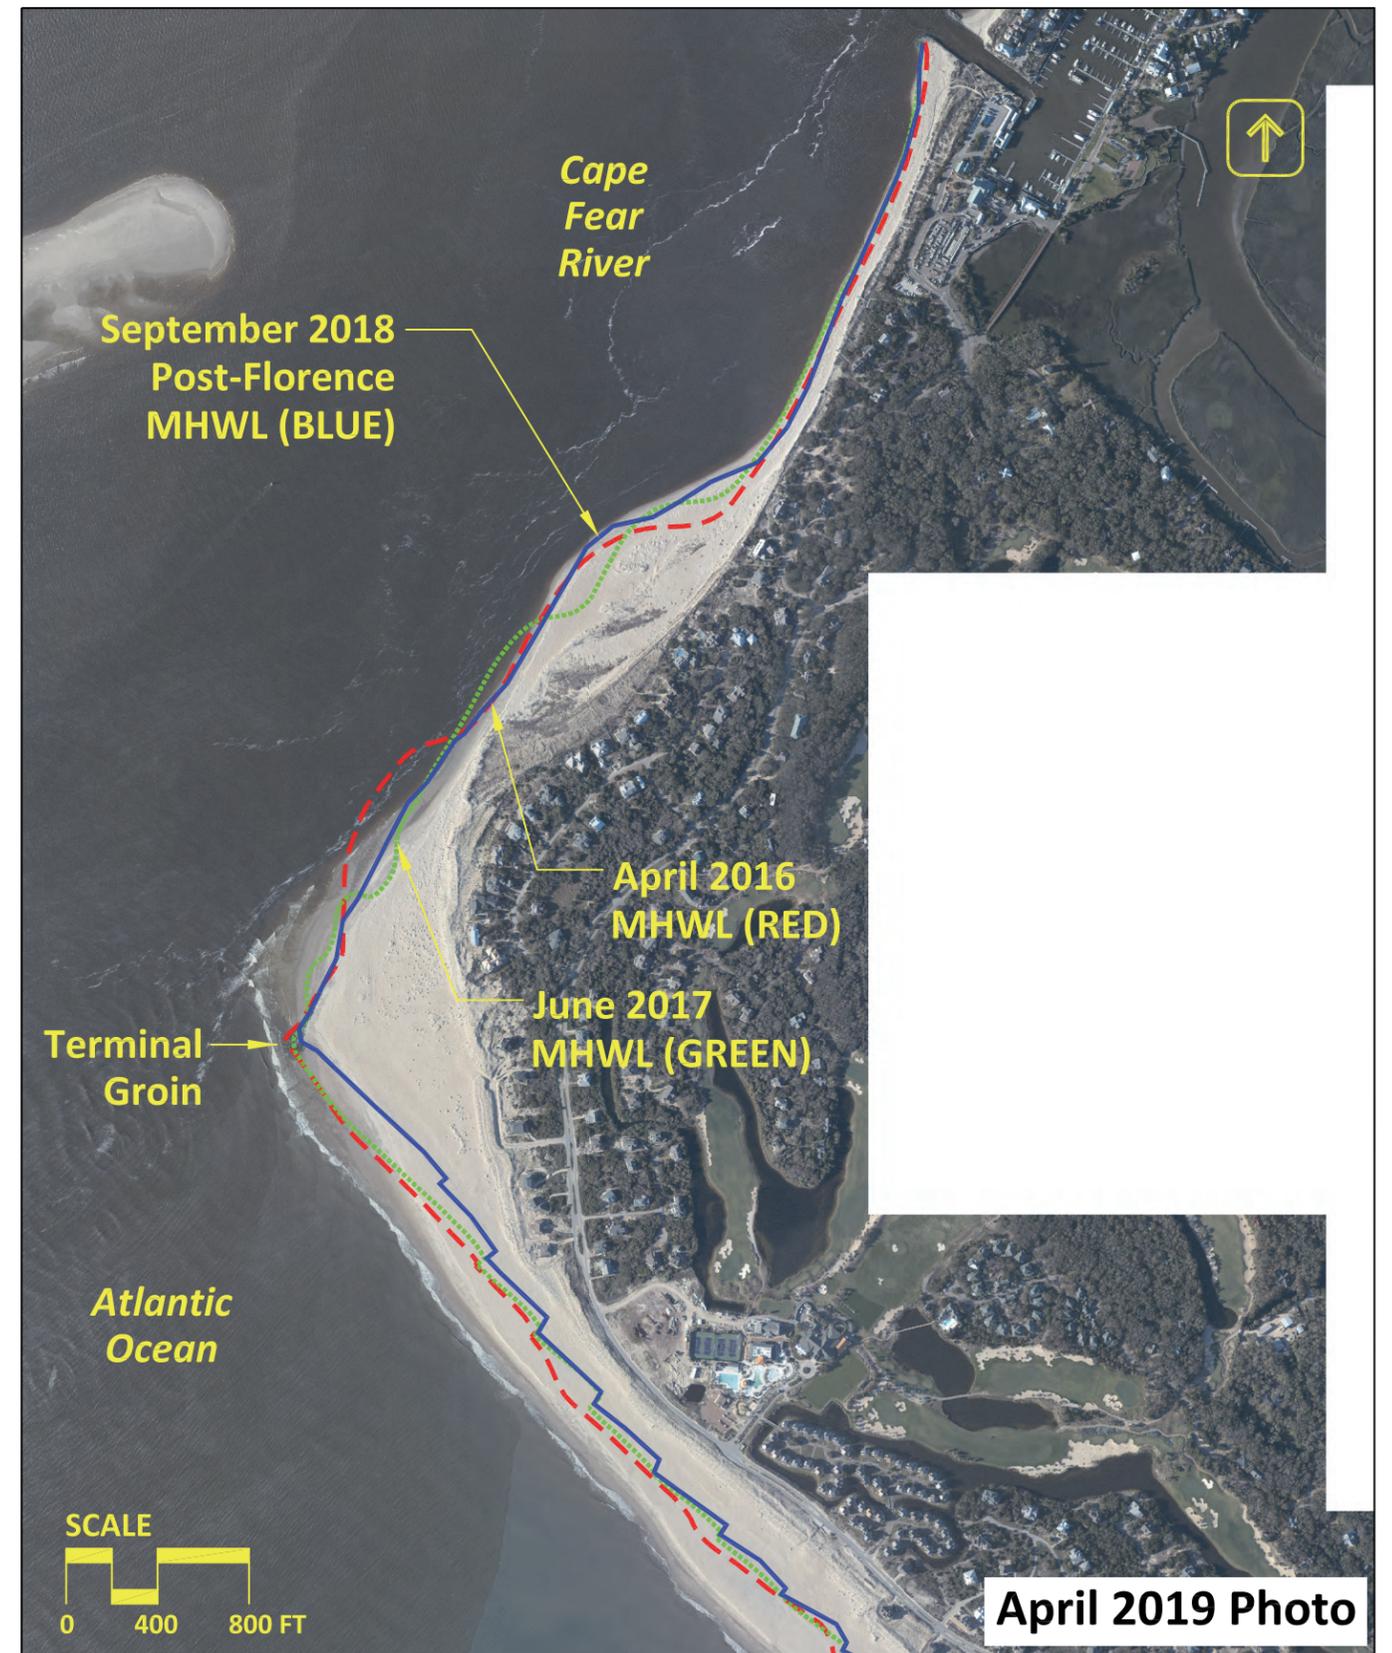
**Figure 5.8:**  
MHWL positions in the vicinity of the terminal groin Bald Head Island, NC

As part of the permit required monitoring for the terminal groin project completed in late 2015, the MHWL was surveyed in December 2015 (post-construction), April 2016 (5 months post-construction), June 2017 (19 months post-construction), May 2018 (30 months post-construction), September 2018 (post-Florence) and May 2019 (post-fill). The surveys completed to date are plotted in **Figure 5.8**. The purpose of the surveys is to be able to intercompare and assess both updrift fillet conditions and the location of the downdrift shoreline fronting the Cape Fear River. Through May 2019, terminal groin project performance – based upon monitoring – has been both as intended and as predicted.

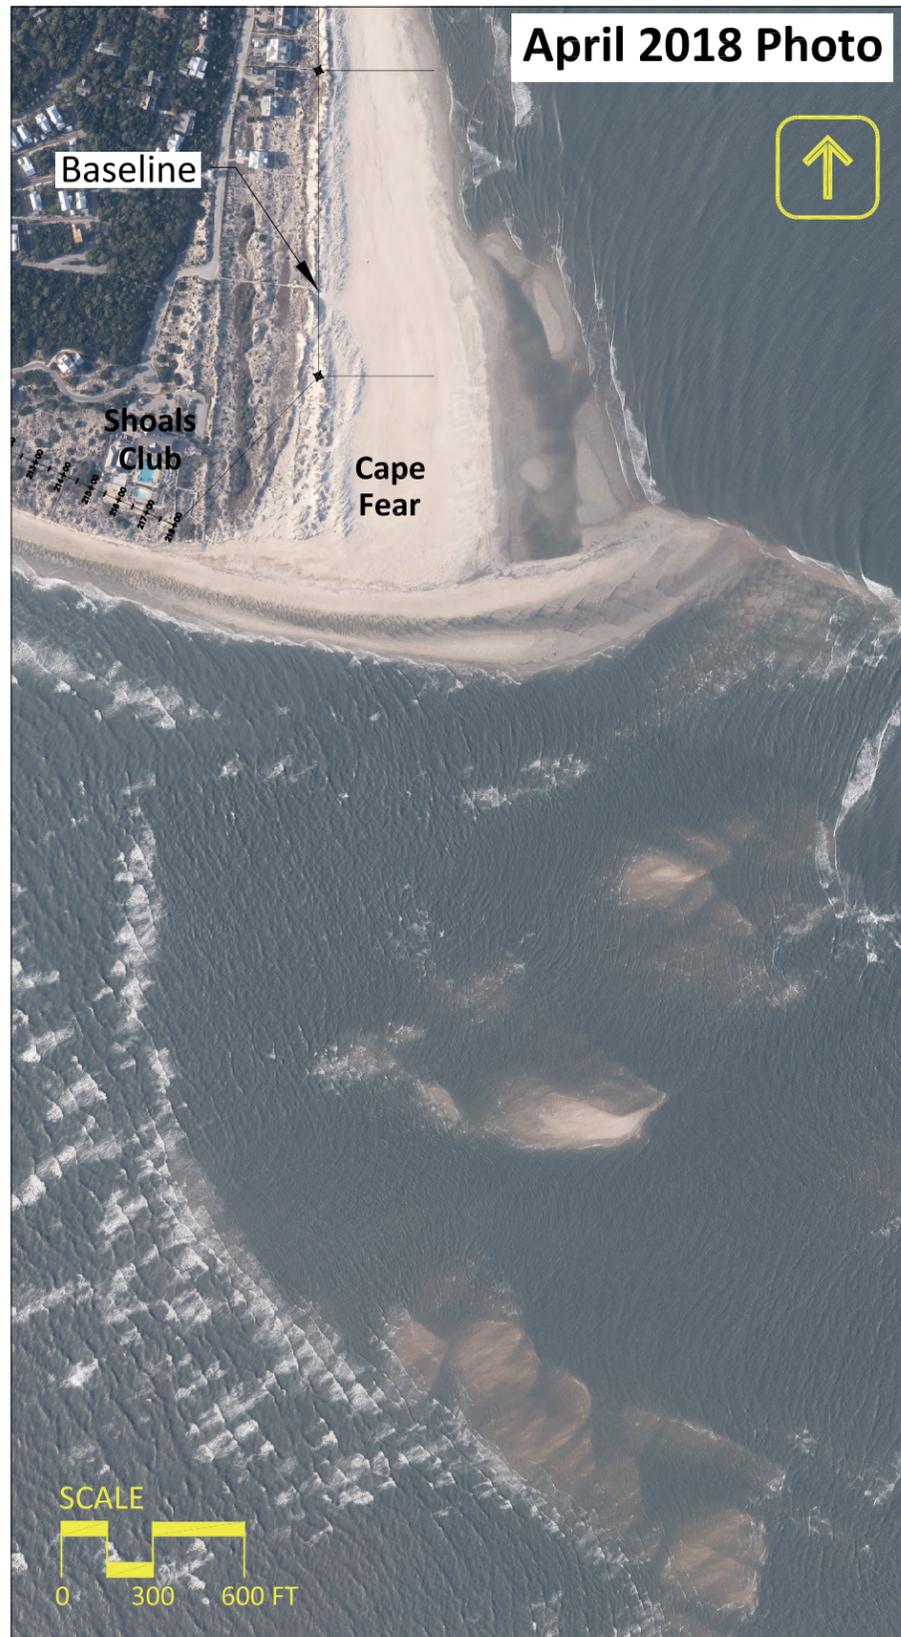
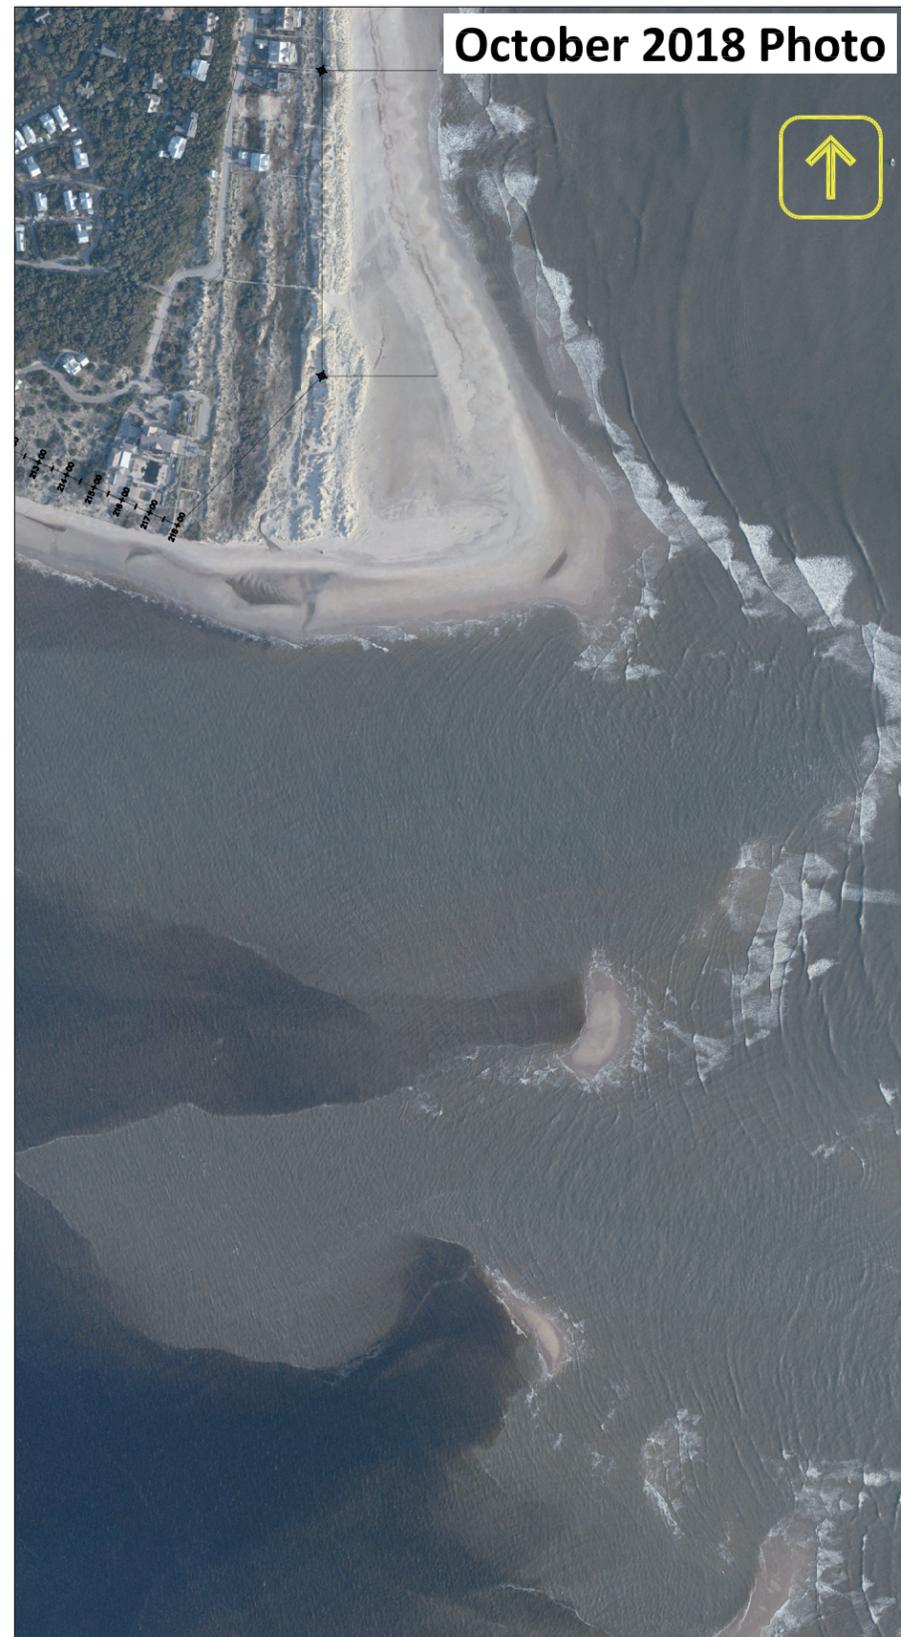
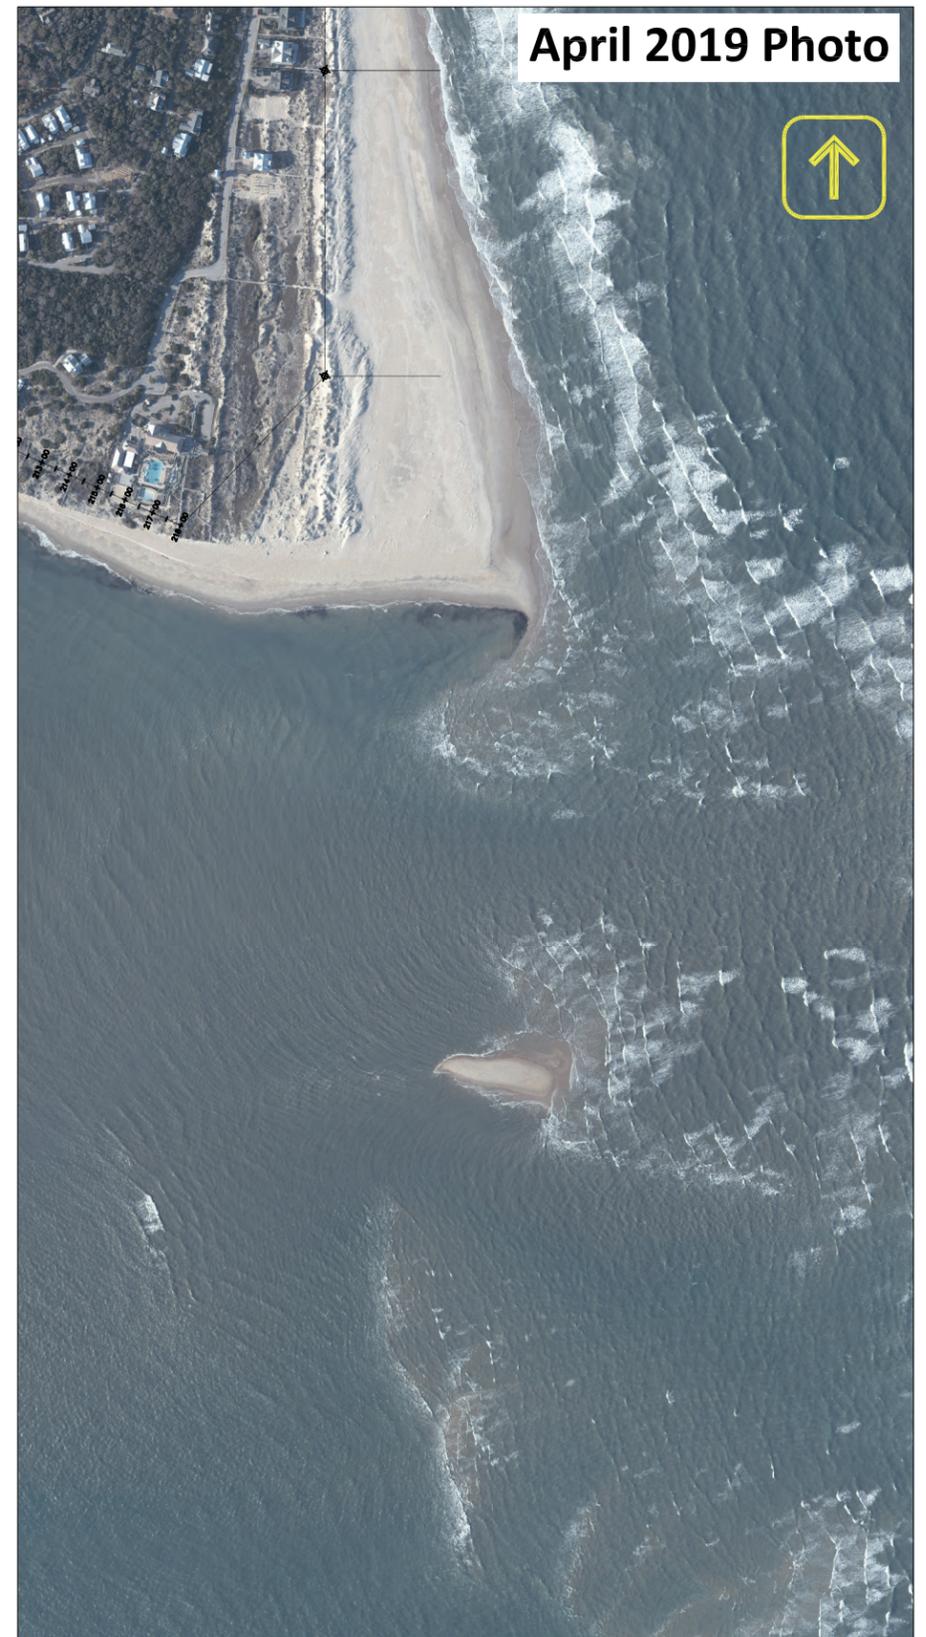
**Figure 5.9:**  
Cape Fear aerial photography  
Bald Head Island, NC

As demonstrated by the survey and photographic data (**Figure 5.9**), it can be reasonably assumed that the condition of East Beach at any one time is, has been and will continue to be highly influenced by the configuration of the depositional spit and shoals associated with the “Cape Fear Point”. Of further interest are the variations in spit size and orientation over the 11 years (2008-2019) which are depicted by **Figure 5.10**. In its simplest sense, the Cape Fear spit is a highly dynamic feature which is influenced by sand supply originating from both the west (along South Beach) and the north (along East Beach). The Point is also susceptible to storm waves originating from *both* the west (Atlantic Ocean) and the east (Onslow Bay) and resultant tidal channels which episodically break through and subsequently influence localized patterns of sand deposition (or erosion).
