# Bald Head Island, N.C. Beach Monitoring Program

## Monitoring Report No. 17 (May 2018 to May 2019)

**Prepared for:**  
Village of Bald Head Island

**Prepared by:**  
Olsen Associates, Inc.  
2618 Herschel Street  
Jacksonville, FL 32204  
(904) 387-6114  
(Fax) 384-7368  
olsen-associates.com  
C-1468

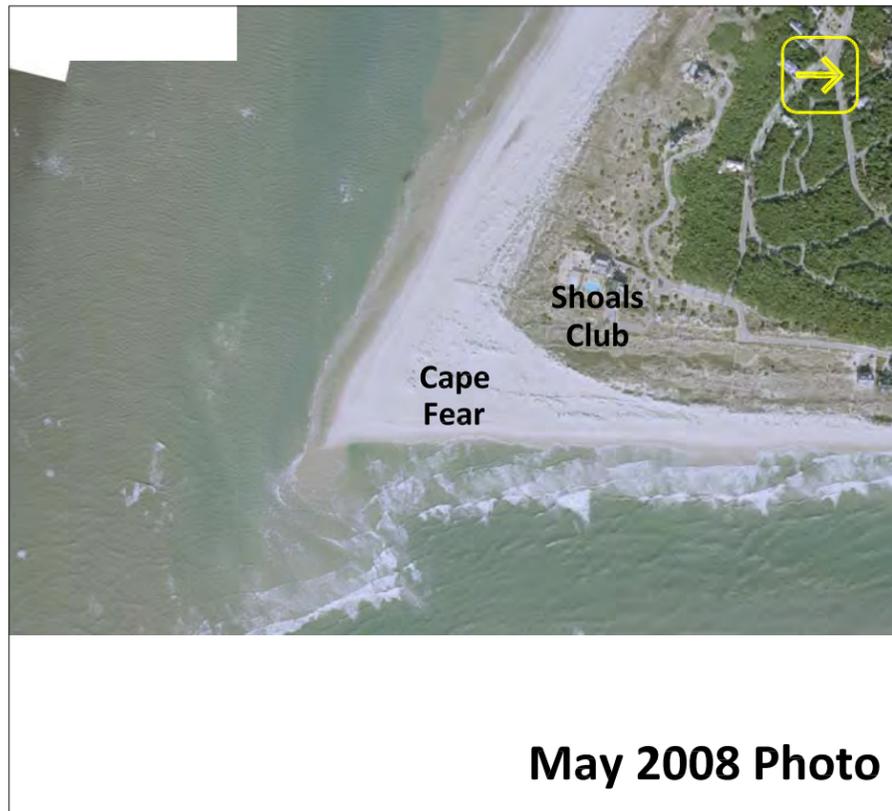
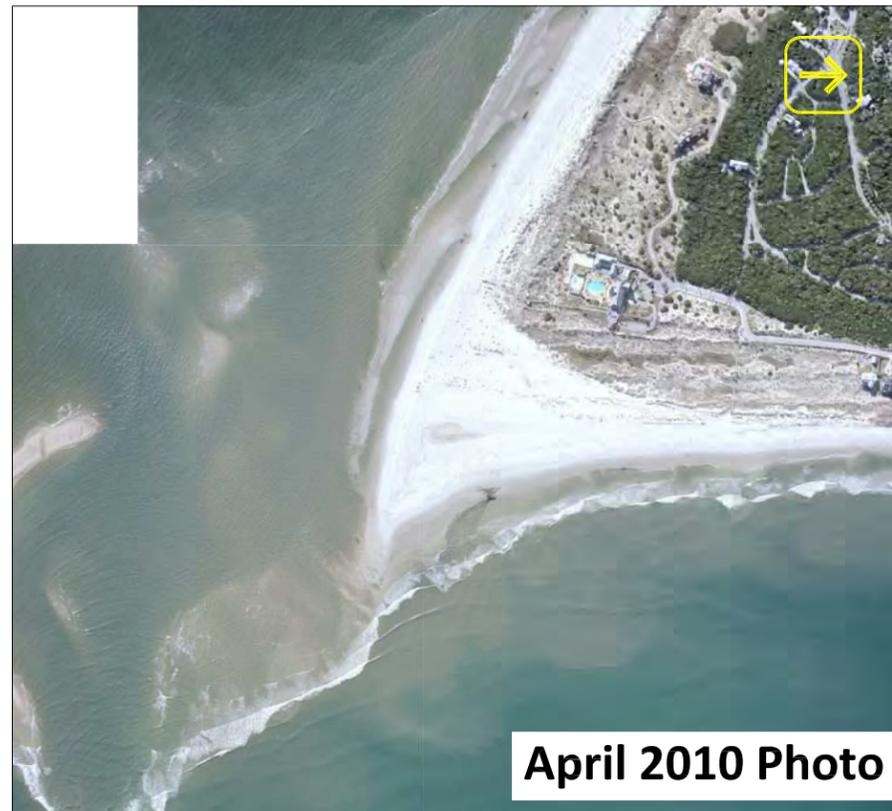
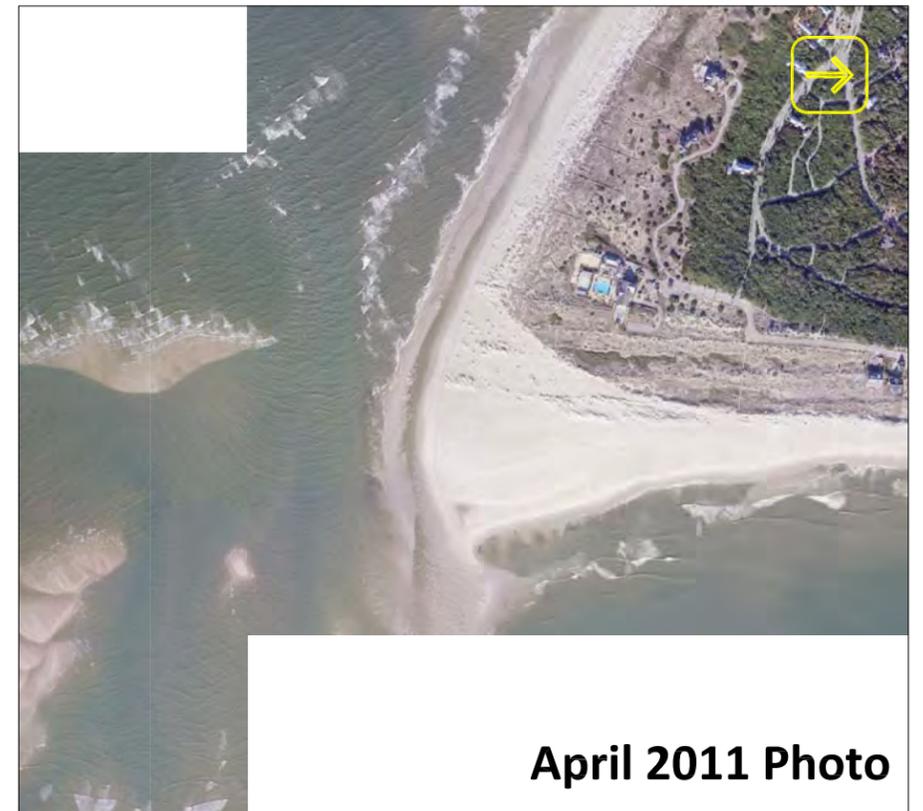
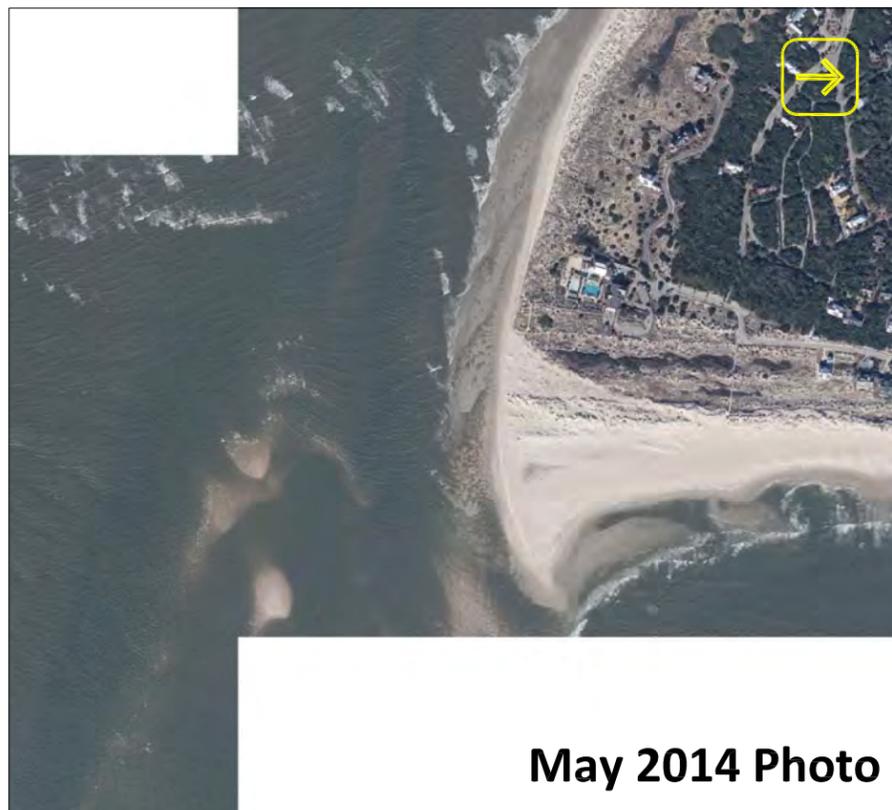
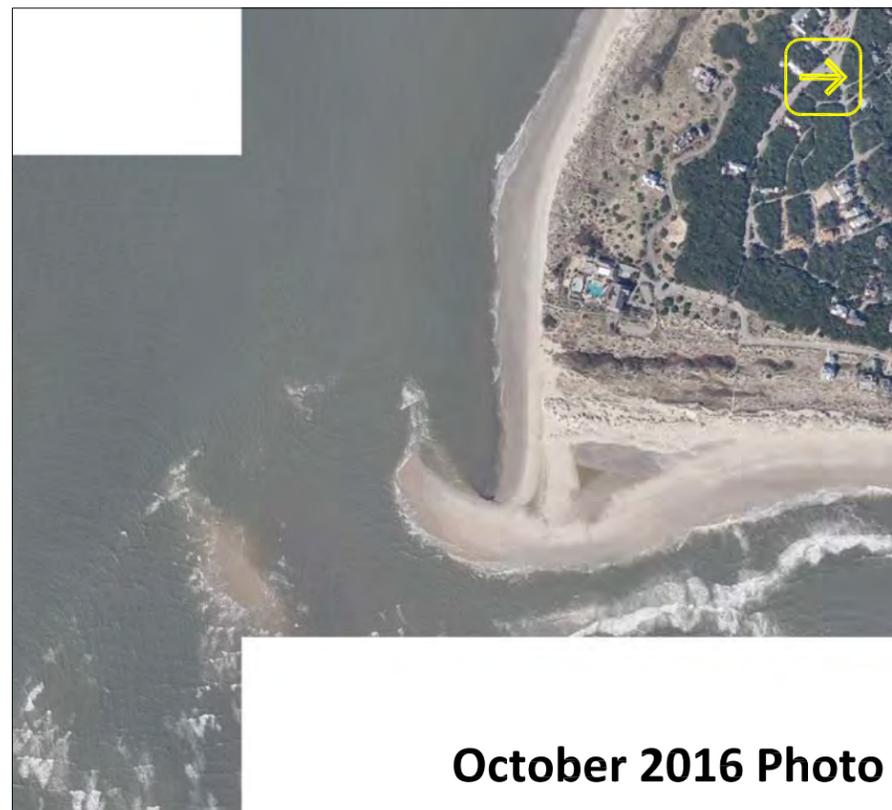
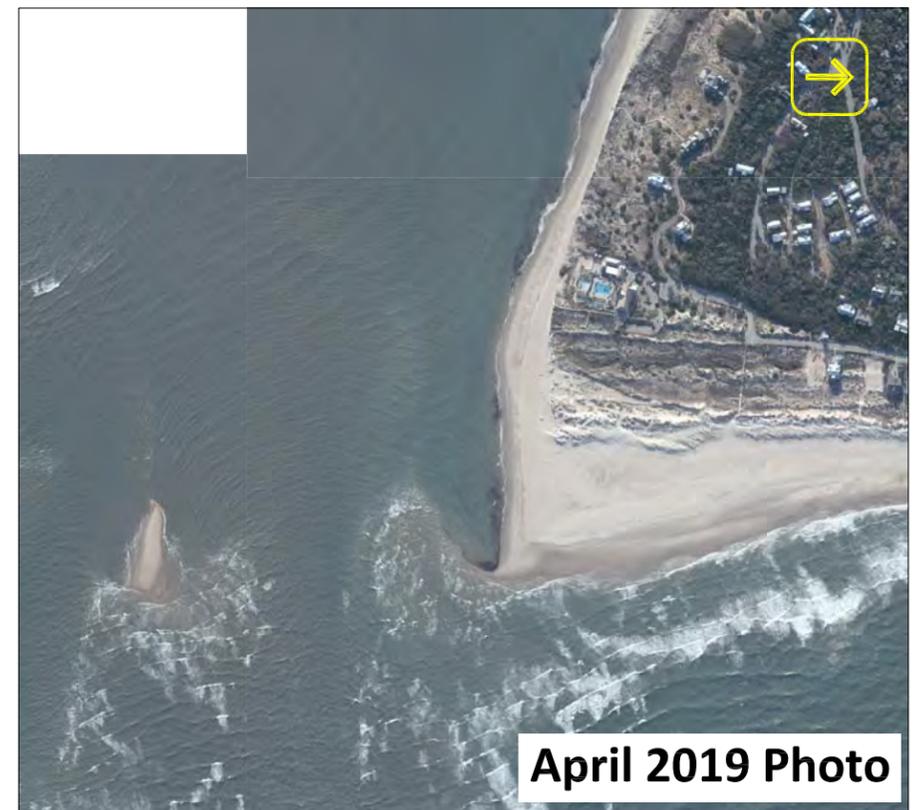
**Figure 5.10:**  
Cape Fear aerial photography  
Bald Head Island, NC

Although the location of the Cape Fear spit has been beneficial to East Beach properties, it has caused significant shoreline and dune recession seaward of the South Beach Shoals Club facility. That section of shorefront is monitored via beach profiles B-54 and B-55 (Sta. 214+00 and 218+00). The Shoals Club lies approximately mid-way between these two survey stations. May 2019 shoreline conditions are visually shown by **Figure B-9** (Appendix B – May 2019 Aerial Photography – page B-10). Since November 2000, the MHWL at profile B-54 has receded by -232 ft, or about -12 ft/yr. At B-55, over the same period of time, the MHWL has receded -294 ft, or about -16 ft/yr. More recently however, between November 2014 and May 2019, the MHWL at B-55 had receded by about -124 ft which equates to a rate of -28 ft/yr.

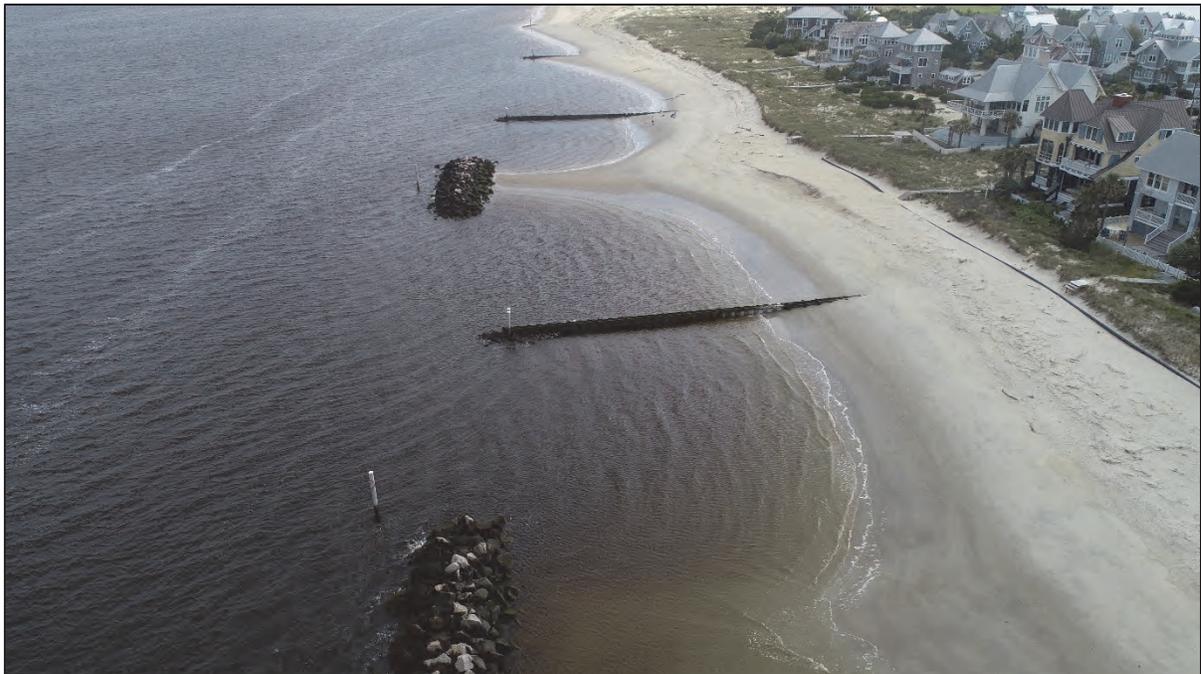
**Figure 5.11:** Northward looking view of the Row-Boat-Row shoreline detached breakwaters. (April 2019 Photo)

During the monitoring year (May 2018 to May 2019), the shoreline showed net losses of roughly -800 cy (-0.5 cy/ft) above the MHWL and -6,200 cy (-3.9 cy/ft) above -16 ft-NGVD. Similarly, the berm and MHWL receded by weighted averages of -3.9 ft and -13.6 ft, respectively over this period. This is irrespective of several sand bypass operations associated with marina channel maintenance.

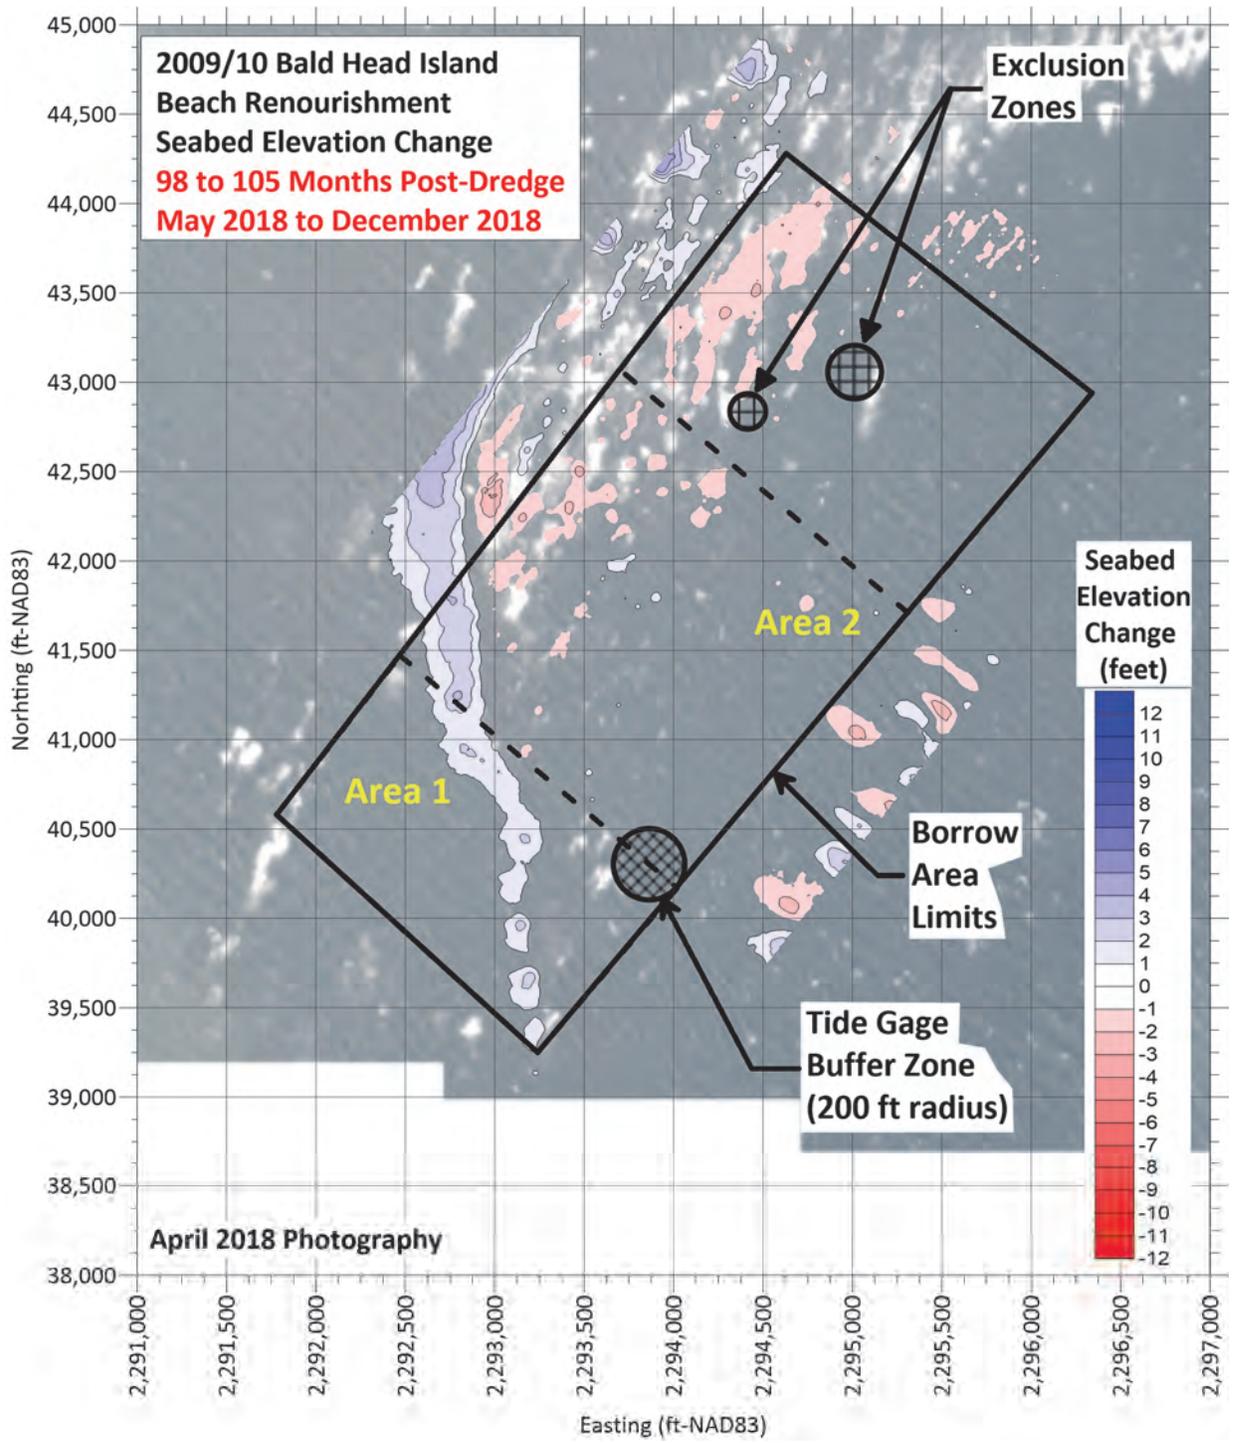
**Figure 6.5:** Jay Bird Shoals seabed elevation changes 98 to 105 months post-dredge (May 2018 to December 2018).

During the Year 9 monitoring period, prior to the 18/19 excavation (May 2018 to December 2018), the borrow site gained approximately +18,600 cy within the entire 09/10 *excavated* area. In the nine years since project completion (March 2010 to December 2018), the 09/10 *excavated* area gained roughly +680,300 cy or approximately 37 percent of the estimated dredge volume (-1,835,700 cy). Overall, within the *permitted* limits (both excavated and unexcavated), the borrow site gained +233,300 cy during this same period.
